THE EFFECTS OF A COLUMN DAMAGE TO STRUCTURAL BEHAVIOR OF A LOW-STRENGTH CONCRETE BUILDING

Atakan MANGIR*, Turgay ÇOŞGUN, Barış GÜNEŞ

Istanbul University, Faculty of Engineering, Department of Civil Engineering, Istanbul, Turkey

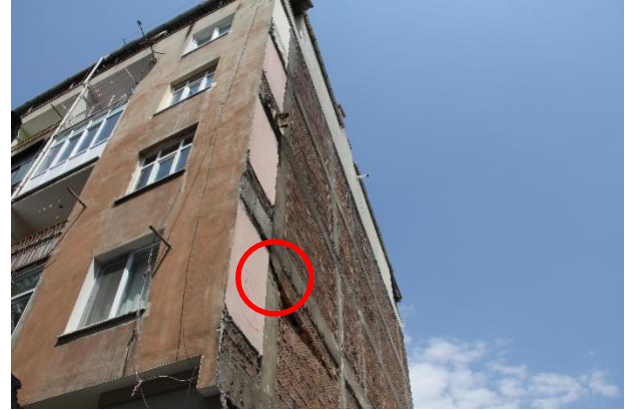
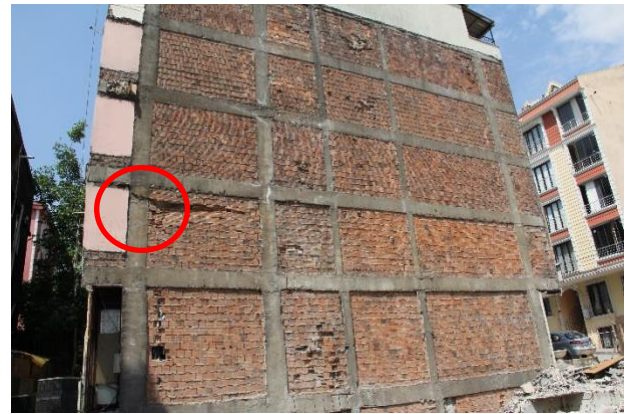
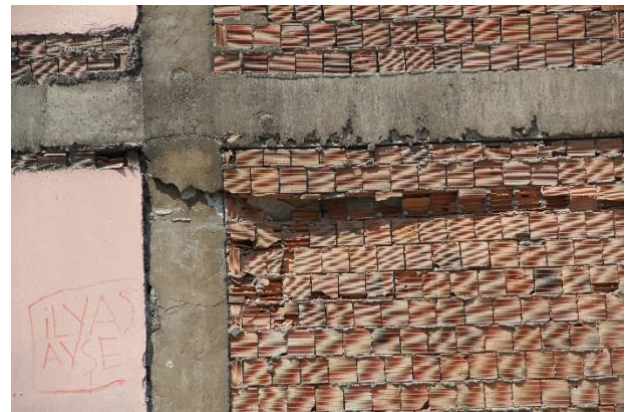
Figure 3. The damaged column (1/2)

A column located at the periphery of the 4th story has been damaged with a hit of a construction equipment during the demolition process in the next parcel. The exact location and the damage on the related column are shown in Figures 3 and 4.

The column is heavily damaged from a point near the top joint. It can be seen also in the next figures that the crack width is measured up to 5 cm. Some of the longitudinal reinforcements in the column are buckled and some of them are ruptured. It should be noted that, when the incident occurred, a part of the column was shifted from its vertical axis resulting in an undesired eccentricity. Thus, this situation should be considered while determining an appropriate strengthening method.

Two different strengthening approaches may be followed for this region. As the first option, the crack can be filled with high-strength cement-based materials. As the second option, the column can be re-

constructed keeping the unbuckled part of longitudinal reinforcements and total destruction of the damaged column. Thus, new bars will be attached to existing bars and concrete can be filled around. Since most of the existing reinforcements are ruptured in the related area, the second option will be preferable.

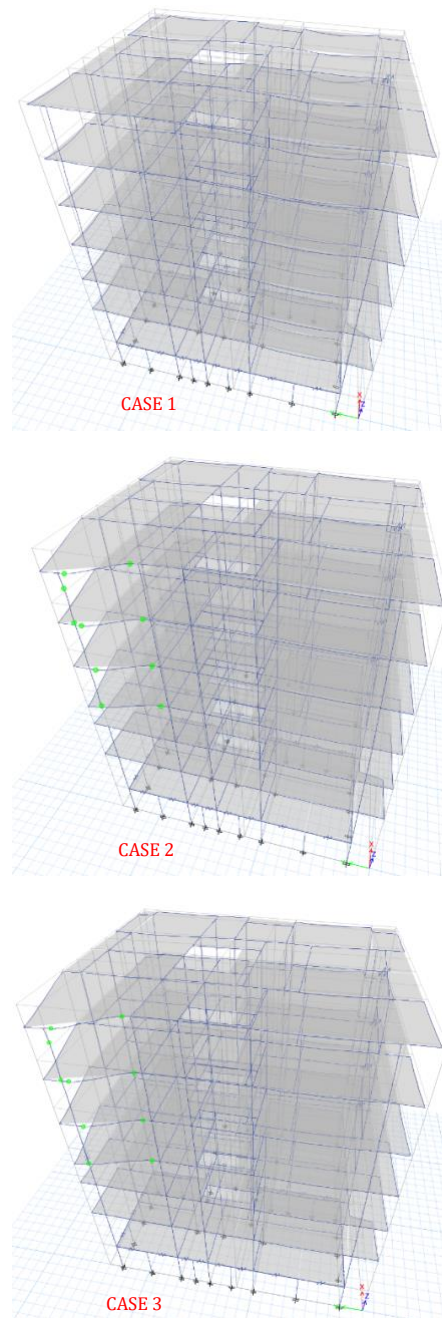
Figure 7. Plastic Hinge formation at the end of vertical pushover (Push-G) analysis

In the first case, no plastic hinge formation observed since the region was not damaged. In Case 2, the vertical deformation of the top joint is calculated as 21 mm. The vertical movement of the damaged region caused the formation of plastic hinges on the members located above the damaged zone. Since the first case's vertical deformation freedom on the damaged region's top joint is assigned to case 3 with a nonlinear gap element, similar plastic hinge formation is observed in the case 3. It should be noted that, in the case where the damaged zone is represented by a deleted column, the damaged region affected most of the beams connecting the columns on the upper floors. The plastic hinge formation on damaged members shows that, yield moment capacity of the members is exceeded and irreversible plastic deformations are occurred. The lateral pushover cases' hinge formations for both directions are given in Figure 8.

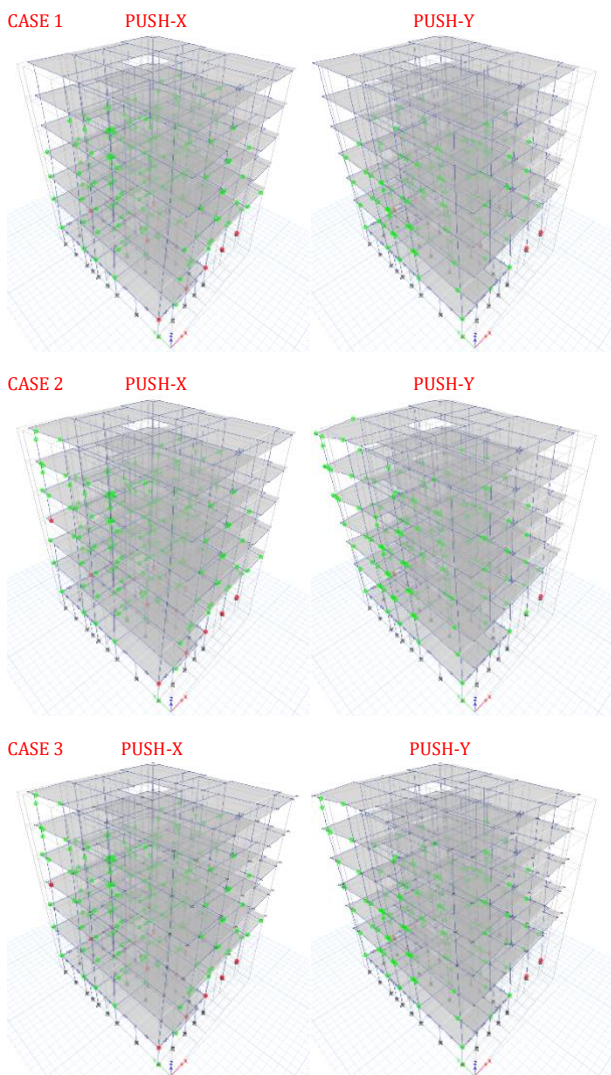
Figure 8. Plastic Hinge formation at the end of lateral (Push-X and Push-Y) pushover analysis

Deformed shapes at the end of lateral pushover analysis of all cases show that some columns located on the base floors exceeded their ultimate strain limit (red marked ones). Some beams and columns are also

exceeded their yield strain limit (green marked ones). The upper column located above the damaged zone reached its ultimate strain capacity in X direction's pushover analysis (Case2&3). This is because of previously occurred plastic deformations at the end of vertical pushover analysis. Most of the structural members located above the damaged region have irreversible plastic deformations in cases 2 and 3. Same members do not have such deformations in case 1. The results of an example plastic hinge on a beam connected to the damaged region (marked with a green circle in Figure 6) is shown in Figure 9 in order to compare the aforementioned effects. The pushover curves of both cases are given in Figure 10.

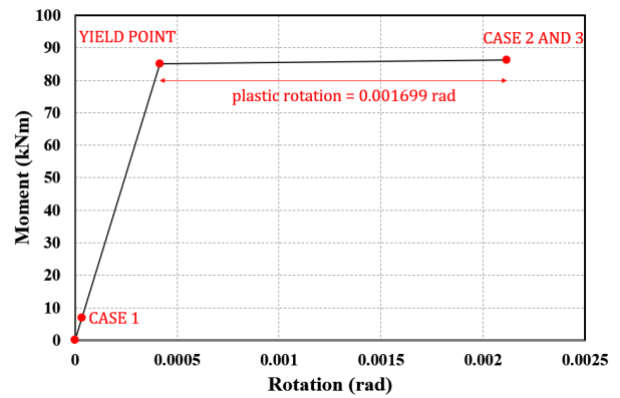
Figure 9. Moment-rotation results of an example plastic hinge at the end of the vertical pushover analysis (Push-G)

At the end of vertical pushover analysis (Push-G), the example beam exceeded its yield moment capacity

(around 85kNm) and plastic rotations are formed as 0.001699 rad in cases 2 and 3. However, when the same beams' plastic hinge state is considered for the undamaged case, the moment on the section is far below than the yield moment value (around 6.89 kNm) and there is not any plastic rotation occurred. In other words, for the undamaged model (case 1), the hinge states of the structural elements in the related region have remained in the elastic zone.

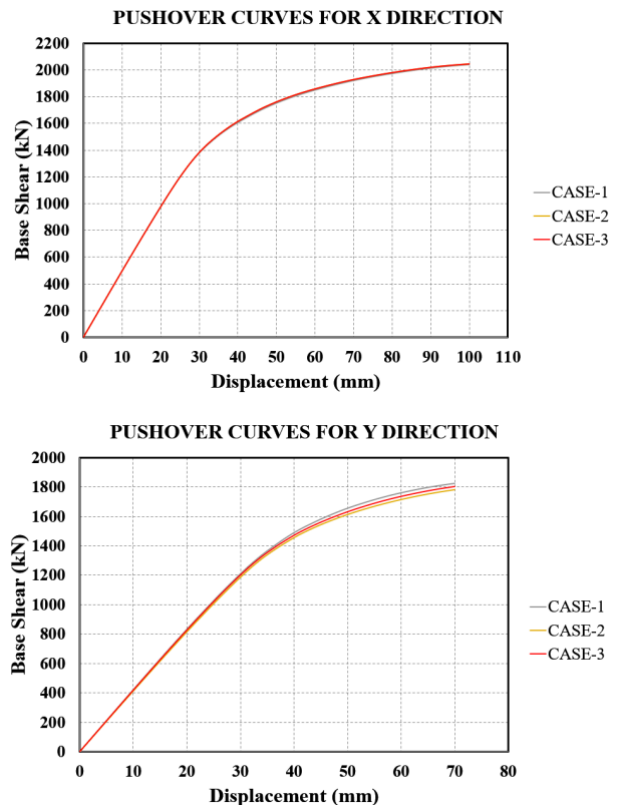
Figure 10. Pushover curves

It is understood from the pushover curves that in X direction, all of three cases have given nearly same results. However, case 1 has higher performance than case 3 which is also higher than case 2 in Y direction. The higher performance of case 3 than case 2 shows the effect of strengthening on the overall seismic performance of the building. When the base shear values are compared, the difference between three cases' results in Y direction is around 1.3%. Since the trend of the three curves is nearly similar, this value may not be considered as a significant difference. The maximum base shear for three cases are found around 2040 kN in X direction and 1840 kN in Y direction. The building's overall performance is not enough to reach the target displacement value. It can be said that the local damaged column does not have a significant role in the seismic performance of the building with respect to these results.
