## Büyük Depremler Sonrasında Yığma Yapılarda Görülen Tipik Hasar Mekanizmaları

## Typical Damage Patterns In Masonry Structures After Various Major Earthquakes

This study examines the seismic performance of masonry buildings in Turkey between 1992 and 2023, focusing on damage assessments after major earthquakes. Common failure mechanisms identified include out-of-plane wall collapse, inadequate connections between perpendicular walls, improper wall openings, and the absence of bond beams. Heavy compacted clay roofs, often used in rural masonry structures, contribute significantly to seismic vulnerability by increasing inertial forces. The irregular use of rubble stones and insufficient mortar adherence led to early structural degradation. The study emphasizes the need for improved construction practices, compliance with seismic codes, and effective retrofitting strategies to enhance the seismic resilience of masonry buildings. Lessons learned from past earthquakes can enable engineers and policymakers to develop more robust guidelines for future earthquake-resistant masonry construction.

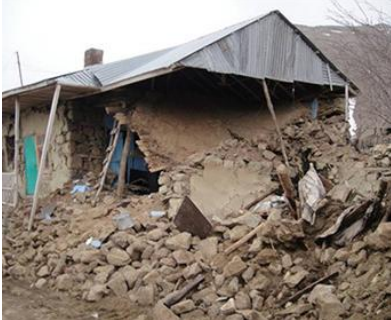
Ref.	Earthquake Name	Photos
[91]	2010 Kovancilar, Palu (Mw:6.0)

In rural areas, masonry buildings are the preferred construction method. On the other hand, they are generally constructed with poor workmanship and inappropriate materials. The smooth rubble stones used to construct these structures were gathered from the surrounding area and were often irregularly shaped. As a result of the lack of adequate friction between the masonry elements, the masonry buildings became seismically unstable. Various views of the current damage are shown in Table 3.

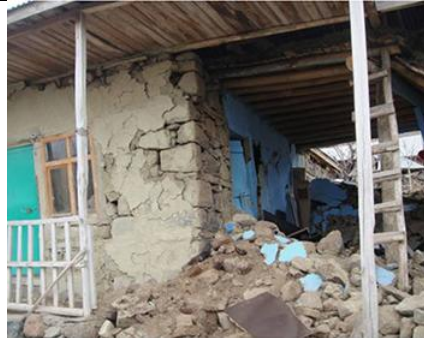
Ref.	Earthquake Name	Photos
[91]	2010 Kovancılar, Palu (Mw:6.0)

The shear strength of masonry walls mostly depends on the adhesion provided by the mortar connecting individual masonry units. Previous Turkish Codes, TEC (1998–2007), specified that lime mortar reinforced with cement or cement mortar may be used as the binding in load-bearing walls. Moreover, according to TBEC 2018 and Eurocode 8, the recommended minimum strength values are 5 MPa for unreinforced and 10 MPa for reinforced masonry. Previous investigations indicate that a mud mortar binder was utilized in nearly all stone masonry structures (Table 4). These structures have low compressive strength due to the use of mud mortar, which is not as strong as cement mortar. Additionally, the lack of proper reinforcement in wall intersections weakened the overall stability of these buildings.

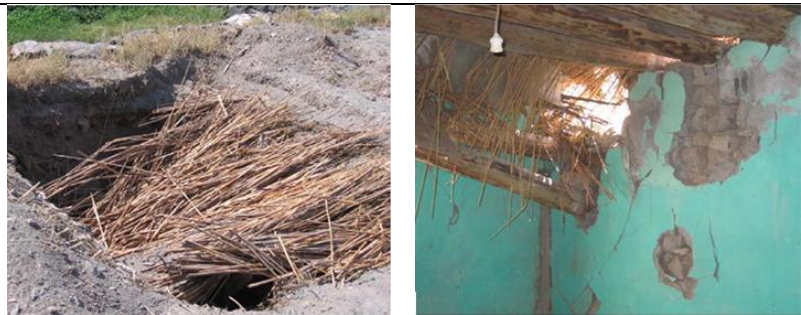
Ref.	Earthquake Name	Photos
[9]	2004 Doğubeyazıt (Mw:5.2)

Another important reason for the collapse of masonry structures is heavy compacted earthen roof system. This type of system is commonly constructed to address harsh environmental conditions. The aim of this application was to isolate the earthen roofs for the water leakage. The thickness of the roof increases over time, and this heavy roof significantly increases the mass of the structure, thereby increasing the seismic forces acting on the structure during an earthquake. Moreover, the wooden bond beams of the roof system were supported in one direction to the load bearing walls. These walls are subjected to vertical loads because of the heavy earthen roof. Other walls which are not supported with wooden logs behave as cantilever components are vulnerable to seismic loads. Out-of-plane failures may occur in these walls. To prevent this type of damage, roof systems should be constructed with lighter elements and wooden bond beams should be supported in two perpendicular directions. Examples of failures caused by heavy earthen roofs are presented in Table 5.

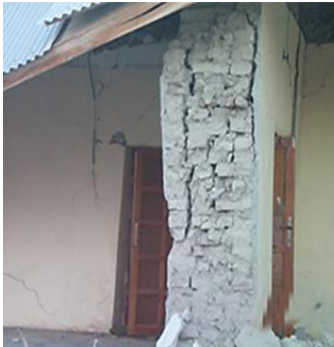
Ref	Earthquake Name	Photos	Ref	Earthquake Name	Photos
[92]	2011 Van (Mw:7.2)

In rural areas, structural walls consist of inner and outer layers, which are generally formed with stones of different sizes. However, these walls constructed without an interlocking component. For this reason, cavities are observed between the inner and outer walls. These cavities further reduce the shear strength of the walls, thereby increasing their vulnerability during an earthquake. Although the proportion of cavities was not determined or measured, previous field observations have shown that when the cavity ratio is greater than 10–15%, remarkable reductions can occur in the shear capacity of the walls [21]. Typical earthquake-resistant wall cross sections are shown in Figure 6, and examples of this type of damage are given in Table 6.

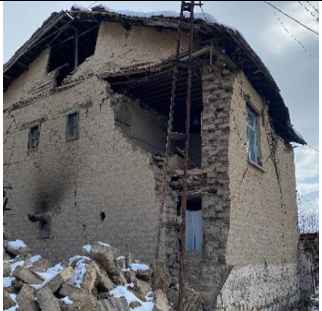
Ref	Earthquake Name	Photos	Ref	Earthquake Name	Photos
[74]	2023 Kahramanmaraş (Mw:7.6 and 7.7)

Insufficient connections between perpendicular walls and the absence of vertical and horizontal bond beams can lead to severe corner damages, especially under seismic loading. TBEC 2018, Eurocode 6, and Eurocode 8 emphasize the importance of effective wall connections, mechanical interlocking, and bond beams to mitigate these vulnerabilities. TBEC 2018 mandates the application of horizontal and vertical bond beams to reinforce intersections and prevent corner failures, while Eurocode 6 emphasizes the importance of mechanical interlocking between masonry walls to maintain structural integrity. Eurocode 8 provides additional regulations for enhancing ductility and energy dissipation capacity of masonry structures, requiring the use of horizontal tie beams or ring beams at every floor level to strengthen wall intersections and resist lateral forces. It categorizes unreinforced masonry as low-ductility construction and discourages its use in high-seismicity regions unless confined or reinforced. The absence of these essential design elements results in a high vulnerability to lateral loads, leading to severe damage in the form of corner separations, instability, and structural collapse. Compliance with these regulatory provisions is essential to provide the structural integrity and seismic resilience of masonry buildings. Some corner damages are given in Table 7.

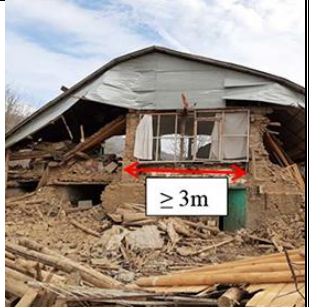
Ref	Earthquake Name	Photos	Ref	Earthquake Name	Photos
[32]	2020 Sivrice (Mw:6.8)

The incorrect placement of openings constitutes a primary form of damage. The Turkish Building Earthquake Code 2018 (TBEC 2018) imposes some restrictions concerning the spacing between openings, the dimensions of windows and doors, and the distance from openings to the wall corners. In masonry structures, walls are the sole components that resist to interior and exterior loads. Figure 7 shows the required standards for openings in load-bearing walls, as given in TBEC 2018. Most masonry constructions were damaged due to the inadequate distance between the opening and the building corner. This category of damage is given in Table 8.

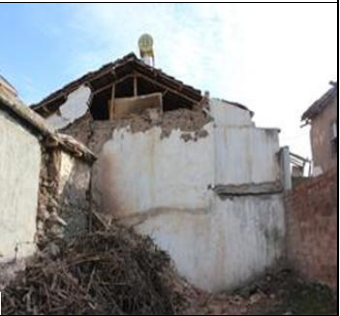
Ref	Earthquake Name	Photos	Ref	Earthquake Name	Photos
[21]	2011 Van (Mw:7.2)

The majority of the gable walls were constructed without bond beams. They are vulnerable to earthquakes. This damage is not the primary structural damage falling parts of wall may be cause loss of lives and properties.

The primary causes of this type of damage include extensive unsupported wall length, insufficient wall-to-wall connections, and inadequate wall-to-floor contact. The Turkish Seismic Code 2018 mandates the vertical and inclined reinforced concrete bond beams to prevent damage at gable walls that exceed 2 meters in height. Schematic view of the gable wall utilizing reinforced concrete bond beam is given in Figure 8. Table 9 is shown the failures of the gable walls.

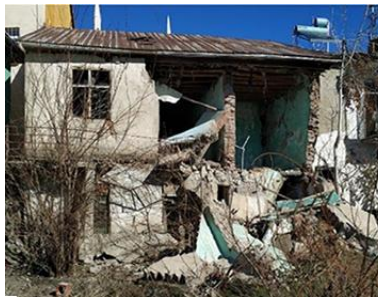
Ref	Earthquake Name	Photos	Ref	Earthquake Name	Photos
[34]	2020 Sivrice (Mw: 6.8)

Out-of-plane failure is common damage type which observed in masonry structures. This type of damage is generally seen by poor wall-to-wall connection, long unsupported wall length, not using vertical and horizontal beams, lack of rigid diaphragm, and poor adherence between wall units. To prevent these damages in masonry structures, the TBEC stipulates that the maximum unsupported wall length must not exceed 5.5 m in Seismic Design Categories (SDC) 1, 1a, 2, and 2a, and 7.5 m in SDC 3, 3a, 4, and 4a in plan view (Figure 9.a). Each 4-meter-long vertical bond beam should be added into the plan. Also, the unsupported wall length must not exceed 16 m (Figure 9.b) (TBEC 2018).

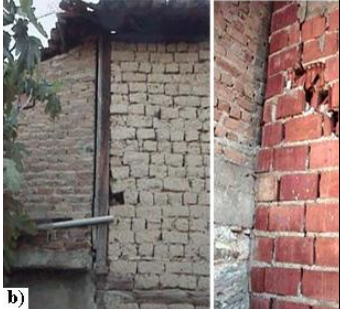
Ref	Earthquake Name	Photos	Ref	Earthquake Name	Photos
[102]	2003 Denizli (Mw: 5.6)

According to previous earthquake codes (TEC-1998 and TEC-2007), natural stones, solid bricks, vertically perforated bricks, solid concrete briquettes, and adobe bricks could be used in load-bearing walls. However, TBEC (2018) prohibited the use of hollow concrete briquettes, infill bricks, adobe bricks, and rubble stones as load-bearing wall elements. The TBEC 2018 and Eurocode 6&8 stipulate that the minimum compressive strength of masonry units must be 5 MPa. When the compressive force exceed the compressive strength of the masonry units, minor vertical cracks may develop in the masonry components. Table 11 presents various examples of this damage.
