# Recommendations for Improving Earthquake Damage Assessment Methods: Insights Drawn from the Türkiye Kahramanmaraş Earthquakes of February 06, 2023

Bengi Polat<sup>1\*</sup>, Ceren Ağın Gözükızıl<sup>2</sup>, Senem Tezcan<sup>3</sup>

## Abstract

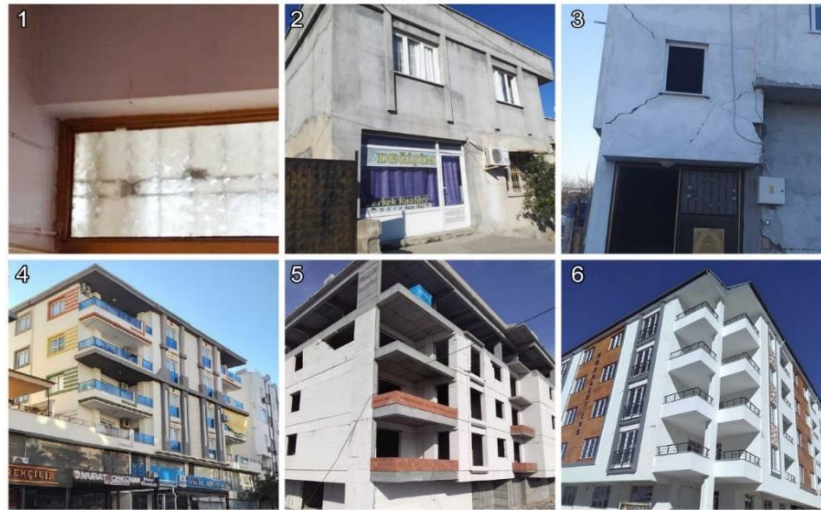
Figure 5: No Objection Buildings

- About Building 1, the participants who assessed it as moderately damaged stated that the photographs were insufficient and it was unclear whether the crack was a plaster crack or a structural one.
- For Building 2, all participants indicated that it was undamaged.
- In Building 3, the participants had the same opinion about the need for intervention.
- About Building 4, the participant who assessed it as moderately damaged stated that the crack on the wall could not be understood and there might also be damage to the load-bearing elements.
- In Building 5, one participant indicated that although it was not a structural issue, there was damage in the areas where the plaster was missing.
- For Building 6, the experts who assessed it as moderately damaged stated that the damage might be in the load-bearing element.

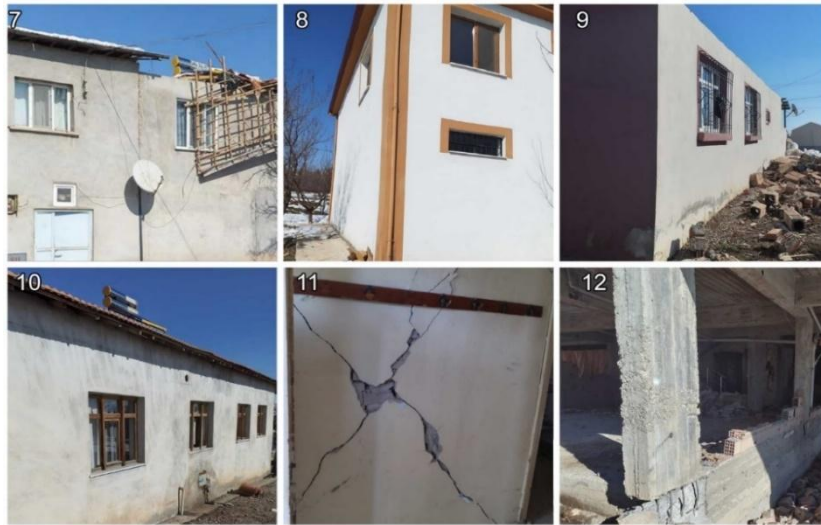
Figure 6: *Unchanged Damage Assessment Buildings*

•In Building 7, roof damage was the primary issue highlighted by the participants. It was noted that it was unclear from the photos whether the load-bearing system had been damaged or not. The building's poor quality was also mentioned.

•In Building 8, all participants reported no observable damage.

•In Building 9, while the participants stated that the building was undamaged, they noted the difficulty in making a conclusive assessment due to the absence of interior photos.

•In Building 10, the evaluations indicated undamaged or slightly damaged. However, the participants emphasized that the crack visible from the outside should also be inspected from the inside, since there could be unseen damage.

•In Building 11, one participant assessed it as moderately damaged, while the others classified it as severely damaged. The building's poor quality and the unclear construction system were the main issues discussed.

•For Building 12, all experts shared the opinion that the building required intervention because of the damage.

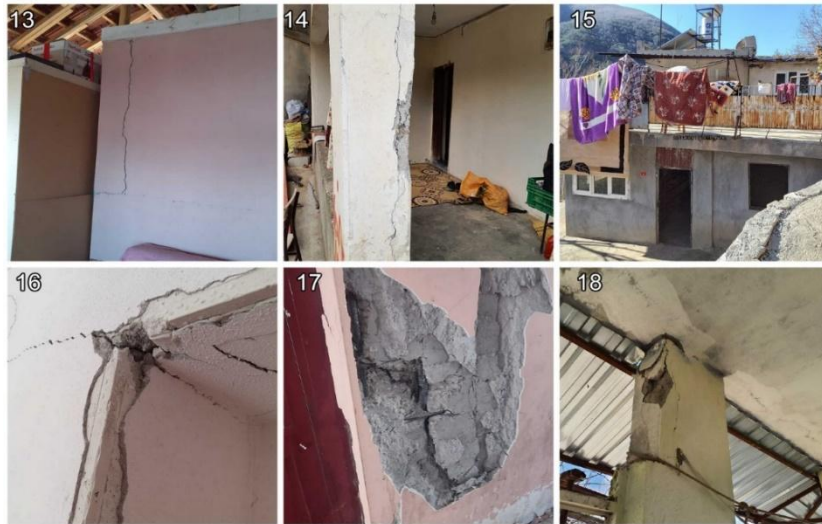
Figure 7: Changed Damage Assessment Buildings

- In Building 13, the participant who assessed it as severely damaged stated that there was damage to the load-bearing wall and the roof. Those, who assessed it as slightly damaged, think that the damage was limited to the infill walls and did not cause any damage to the load-bearing system.

- In Building 14, those who assessed it as slightly damaged suggested that the vertical crack seen in the free-standing column which was suspected to be the part of an addition made later, was probably a plaster crack. Those who rated it as moderately damaged did so because the damage appeared to be limited to a single column in the photo. Those who assessed it as severely damaged believed there was damage to the load-bearing system and that there could also be unseen damage not visible in the photos.

- In Building 15, participants who considered it undamaged or slightly damaged reported no visible damage to the load-bearing system. Those who assessed it as moderately damaged mentioned that there might be damage not visible in the photos, such as cracks that appeared in the walls. Structural issues like the building's poor quality and the thickness of the slab were also noted.

- In Building 16, participants who rated it as moderately or severely damaged pointed out damage to the load-bearing system, particularly at the beam-column joints. Those who assessed it as severely damaged noted visible reinforcement, shear cracks, plastic hinges, and a compromised frame system.

- In Building 17, the damage was reported by participants as severe with visible reinforcement, deformed stirrups, and other reinforcements, indicating the structure had been significantly stressed.

- In Building 18, participants who rated it as slightly damaged believed that the damage, because it is located in the terrace area, did not affect the structure. Those who rated it as moderately damaged thought the damage at the top of the column could be resolved with reinforcement. Those who assessed it as severely damaged suggested that there might be load-bearing damage elsewhere in the structure. The building quality, materials, and construction techniques were again emphasized as important factors.
