FAILURE ANALYSIS OF A SUPERHEATER PIPE BASED ON MICROSTRUCTURE / MECHANICAL PROPERTIES STUDY

R. Bakhtiari, M. Ahmadian, A. Olfati, M. Derhambakhsh

Original scientific paper

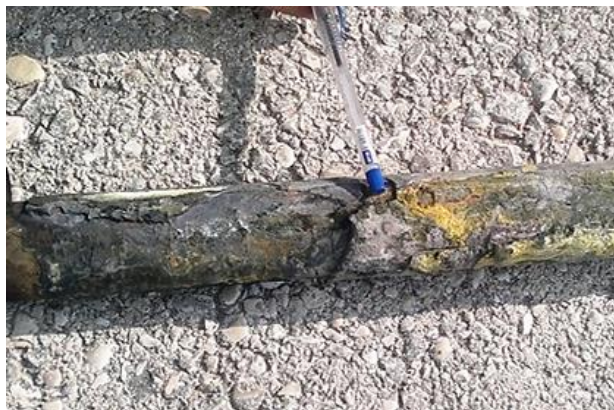
Figure 1. Combustion deposits on the outer surface of the damaged superheater pipe.

The damaged pipes were studied visually. The observation showed that the whole outer surface of the pipe was covered with a thick and continuous layer which was the deposits of combustion exhaust (Fig. 1). Formation of the deposits on the outer surface of the pipe increased the working temperature of the pipe which resulted in severe hot corrosion and oxidation. Therefore, the pipe was exposed to damage under higher internal pressure and higher working temperature than the design. The deposited layer thickness was determined to be 6 mm which was high enough to cause damage.

- Controlling the boiler temperature to prevent unwanted temperature rise during service.
- Selecting appropriate steel for service conditions of the boiler.
- Lowering oxide deposits inside the pipe using proper acid washing.
- Using fuels with appropriate composition to control the content of undesirable elements such as sulfur.
- Using sandblast to clean the outer surfaces of the pipes.

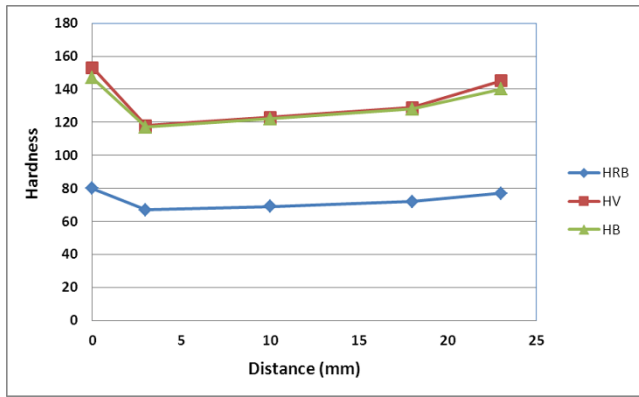
In order to determine the hardness variation in the damaged area of the pipe, a hardness profile was plotted (Fig. 2). The results showed that the hardness of damaged area was the highest value but this value was not high enough to cause brittle behavior. Cold working at the fractured area at the service conditions can be the reason for slightly higher hardness of this area.

Figure 2. Hardness profile as a function of distance from the fracture area of the damaged pipe.

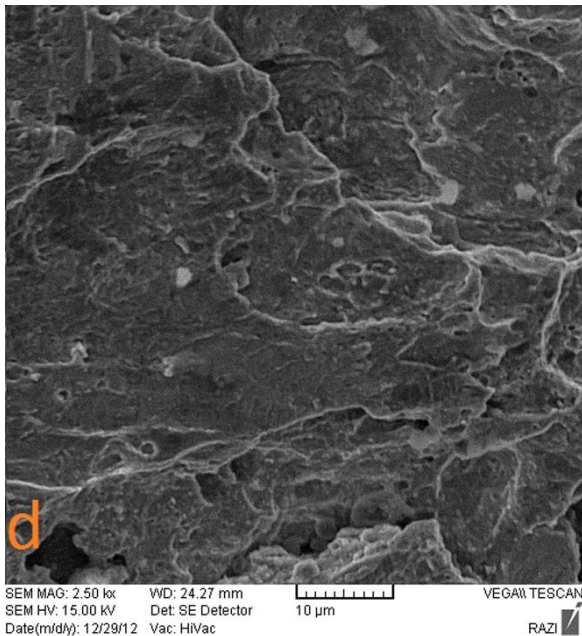
Inner surfaces of the superheater pipes are in contact with hot and high pressure steam. Therefore, oxidation occurs on the inner surface of the pipe and thickness reduction will result due to the pressure and flow of the steam. This can be a factor in superheater pipe failures. Fig. 3 shows the inner surface of the damaged superheater pipe which contains layered oxidation. These oxidations are visible at the surface and their thickness can show the oxidation volume. Studies have shown that these layers could be iron oxide that formed with the presence of oxygen under favorable thermodynamic conditions. The related reaction is the following:

Figure 3. SEM micrograph of inner surface of the damaged pipe containing layered iron oxide.

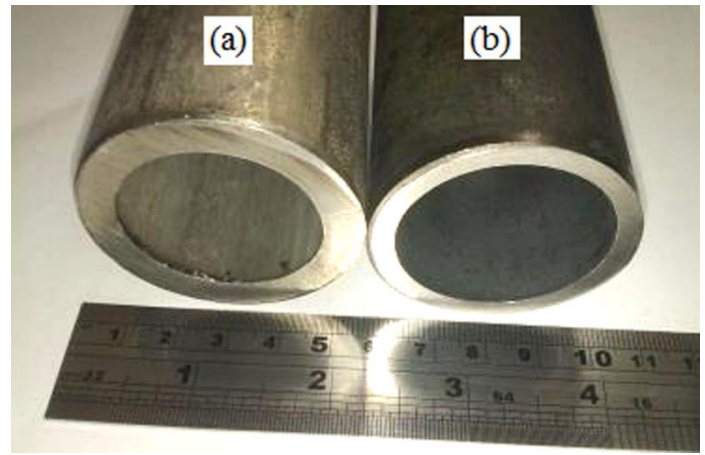
For further study, the internal diameter of a new and damaged pipe of a similar lot was measured. Fig. 4 shows the comparison of the thickness reduction for the pipes. Results showed that the internal diameter of the damaged pipe increased by 2 mm and its thickness was reduced.

Figure 4. Comparison of thickness reduction between the (a) original and (b) damaged pipes.

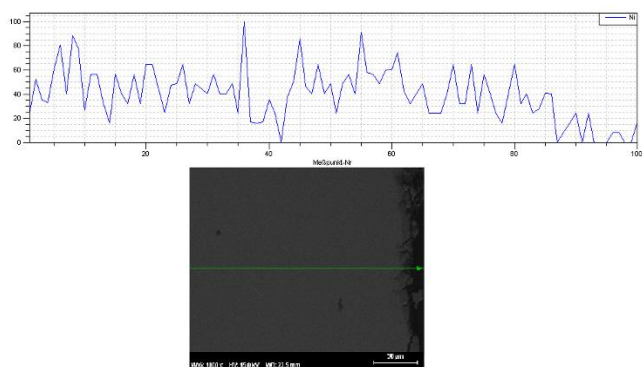
According to Table 2, the compounds also contain nickel and chromium. There are several sources of nickel to be deposited on the outer surface of the pipe such as boiler fuel in the combustion chamber and the burner nozzle. These nozzles are generally made of nickel-based superalloys, which could release nickel to be deposited on the adjacent pipes. Line scan analysis of nickel across the fracture area on the outer surface of the pipe is shown in Fig. 5. This profile indicates a high content of nickel in the surface deposits.

Figure 5. Line scan analysis of nickel across the fracture area on the outer surface of the pipe.

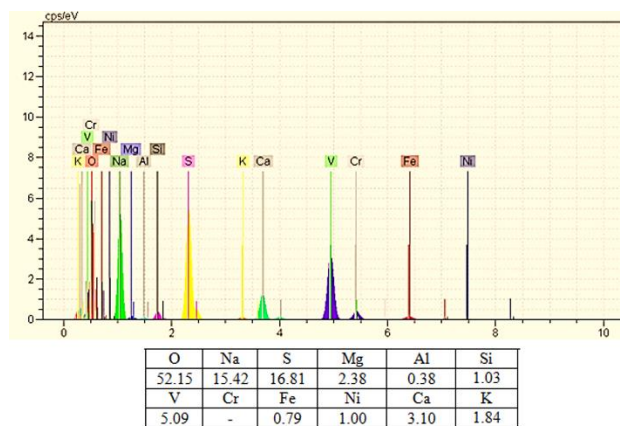
The most harmful elements in fossil fuels are vanadium, sodium and sulfur. These elements can form low melting point (249-677oC) complexes. The resulting liquid dissolves iron oxide, and this molten layer facilitates oxygen transport and oxidation of the pipe outer surface. The SEM/EDS analysis of dark green deposits on the outer surface is shown in Fig. 6. Due to the high percentage of vanadium in the deposits and also the presence of sulfur and sodium, the formation of Na₂SO₄ and its combination with V₂O₅, which leads to formation of sodium vanadate complexes, is probable. These complexes have low melting points and cause adhesion of ash particles on the pipe outer surface and therefore reduction of heat transfer.

Figure 6. SEM/EDS analysis of dark green deposits on outer surface of the damaged pipe (wt.%).

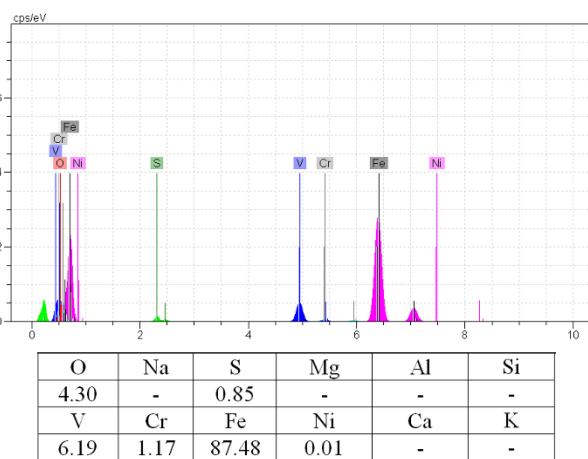
Analysis of yellow-green deposits (Fig. 7) showed that the content of elemental vanadium was the highest. Some vanadate complexes is known as the most corrosive compounds. Furthermore, the content of sulfur is considerable (according to Fig. 7), and sulfur compounds have an important role on the corrosion of the pipe. Therefore, combustion deposits could be considered as one of the most important factors of failure in the superheater pipes. The results of all analyses showed the content of calcium of 2-4% which caused high strength scale deposits to form on the outer surface of the pipes.

Figure 7. SEM/EDS analysis of yellow-green deposits on outer surface of the damaged pipe (wt.%).

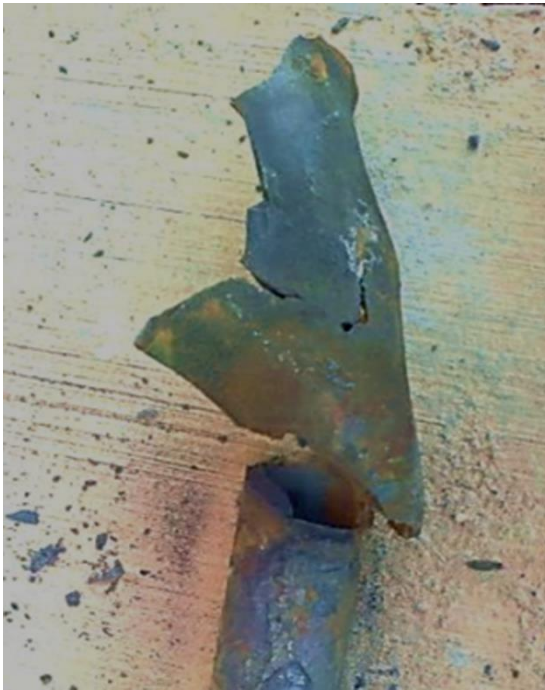
In this study, fracture of superheater pipes was observed to occur at the knee bends in some cases (Fig. 8). Due to the high heat concentration at knee bends, severe deformation and rupture occurs. Therefore, these parts are among the most frequently fractured areas in the boiler. Being in direct contact with flame and hot corrosion and oxidation, as well as deposits from fossil fuel combustion exhaust, causes thickness reduction of the pipe and finally a sudden failure.

Figure 8. Fracture of a superheater pipe at the knee bends.

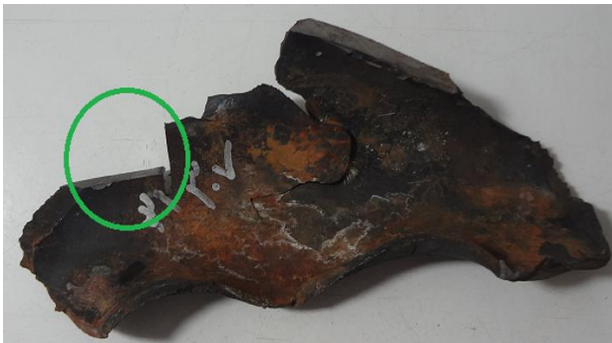
In other damaged samples, the failure occurred next to the knee bends. According to Fig. 9, these damaged pipes have sharp edges. In this case, plastic yielding at high temperatures can result in opening up the pipe and forming sharp edges. Also, the fracture mechanism can be crack nucleation at the parts which lost their thickness and then a rapid crack growth and final fracture. The rapid growth of cracks can be due to sudden increase of pressure in the pipes.

Figure 9. Fracture of a superheater pipe next to the knee bends (Highlighted area is the location used for SEM studies).

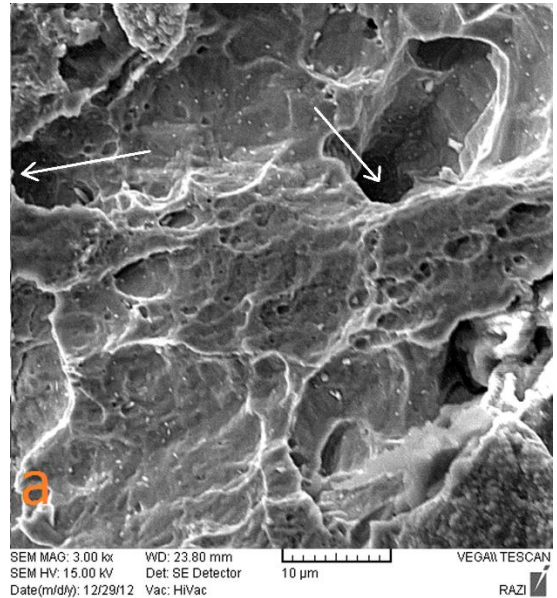
An SEM micrograph of the fractured area at a knee bend (Fig. 8) is shown in Fig. 10. According to this figure, growth of deposits because of exposure at high temperatures caused formation of cavities at the fracture surface. In steels, hydrogen damage takes place generally in the presence of atomic hydrogen. In humid atmospheres and at high temperatures, corrosion and electrolysis reactions can lead to atomic hydrogen formation via the reduction of hydrogen ions. Some of these atomic hydrogen form molecular hydrogen again and the others penetrate into the steel structure. The penetrated hydrogen atoms gather in grain boundaries and form cavities. Furthermore, some dimples are visible in Fig. 10. The dimples can show relatively ductile fracture. As discussed before, the plastic deformation caused formation of sharp edges at the damaged pipe.

Figure 10. SEM micrograph of the fractured area at a knee bend including cavities (indicated as white arrows).

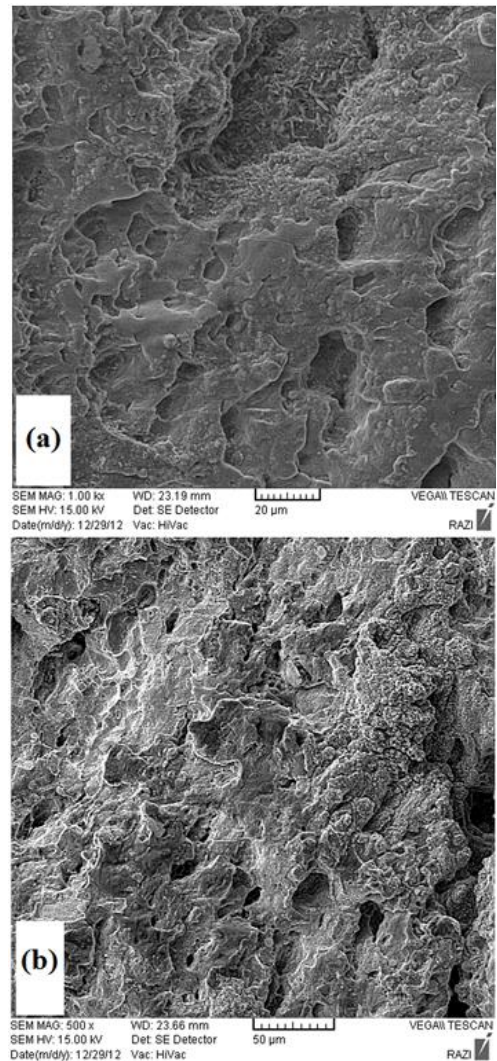
Fossil fuel combustion deposits on the outer surface of pipe surfaces can lead to hot corrosion and severe oxidation. In Fig. 11.a, the deposits, which can be mainly sulfur-riched, are accumulated and have cavities. In Fig. 11.b, vanadium-riched deposits, with higher hardness in comparison with those of Fig. 11.a, can be detected which have a melting point at about 600°C.

Figure 11. SEM micrograph of (a) fossil fuel deposits and (b) hard oxide layer on the outer surface of the damaged pipe.
