Failure Analysis of Jet Turbine Engine High Pressure Nozzle Material Made of Cobalt Based Super Alloy

Ozan Çoban, Özgür C. Arslan, and Tuba Karahan

Metallurgical and Materials Engineering Department, Istanbul Gedik University
Kartal Campus, Kartal/Istanbul, 34876, Turkey
ozan.coban@gedik.edu.tr; ozgurcagatayarslan@outlook.com; tuba.karahan@gedik.edu.tr

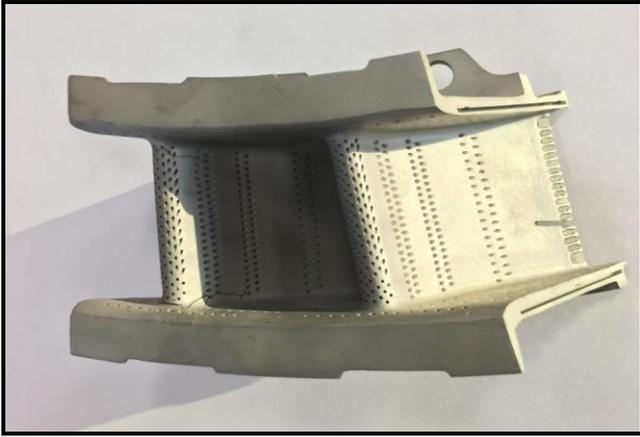
Figure 1. First stage high pressure nozzle

The material on which failure analysis has been carried out is a cobalt based superalloy which had operated for 30,000 hours inside the General Electric CF6-50 high bypass turbofan engine as first stage high pressure conveying nozzle and it has been shown on Figure 1.

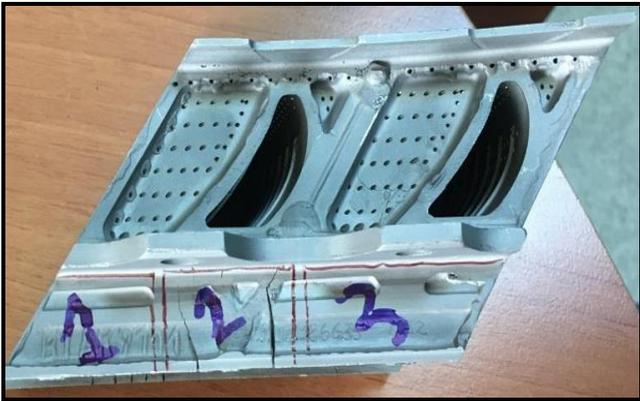
Figure 2. Sampling zones

After visual inspection, sampling was carried out from the macro crack zones and also non-damaged parts for comparison. The sampling zones of the sample and the names of zones were shown on Figure 2.

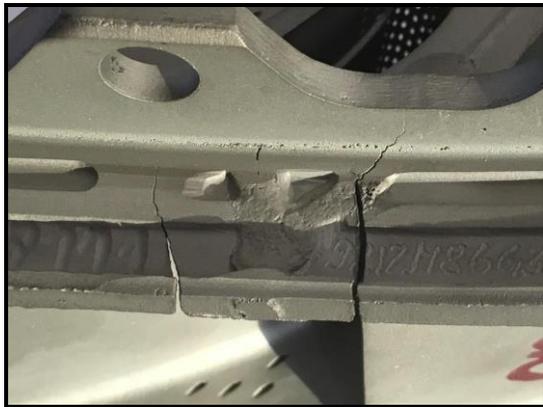
Figure 3. Failure zone detected by visual inspection

As the first step for failure analysis of the sample which had operated for 30,000 hours in turbine engine combustion chamber, visual inspection was carried out and macro fractures and macro cracks were detected on outer surface as shown on Figure 3.

As the result of visual inspection, 2 main fracture failures and 1 macro crack failure were detected. The failure has occurred on a zone on which hot and high pressure gas might have been circulated and which is close to the connection zone with the platform. Both high temperature and pressured gas were existed around that zone and also stresses might have occurred on it. For that reason, it has been thought that the failure mechanism would be a stress-corrosion cracking.

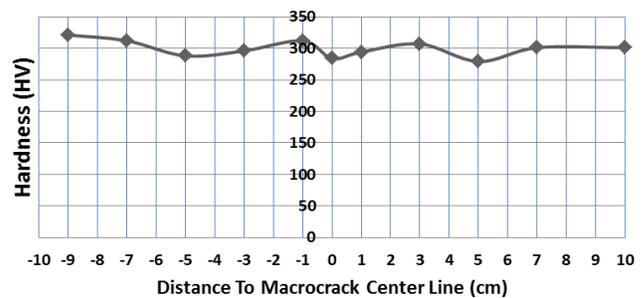
Figure 4. Hardness test result

Before the microstructural analysis, hardness tests were carried out on different points which have particular distance to macro crack center line. Hardness test results have been shown on Figure 4. Hardness values are approximate to each other in macro scale. Therefore, it was thought that locational hardening due to heat treatment effect or softening due to grain size growth should not have been occurred on the microstructure.

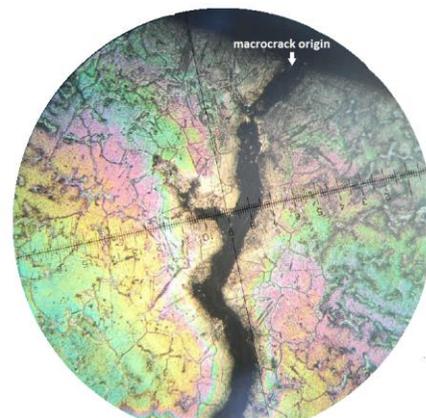
Figure 5. Microstructure of macro crack zone (100x – electrolytic etched with 6% chromic acid + 10% HCl)

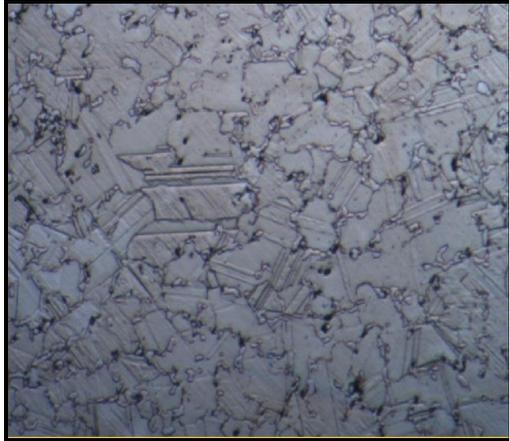
On Figure 6, the microstructure of the area that macro crack had occurred and propagated through has been given. When we looked at the structure of the crack, we thought that macro crack could have occurred by growth of intergranular micro cracks. In order to understand the mechanism of failure, first, microstructural investigation of non-damaged zone was carried out. On Figure 6, the microstructure taken from zone 3 has been given.

Figure 6. Microstructure of cobalt based superalloy (100x – electrolytic etched with 6% chromic acid + 10% HCl)

Twinnings inside the austenitic matrix of face centered cubic (FCC) structure and also carbide precipitations on grain boundaries and inside the grain can be seen on the microstructure that given on Figure 6. The transformation of lattice structure from face centered cubic (FCC) to hexagonal closed pack (HSP) structure occurs on cobalt based superalloys over 417⁰C. In order to avoid this transition, cobalt based superalloys are alloyed with nickel [3]. Because our material includes nickel over than 10 %, it could be understood that the lattice structure of the matrix is FCC. The basic phases that affect the mechanical properties of cobalt based superalloys are the carbide phases. Therefore, the microstructures of carbides have been investigated and the results were obtained as;

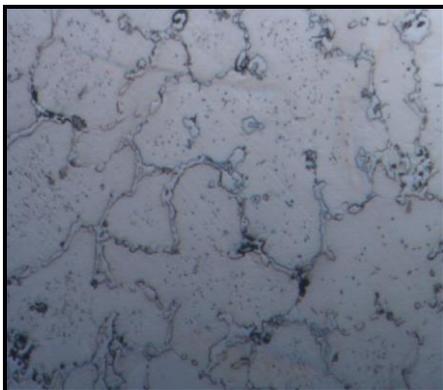
Figure 7. Microstructure of carbides obtained from non-damaged zone (100x - electrolytic etched with 6% chromic acid + 10% HCl)

The microstructure obtained from zone 2 but far from the main fractures and macro crack has been given on Figure 7. It can be seen on microstructure that spherical and chain type carbides have precipitated on the grain boundaries. However it has been detected that, the morphologies of carbides are changing by approaching to the macro crack. When the microstructure, obtained from closer point to macrocrack, given on Figure 8 is considered, it can be seen that some of the spherical and chain type carbides, are replaced by continuous formed carbides.

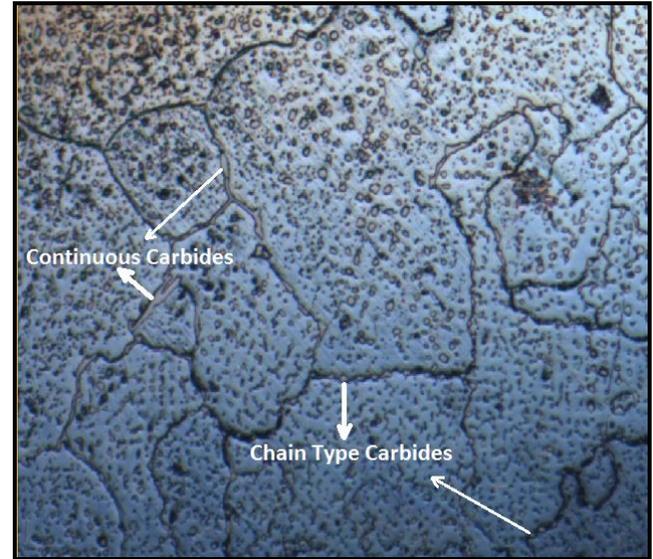
Figure 8. Microstructure of carbides obtained from closer zone to macrocrack (100x - electrolytic etched with 6% chromic acid + 10% HCl)

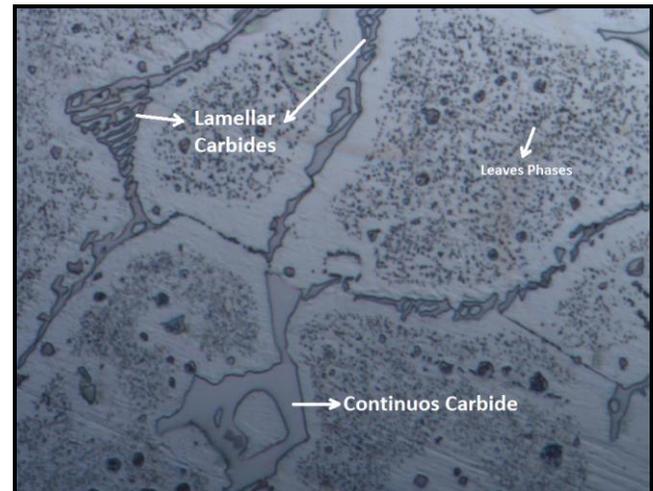
When we get closer to the macro crack, it can be seen that the amount of continuous formed carbides are increasing as shown on the microstructure that given on Figure 9.

Figure 9. Microstructure of carbides near the macrocrack (200x - electrolytic etched with 6% chromic acid + 10% HCl)

Lamellar morphology carbides and continuous formed carbides precipitated on grain boundaries and also other types of carbides and leaves phases inside the grains can be seen on the microstructure given on Figure 9.

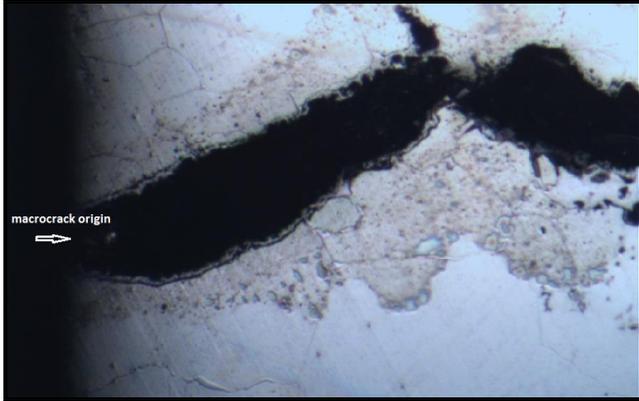
Figure 10. Microstructure of macrocrack origin (100x – slightly chemically etched with Kallings No:2)

Microstructure of macrocrack origin zone, which had been slightly chemically etched, has been given on Figure 10. Due to the fact that oxides are electrochemically affected by etchants more than metallic phases, it has been thought that the brown colored parts surrounding the crack could be hot corrosion products. After that estimation, we decided to carry out electrolytic etching.

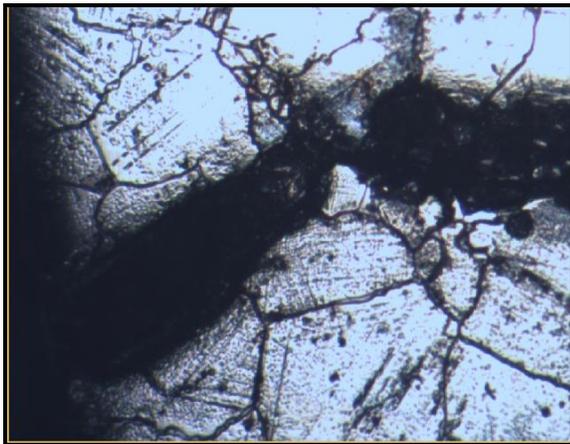
Figure 11. Microstructure of macrocrack origin (100x – electrolytic etched with 6% chromic acid + 10% HCl)

On the microstructure of macrocrack zone has been given on Figure 11, intergranular corrosion cracks and continuous carbides on grain boundaries could be seen. After that we decided to investigate the tip zone of the crack in order to see propagation mechanism of it.

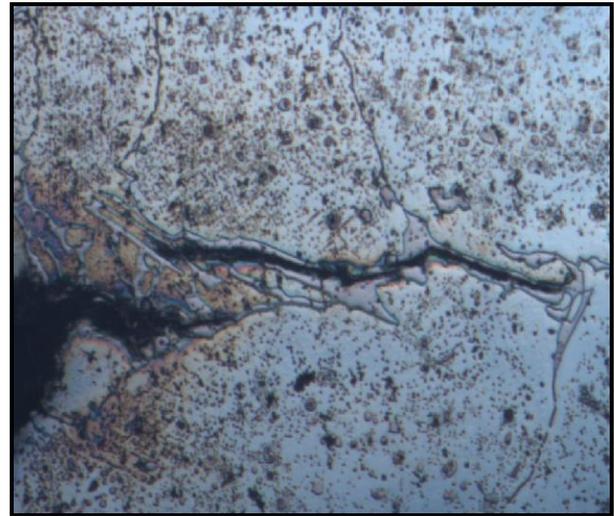
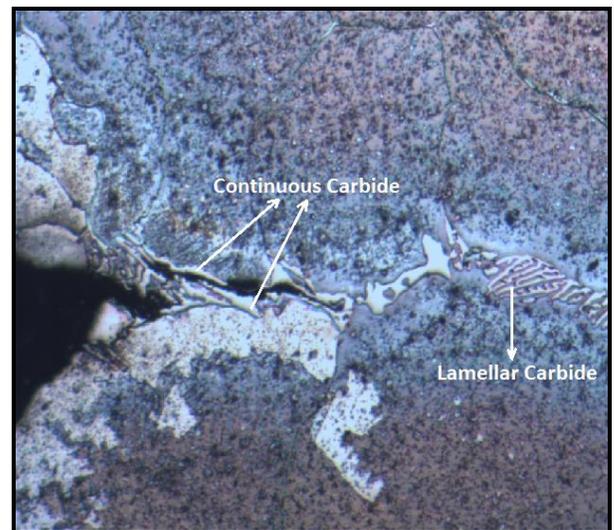
Figure 12. Microstructure of the tip zone of crack (200x slightly chemically etched with Kallings No:2)

Figure 13. Microstructure of the tip zone of crack (100x - electrolytic etched with 6% chromic acid + 10% HCl)

As it can be seen on Figure 12 and Figure 13 which shows the microstructure of tip zone, macrocrack has propagated up to a point and then it continued as micro crack on its path passing through the continuous formed carbides that have precipitated on the grain boundaries as it can also be seen on Figure 14 which shows the microstructure of micro crack tip. It can also be seen that microcrack propagation stops and possibly nanocracks propagation occurs up to lamellar morphology carbides which have also precipitated on grain boundaries.

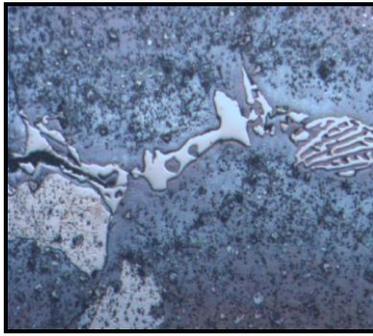
Figure 14. Microstructure of microcrack tip (200x - electrolytic etched with 6% chromic acid + 10% HCl)

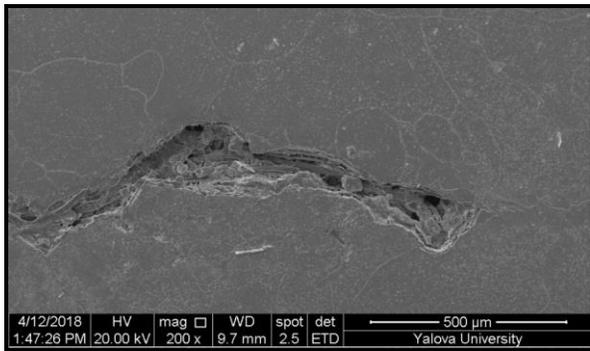
Figure 15. SEM image of macrocrack

After optical microscopy analysis we considered the results and decided to carry out electron microscope analysis in order to determine the types of carbides chemically and morphologically. On the Figure 15 and Figure 16, SEM images of crack zone have been shown. It can be seen that macrocrack had propagated mostly through grain boundaries zone. And also corrosion products can be seen around the macrocrack.

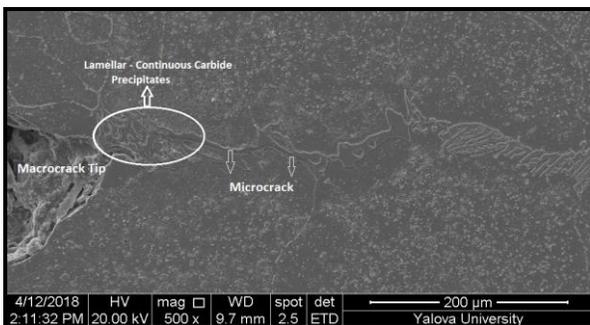
Figure 16. SEM image of macrocrack tip zone

As shown on the SEM image of macrocrack tip zone on Figure 16, macro crack propagation is blocked by semi lamellar semi continuous morphology carbide precipitates. However, macrocrack had found a path for propagation as microcrack. As it can be seen on Figure 17, the path of microcrack is surrounded by continuous morphology carbides. It means that microcrack had propagated through the continuous carbides on grain boundaries.

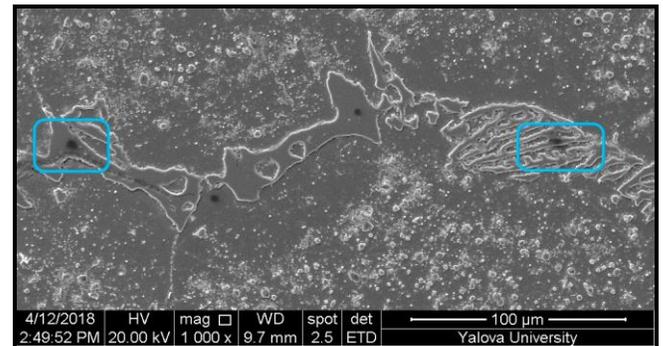
Figure 18. SEM-EDS image of carbides

SEM-EDS analysis was carried out on the points shown by blue rectangles on Figure 18. According to the results given on Table 2, continuous carbides include higher carbon and lower wolfram and molybdenum in comparison with lamellar carbides. When we compare the Cr/C ratios, while the ratio of continuous carbide is 2.012, the ratio of lamellar carbide is 2.904. As the result of SEM-EDS analysis, it could be understood that lamellar carbides are $M_{23}C_6$ and continuous carbides are M_7C_3 .

and electron microscopy investigations, the failure that had occurred on the nozzle, the macrocrack and microcrack, had propagated through M_7C_3 type continuous carbides and the propagation had been blocked or slowed down by $M_{23}C_6$ type lamellar carbides.

In all super alloys, carbides are the weak phases against oxidation. In order to minimize the high temperature corrosion failure, carbides need to be small and discontinuous [7]. When all the microstructures are considered in our study, it can clearly be seen that the crack had propagated through continuous morphology carbides. In order to avoid this occurrence, the carbide transformation needs to be blocked. As a resolution advisory, molybdenum and/or wolfram contents could be increased in order to succeed it. These elements increase the potential of

We also estimated that the lifetime of the nozzle could be increased by preventing carbide transformation by increasing the molybdenum and wolfram content of the material, because they increase the possibility of $M_{23}C_6$

carbide occurrence at elevated temperatures despite carbon diffusion during service. In addition to molybdenum and wolfram content increasing advisory, we also estimated that increasing MC carbide making alloying elements content such as Ti, Nb, Ta and Hf could be beneficial for cobalt based superalloys which operate at high temperatures and under the conditions of carbon diffusion might be occurred.
