DOCUMENTING RURAL ARCHITECTURAL HERITAGE: ANKARA FETHIYE VILLAGE

Özlem SAĞIROĞLU¹

Arzu ÖZEN YAVUZ¹

¹Gazi University, Faculty of Architecture, Department of Architecture, Maltepe / Ankara. TURKEY

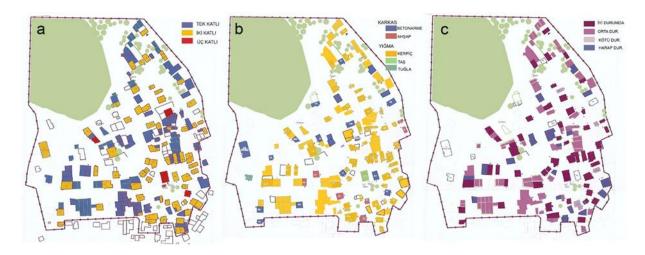
Figure 2. The number of floors (a), construction system (b) and structural status (C) are determined in the field.

The examination found that 35% (50 units) of the structures were in good condition; 48% (68 units) were in medium Condition; 3% (4 units) were in poor condition; and 14% (20 units) were in dilapidated condition. Since the structures in the study area were 13 pieces of reinforced concrete - not original – the structural situation was excluded from the scope of the examination.

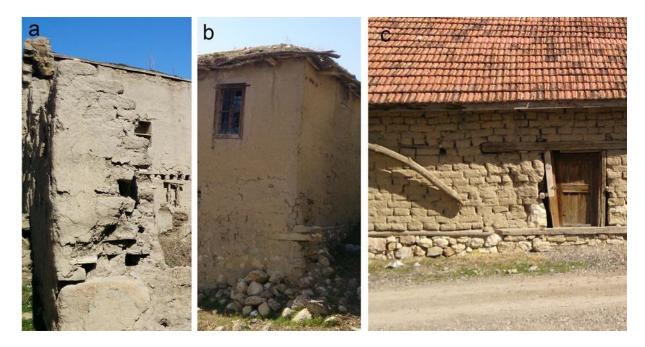
Figure 4. Examples of Adobe and calligraphy

The walls of the buildings in the study area were constructed in the form of massive masonry adobe walls (Figure 4a). No thick or sparse wooden skeleton was seen in any structure. The mudbrick section of the walls begins after the masonry stone wall is finished at the level of flooding and is leveled with wooden calligraphy. The wooden hatillas used at this stage were made of coarse wood branches or of smooth-cut wood. It is possible to see properly cut wood more densely in the recently built (1950 and later) of the structures. Wooden calligraphers are connected to each other in the corners by kertme method, and in early specimens they were often left sloppy without cutting (figure 4b).

It is possible to see the use of wooden calligraphers as lintels at the top and bottom of the windows and on the door, between the floors and at the end of the wall, except for the passage from the masonry masonry to the masonry adobe wall(Fig4c). In a small number of examples, there is also the application of intermediate lines at various distances (such as 100-150 cm).

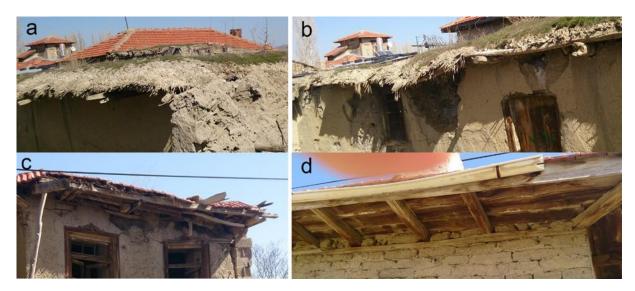
Figure 6. Photos on top cover: earthen dam (a, b); gable roof (c, d)

There are 2 types of roof applications in the buildings in the area. The first of these is the soil dam application (Fig6a,b), and today only examples of dilapidated structures or single-storey outbuildings can be seen. Since an example of this type of dam is under constant care, no measurement of the slope of the dam has been made. However, the observations made, 12-15 cm rough wood tree branches 30-50 cm after laying, 2 types of application has been made on the determination. The first is the laying of thin branches in opposite directions at intervals or very short intervals and covering them with a dense soil of lime (barren). The second type of application is the use of straw bunches or wicker cover instead of tree branches. Examples of this type of application have often been encountered in the field (figure 6b). In this type of application, the application of barren bunches on the harvest and then compression is made. Since this soil (barren) coating was made again every few years, it has not been possible to tell exactly its original thickness. However, Kafescioglu found that this layer was made as thick as 20 cm (kafescioglu,1954).

In other structures, ground dams were removed over time and the application of breaking or gable roof was made (Figure 6 C,d). Since they were made in the late period, the roof coverings have survived to the present day as Marseille-type tiles.

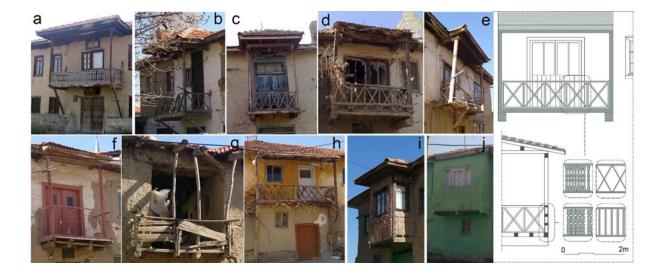
Figure 7. Open and closed jumps on façade

the door. Only one exception (figure 7g) has been found to be in the door axle of the Open jump on façade. The tiles of these exits are usually at the same level as the tiles (Figure 7a, e), as they are formed by extending the wooden rough beams that form the flooring in the structure towards the outside of the structure. In some examples, it was also observed that two thicker wooden rough beams extended out of the structure were placed between the beams in the opposite direction (Figure 7 b,c, d).

The balustrades of open jumps on façade constitute a typology for the village, as they are usually designed in the same way (Fig7b, c,d). These balustrades were formed by designing the cross between the Struts, which were set at different intervals between the wooden base and the handrail, with finer pieces of wood. However, 4 different types of railings were identified in the study (Figure 7-detail). One of these examples is found in the village.

Above the open jumps on façade are closed by extending the roof to the carrier struts at the exit corners. In a small number of examples, it has been observed that the dating with wooden buttresses is entrenched (Fig 7a,b).

Closed jumps on façade, which constitute another type of jump on façade in the field, are available in fewer instances. These examples were created and carried out by extending the trim beams outwards, as in open jumps on façade (Fig7i, j).

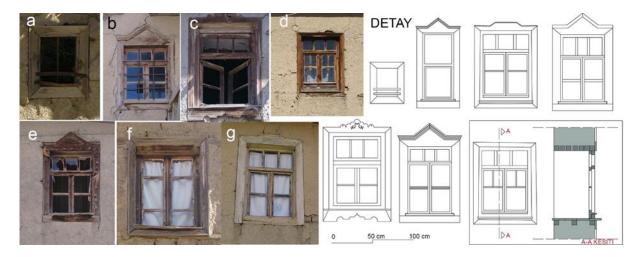
Figure 8. Windows

Since the majority of the buildings in the area are reserved for service units such as ground floor storage, haystacks and animals, they are designed in different sizes (Fig8a), far from forming a specific type of Windows.

But the upper floor, which is the living space, has qualified wooden windows in the original examples. 6 types of original windows have been identified (Figure 8 detail) some of these windows also contain examples of qualified wood carving (Fig8c) in the village, where the type of triangular upper pediment window seen in Ankara and its surroundings is also seen as dense.

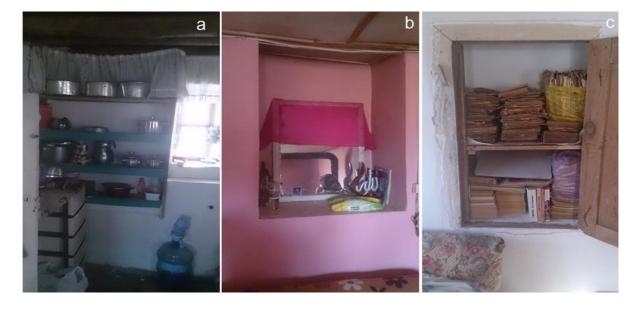
Figure 11. No. 2 (Env.No:100) interior photos of the residence

The upper floor is built as a living space for the family. On this floor there is a kitchen (ashhane) with rooms. It was observed that cooking activities were carried out using a scuba cooker – tube in the ashhouse in the houses that can be identified in the area, and it was determined that the elements for cooking were removed over time. However, Karakul and Şahin Güchan (2016) found that there was a cooking stove in these places and that meals were also cooked in addition to bread prepared on a weekly basis (Karakul and Şahin Güchan, 2016). There are also niches with simple unadorned lids and pieced tereks in ashhane spaces (Fig.11a).

The rooms of the residences, however, are quite simply constructed and have loads and niches. Today, looms are used for different purposes, such as lifting the covers and putting on television, for everyday clothes and other items, as well as using non-fixed cabinets placed inside the venue, on the basis of houses that can be entered (figure 11b). The niches preserved in their original form are functionally qualified (fig11c), with a fairly simple lid.
