An Investigation of the Surrounding Environments of Selected High School Buildings in Ankara with Regard to Turkish Standards Related With Accessibility

Cansu DİŞYAPAR^{1,✦}, Can GÜNGÖR²

Sincan Vocational and Technical High School (Example 1)

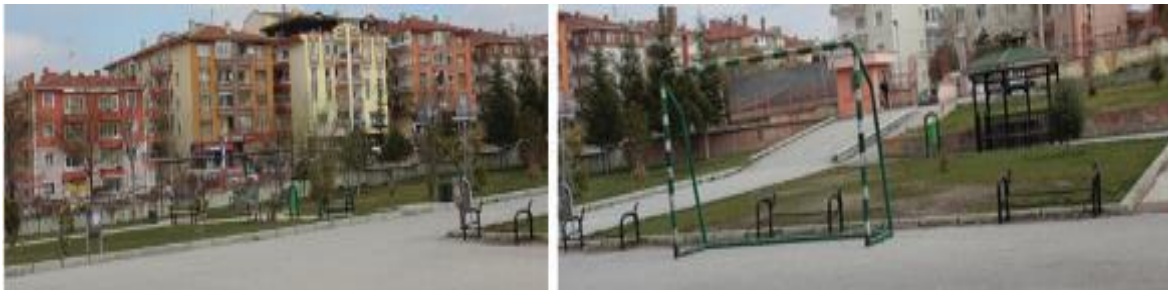
Figure 3 Urban Furniture of Example 1(Photograph: Cansu DİŞYAPAR, April 2015)

- **Form 1: Urban Furniture of Example 1,** No urban furniture was used on route to the building. Along with that the obstacles throughout the route was not signed properly. On the school site there are accessibility problems to recreational areas and no means of perceivable signage along the route for the visually impaired. Deformed materials and furniture poses threat to people with mobility restraints and visually impaired as shown in figure 3.

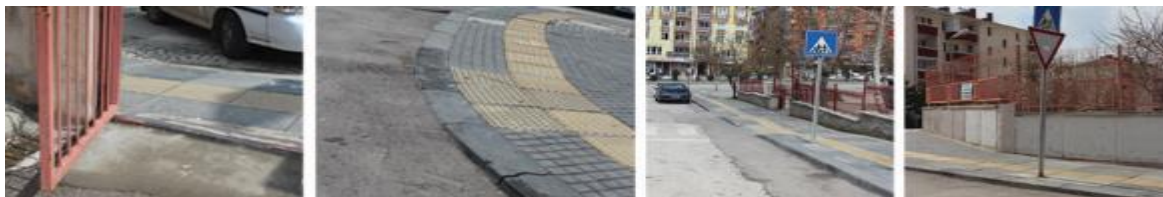
Figure 4 Pedestrian Crossings of Example 1(Photograph: Cansu DİŞYAPAR, April 2015)

- **Form2: Pedestrian Crossings of Example 1**,has some problems such as, the 1.degree road side there is no pedestrian crossing waiting area as required in relevant standard. Also there is no audio visual signage on the traffic lighting fixture to allow controlled crossing for all kinds of disabled people. There is an inadequacy in measurements of the pedestrian crossings as shown in figure 4.

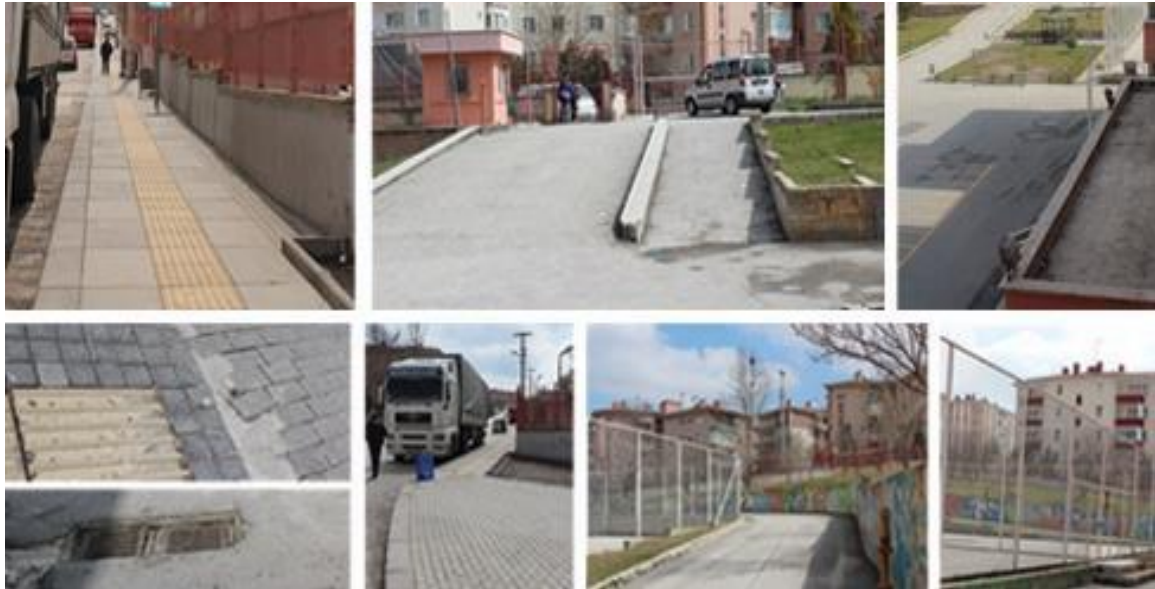
Figure 6 Accessible routes of Example 1(Photograph: Cansu DİŞYAPAR, April 2015)

- **Form 4: Accessible Route of Example 1**, have a lack of resting areas at least 30 meters apart with in school site. Also there is no direct route to building entrances for disabled people marked with perceivable markings or even free of city traffic within the sites. Another problem is that there is no visual, audial or perceivable informative signage with the building sites that would orientate disabled people. The start and ending of the ramps and stairs within the sites are not marked with perceivable marking. The outer stairs and ramps are not protected against the atmospherically conditions and have problems of correct material usage. The uneven natures of pavements are also a problem for disabled people as shown in figure 6.

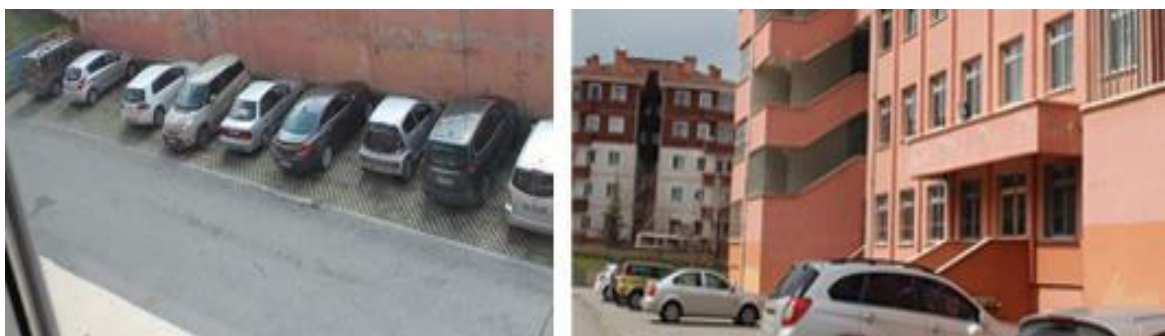
Figure 7 Car Parks of Example 1(Photograph: Cansu DİŞYAPAR, April 2015)

- **Form 5: Car Park: of Example 1**, have no designated and signed spaces for the disabled peoples' vehicles as shown in figure 7. No means of accessibility was achieved in either building. Along with that there are no means of designated accessible route to building entrances covered form atmospherically conditions. The material usages are also not convenient. Example 1 has night time lighting.

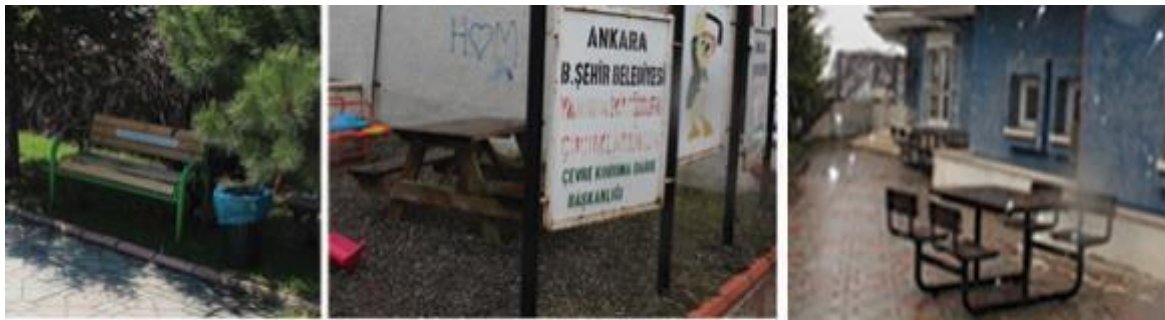
Figure 9 Urban Furniture of Example 2 (Photograph: Cansu DIŞYAPAR, April 2015)

- **Form 1: Urban Furniture of Example 2**, No urban furniture was used on route to the building. On the school site the “Fully compatible” answers were high as of the nature of the furniture’s, but there are accessibility problems to recreational areas and no means of perceivable signage along the route for the visually impaired as shown in figure 9.

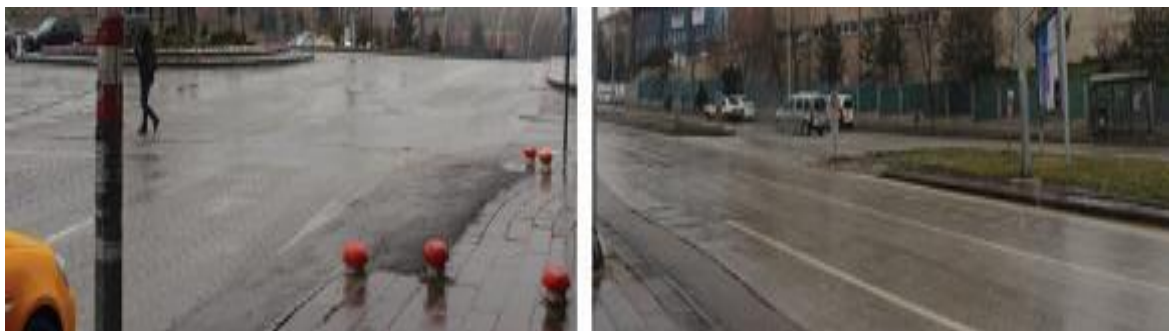
Figure9 Pedestrian Crossings of Example 2(Photograph: Cansu DIŞYAPAR, April 2015)

- **Form 2: Pedestrian Crossings of Example 2**, there is no waiting area at the road side as required in relevant standard. Also there is no audio visual signage on the traffic lighting fixture to allow controlled crossing for all kinds of disabled people. Also there is a lack of markings and signage of the pedestrian crossing.

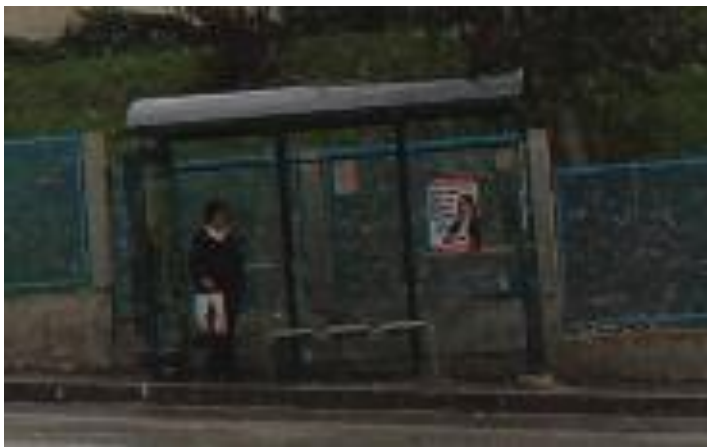
Figure 10 Bus Stops of Example 2(Photograph: Cansu DİŞYAPAR, April 2015)

- **Form 3: Bus stops of Example 2**, have problems about signage of parking restrictions around bus stops. All bus stops are not signed on transparent surfaces to prevent visually impaired from crashing as required in the relevant standards. Along with that all bus stops have a lack of informative signage about the bus schedules and have lack of required furniture that are up to relevant standards as shown in figure10.

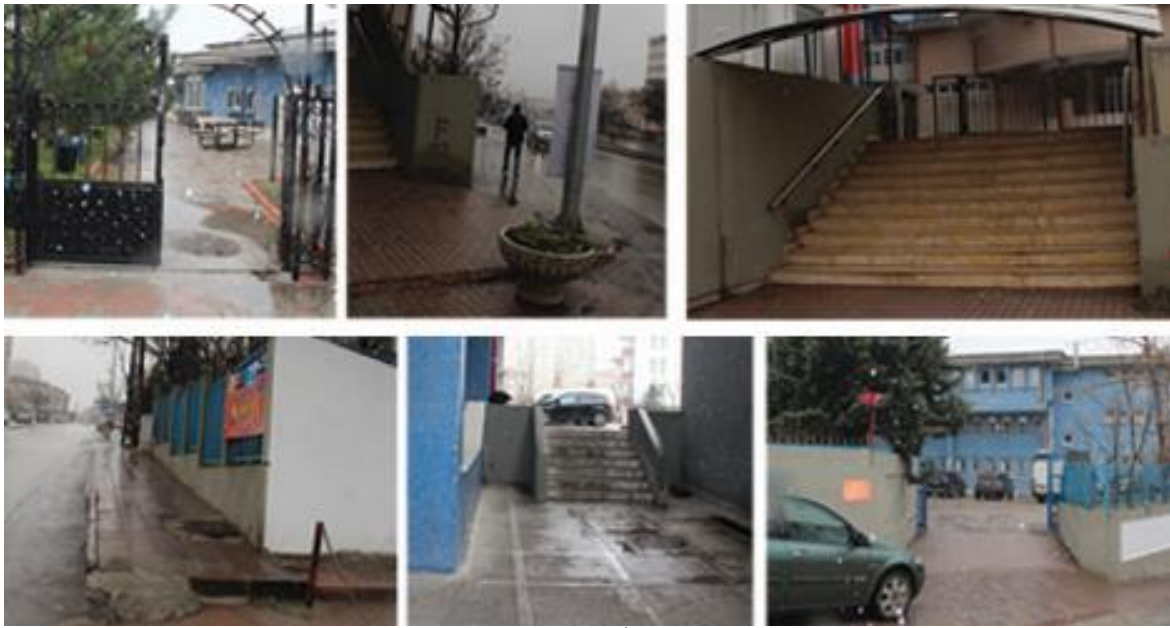
Figure 11 Accessible routes of Example 2(Photograph: Cansu DİŞYAPAR, April 2015)

- **Form 4: Accessible Route of Example 2**, has some other problems apart from the above. There is not even one accessible route to building entrance around the site wide enough as required as relevant standards. The uneven state of pavements is also a significant problem. The high slopes around the site are not solved with accessible ramps and/or other means of accessibility features such as platform lifts. The pavements were not protected against car parking to allow an accessible route. There are no curb ramps. Outer stairs have no railings on both sides and are not wide as 180 cm at any point as shown in figure 11.

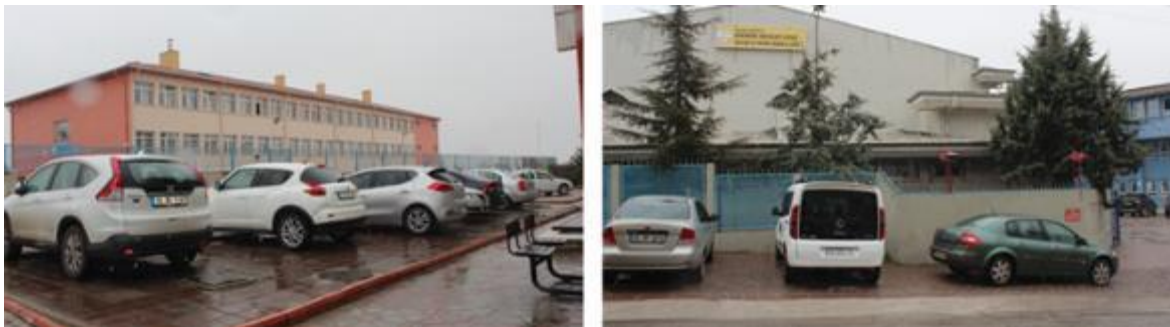
Figure 12 Car Parks of Example 2(Photograph: Cansu DİŞYAPAR, April 2015)

- **Form 5: Car Park: of Example 2**, have no designated and signed spaces for the disabled peoples' vehicles. No means of accessibility was achieved in either building. Along with that there are no means of designated accessible route to building entrances covered form atmospherically conditions. The material usages are also not convenient. Example 2 has night time light in.

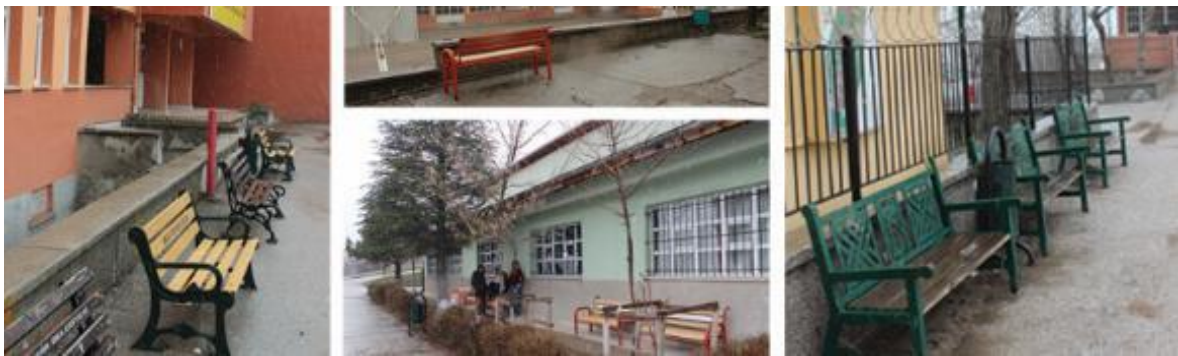
Figure 14 Urban Furniture of Example 3(Photograph: Cansu DİŞYAPAR, April 2015)

- **Form 1: Urban Furniture of Example 3**, No urban furniture was used on route to the building. On the school site the “Fully compatible” answers were high as of the nature of the furniture’s, but there are accessibility problems to recreational areas and no means of perceivable signage along the route for the visually impaired as shown in figure 14.

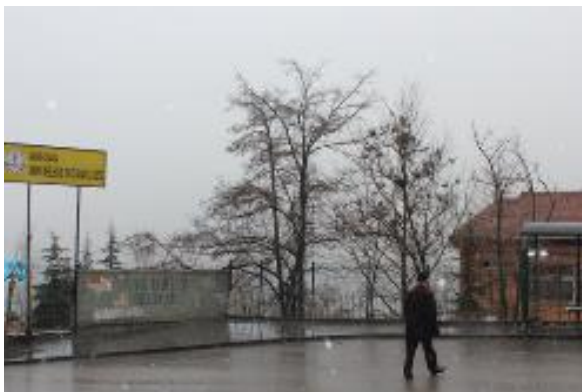
Figure15 Pedestrian Crossings of Example 2(Photograph: Cansu DİŞYAPAR, April 2015)

- **Form 2: Pedestrian Crossing of Example 3**, there is no waiting area at the road side as required in relevant standard. There is no waiting area near the traffic light and there is no curb ramp designed for easy access. Also there is as a lack of markings and signage of the pedestrian crossing as shown in figure 15.

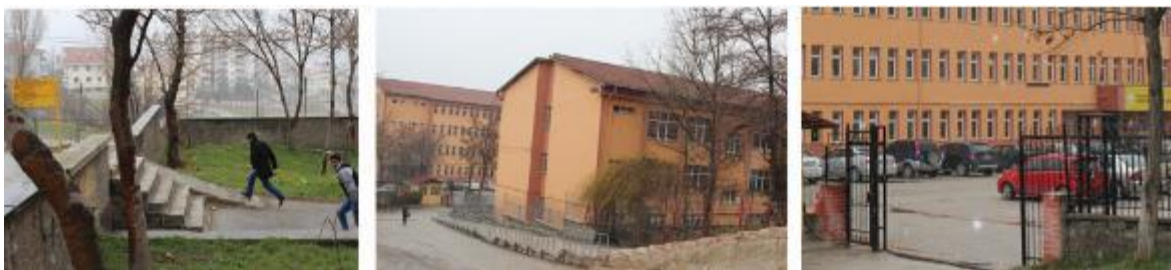
Figure 17 Accessible routes of Example 3(Photograph: Cansu DİŞYAPAR, April 2015)

- **Form 4: Accessible Route of Example 3**, has some other problems apart from the above. There is not even one accessible route to building entrance around the site wide enough as required as relevant standards. There is not at least one accessible route between the buildings within the site. The high slopes around the site are not solved with accessible ramps and/or other means of accessibility features such as platform lifts. There is no railing on higher sides of pavements which is a security problem for everybody along with people with mobility restraints. The pavements were not protected against car parking to allow an accessible route. Ramps higher than 5% does not have surface material as required in the relevant standard. Outer stairs have no railings on both sides and are not wide as 180 cm at any points shown in figure 17.

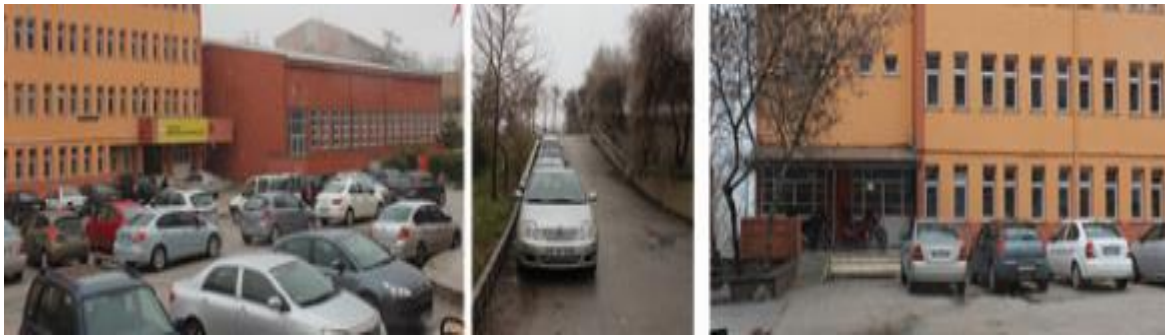
Figure18 Car Parks of Example 3(Photograph: Cansu DİŞYAPAR, April 2015)

- **Form 5: Car Park: of Example 3**, have no designated and signed spaces for the disabled peoples' vehicles. No means of accessibility was achieved in either building. Along with that there are no means of designated accessible route to building entrances covered form atmospherically conditions. The material usages are also not convenient. Example 3 has no night time lighting.
