GEOLOGICAL INVESTIGATION OF THE KÖSENÇAYIRI DAM AREA

Galip OTKUN

*Fazıl İ. Verdi and Sons,
Middle East Technical University, Ankara*

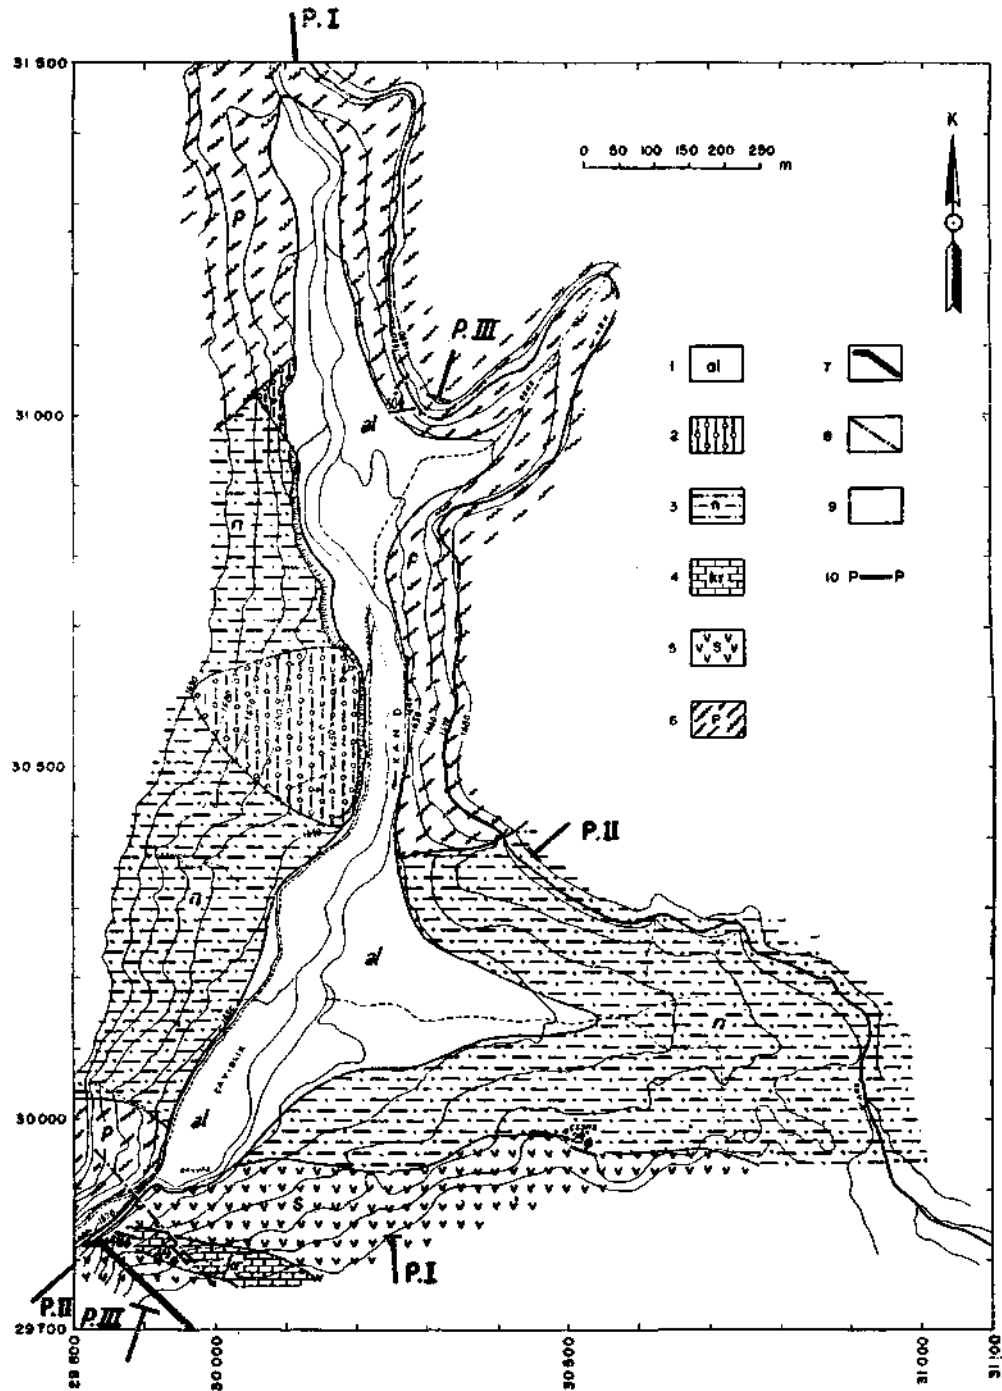
The most important tectonic event in this area is the existence of a fault in the southern part of the dam's axis, dipping towards NW-SE. This fault is clearly seen in the topography. The formation of a lake of some kilometers length, in conformity with the axis of fault, is an evidence showing the existence of this fault. The landslides in the valley and fractures in the uppermost overburden are evidences showing the activity of the fault.

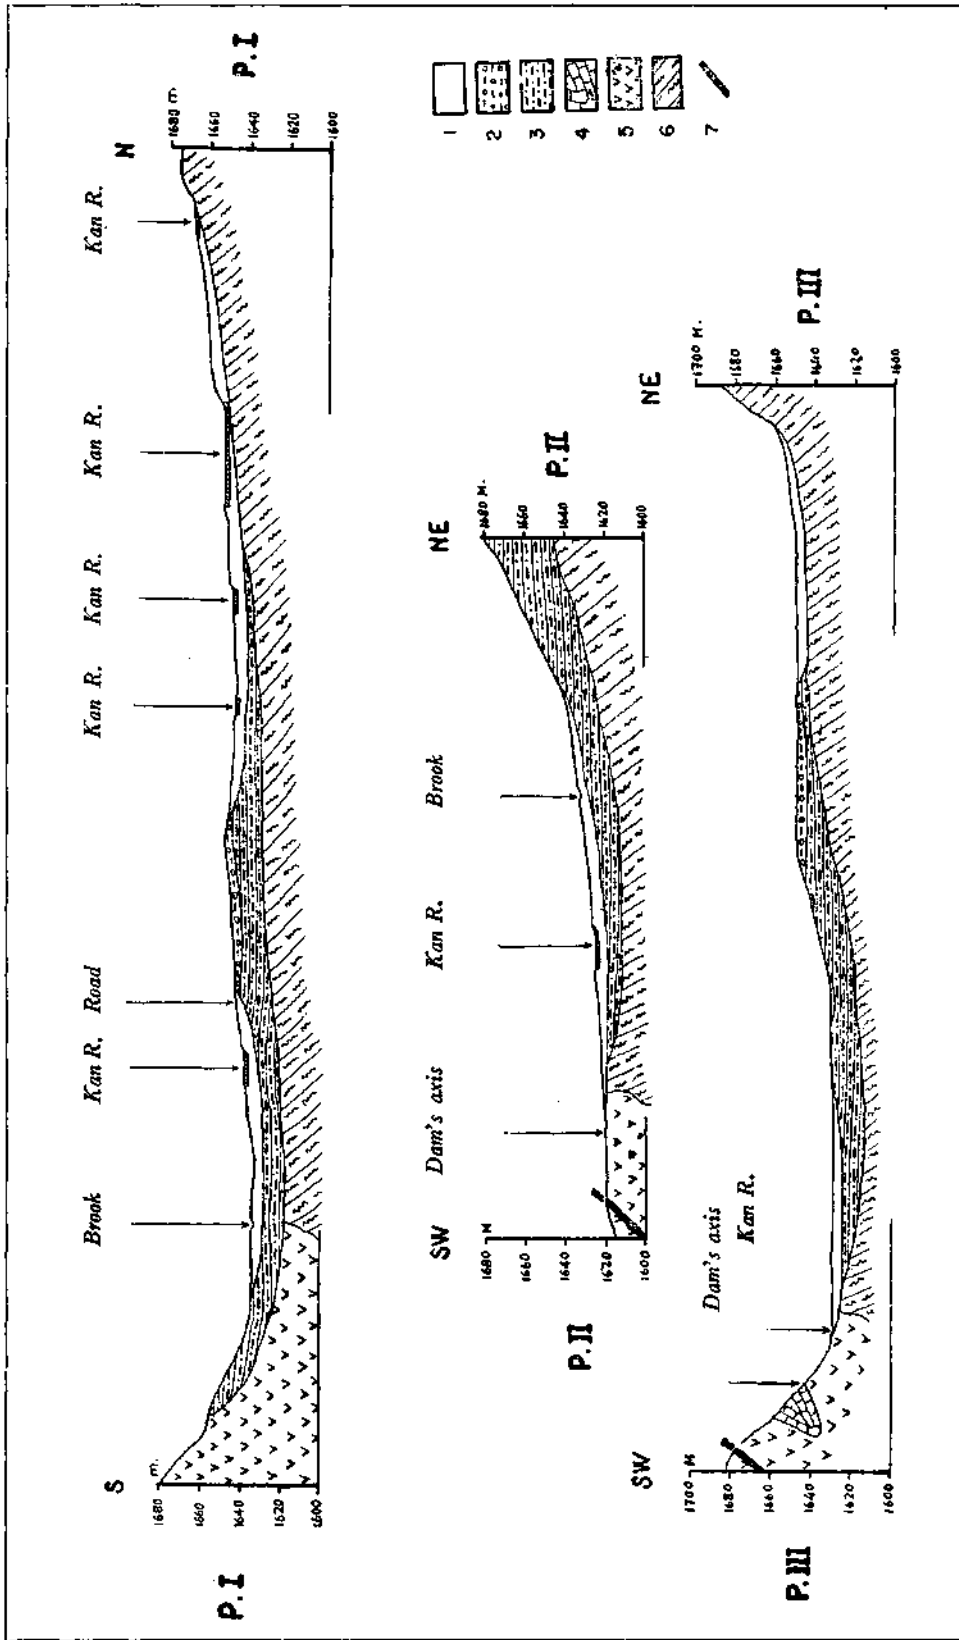
Fig. 3 - Geological cross-sections at the Toşya - Köseçayırı Dam site
 1 - Alluvium; 2 - Accumulation cone; 3 - Clay, sand, gravel - Neogene (continental); 4 - Limestone - Cretaceous?; 5 - Serpentine (decomposed);
 6 - Metamorphic schist - Paleozoic (decomposed); 7 - Fault.

Metamorphic schists. — These formations, predominating all over the investigation area and belonging to Paleozoic, constitute the basis of this area (see Fig. 3).

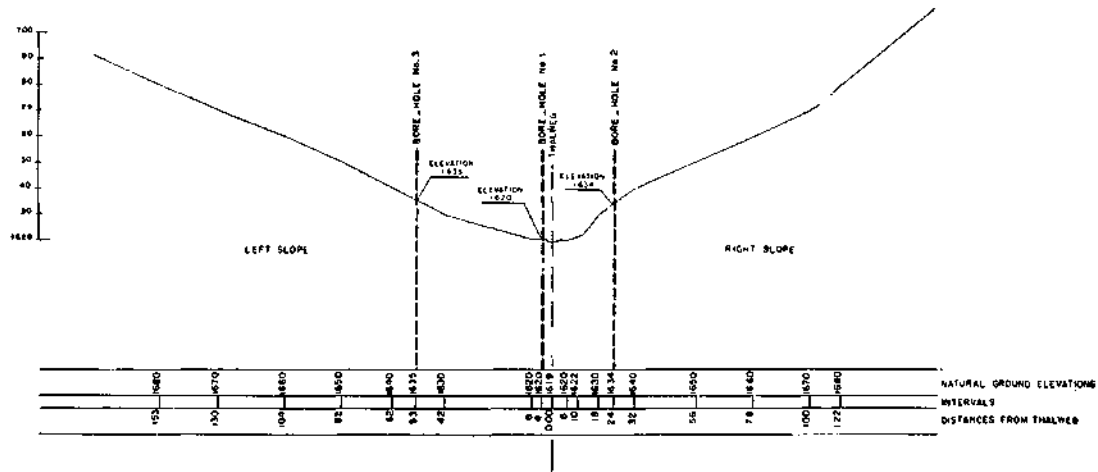
BORE - HOLE No.3

the help of land forms. There are organic clays in the bore-hole no. 3; this probably results from the decay of plant remnants covered by previous landslides.

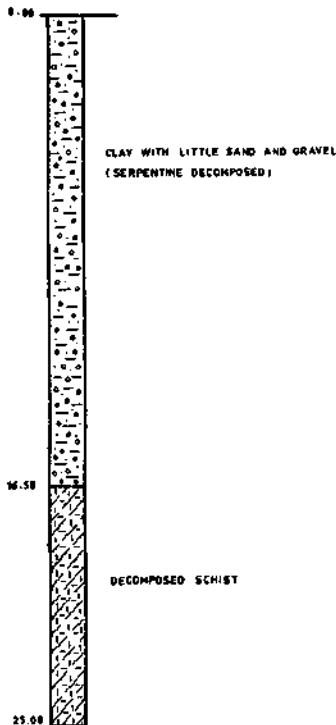
BORE - HOLE No.1

Because of the permeable materials existing in alluvium, it is natural that they should contain ground water. The alternation of permeable and impermeable levels in alluvium secured the formation of «confined aquifers». As a matter of fact, in the bore-hole no. 1, located at thalweg, was observed an artesian water having a piezometric level of + 3.90.

- NOTE
1. WATER PRESSURE TEST FAILED AT NO.1 AND 2
 2. THE PIEZOMETRIC LEVEL OF THE ARTESIAN ENCOUNTERED IN THE 10.50 m. OF No.1 BORE-HOLE IS +3.98 m.
 3. WATER PRESSURE TEST AT No.2 BORE-HOLE

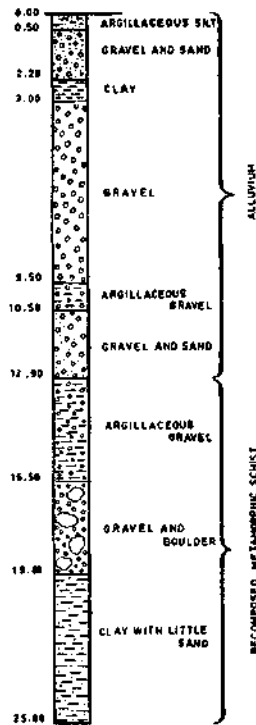
BORE - HOLE No.2

DEPTH	LOSS	Kg/Cm ²	TIME
1.50 - 3.50	146	2	10 Minutes
	251	6	" "
	380	8	" "
	440	8	" "
	572	18	" "
3.50 - 5.50	290	2	10 Minutes
	240	6	" "
	460	6	" "
	526	8	" "
	602	10	" "
