# A Proposal for Sustainable Urban Conservation and Rehabilitation of Ulucanlar District, Ankara

Özlem SAĞIROĞLU<sup>1\*</sup>, B. Işık AKSULU<sup>1</sup>

<sup>1</sup> *Department of Architecture, Gazi Univ., 06570, Ankara, Turkey*

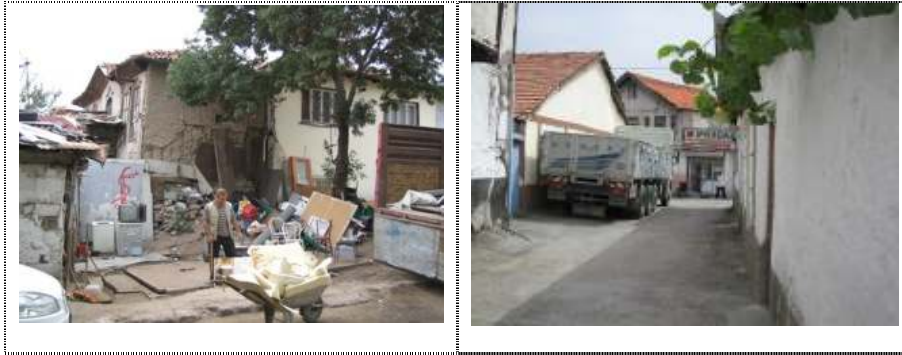
present time, it is seen that a lack of planning control has allowed houses to be converted into “stores” such as junk shops, cafes, repair shops and bottled gas stores, either with additional units or just functionally in accordance with commercial functions, to the detriment of the originality of the buildings.

Fig.3. The examples for the commercial uses.

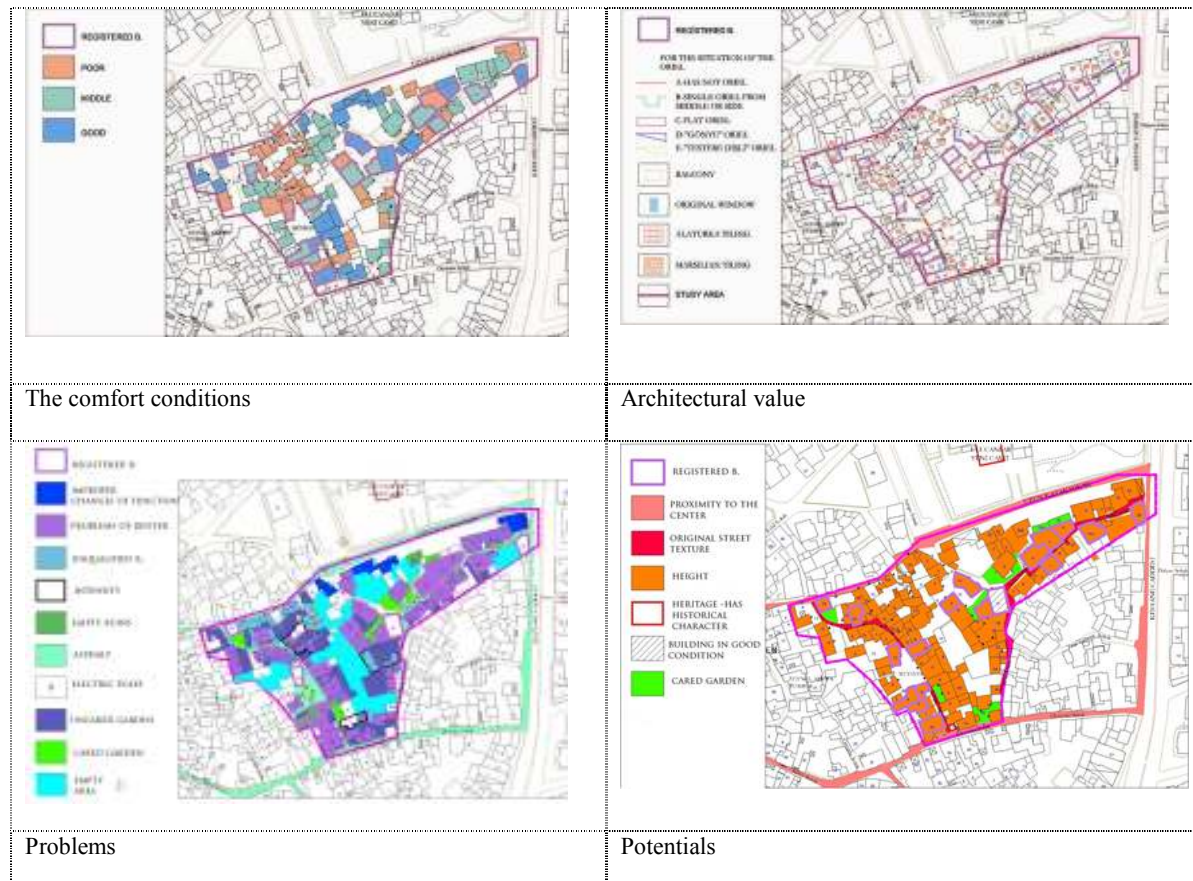
Comfort conditions in the buildings located in the area are inadequate because the buildings were sub-divided and went through many changes. As a result of these modifications and sub-divisions, there are quite small windowless rooms, areas of damp and circulation areas.

In addition, it is seen that the quality of the area has also decreased due to the functional changes. This is also reflected in the façades; the unregulated modifications have resulted in the installation of doors and windows independently from the original building; and altered the original relationships that buildings established with the street and courtyards.

Fig.4. The comfort conditions, architectural value, problems and potentials of the study area.

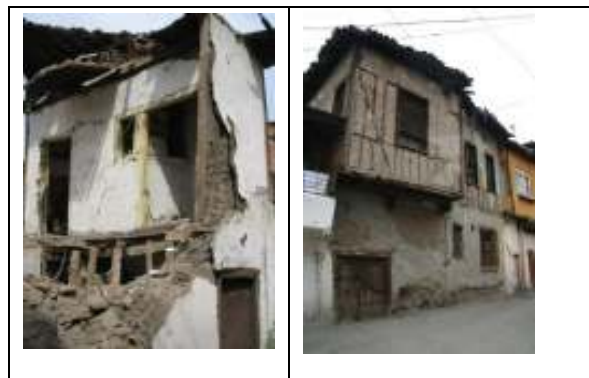
As stated, most of the buildings in the area are frame houses, and the gaps are adobe or brick-filled and plastered. In addition, adobe and brick masonry buildings are also present in the area. Structural examinations indicated that the loss of external plaster on many buildings resulted in water damage and section loss in the adobe structures exposed to atmospheric factors. Examining repairs made by the residents, it was

found that restoration of the original sections using cement-based plaster could not ensure adherence to the old material; and that spills increased and the effect of salt in the cement caused more damage to the building. Spalling and splits are evident in wooden architectural elements, due to the loss of plaster and non-renewable protective paint, resulting in discoloration and exposure to the effects of rain, snow and sun.

Fig.9. The examples for deterioration

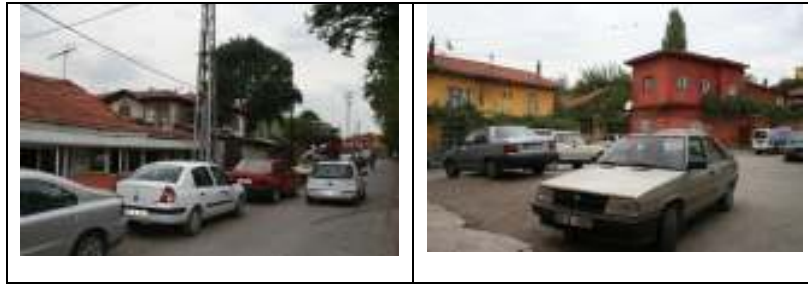
The high number of vehicles and the intensity of traffic in the narrow streets have caused potholes and collapses of the road surface due to abrasion, breakage and

vibration. The use of spaces in the area for parking during the day is one of the factors accelerating the deterioration.

Fig.10. The examples for parking at the streets or the areas between the houses

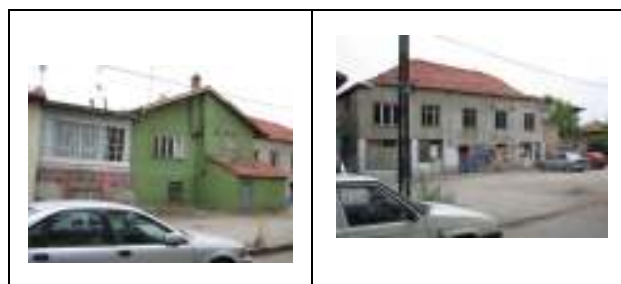
Fig.14. Examples of unqualified buildings from the study area

buildings may be turned into a part of the whole through restoration of their facades. When multi-storey building parcels in the immediate periphery of the area reach the end of their economic lives, it is necessary to immediately redevelop these sites to make them appropriate to the urban texture of the wider area.
