# Conservation Initiatives/Assessments in Rock-Carved Churches Specific to the Göreme Saklı Church

Keywords: Cappadocia, Göreme, Saklı Church, conservation.

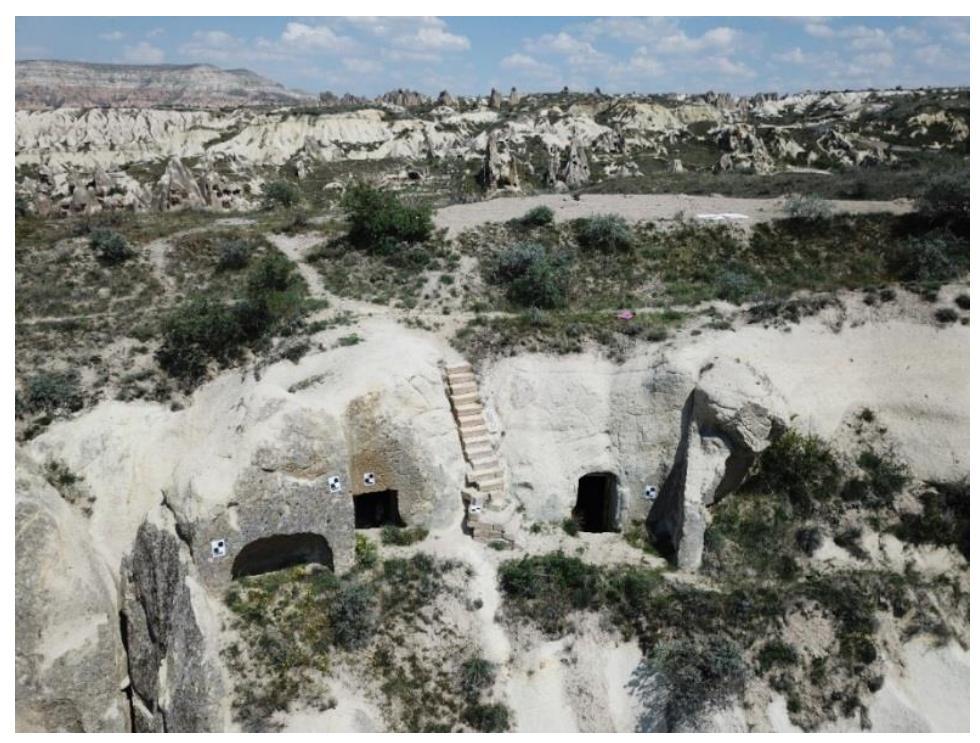
Figure 11. The Saklı Church appearance (Ertürk, 2020, p.100)

Color changes, ruptures, and cracks in the rock material in the region's rock formations are also seen in other monastic spaces within the rock mass where the Saklı Church is located (Figure 11). There are

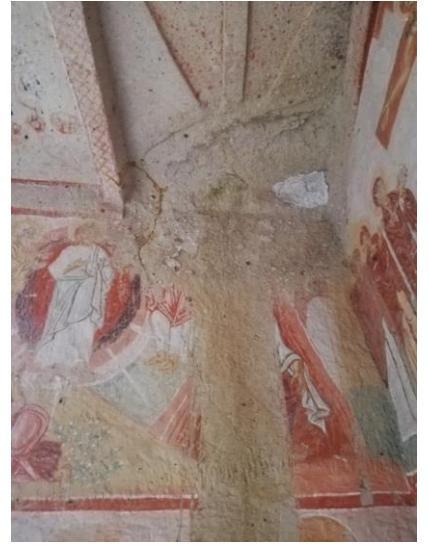
abrasions and ruptures on the floor, terrace, and staircase surfaces of the Saklı Church. The water coming from the slope erodes the tuff surface of the structure, and the surface affected by moisture and salt has deteriorated (Figure 12, 13). As a result of the snow falling on the building for a long time in the winter season, ruptures and separations are observed in the ceiling of the building. In addition, when the church was discovered in 1957, there were losses in the wall paintings in the areas touched by the soil heap.

Figure 12. The Saklı Church western murals distortion detail (Ertürk, 2020, p.151)

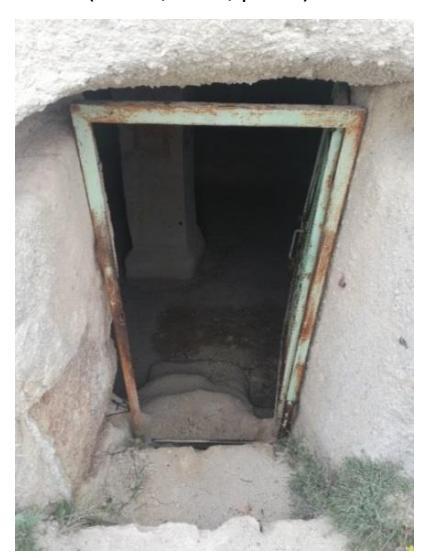
Figure 13. The Saklı Church, abscess distortion detail (Ertürk, 2020, p.151)

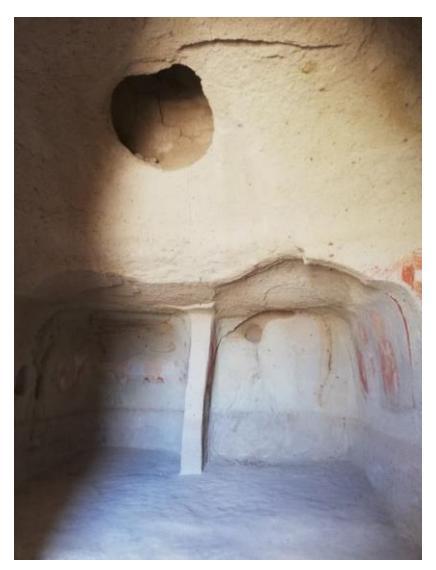
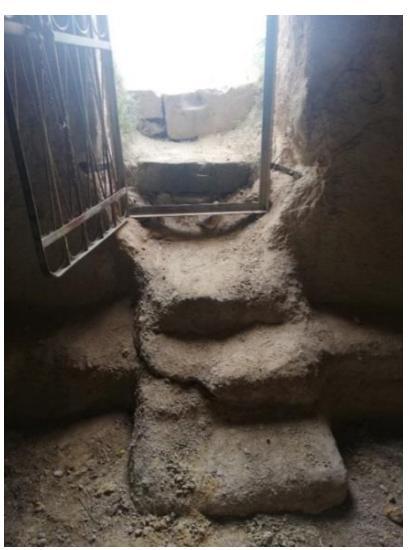
Figure 14. The Saklı Church entry door distortion<br/>detail (Ertürk, 2020, p.145)Figure 15. The Saklı Church, ladder distortion detail<br/>(Ertürk, 2020, p.145)

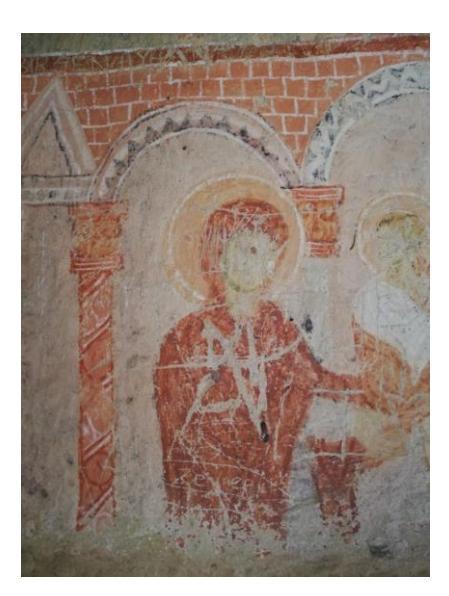
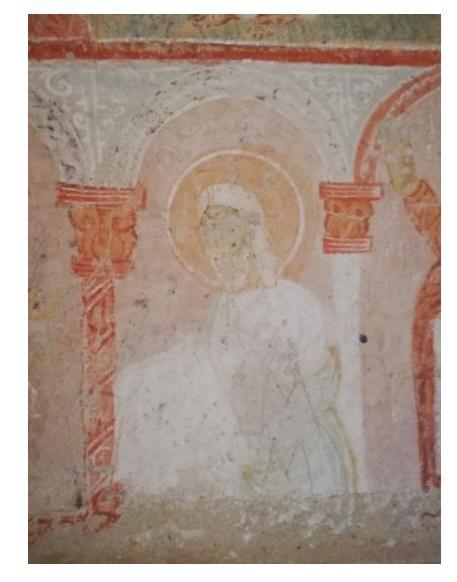
The Saklı Church and the structures in the monastery settlement are of great importance to Christians and are included in the scope of cultural assets that need to be protected today. Other churches and monasteries in the Cappadocia region, such as the Saklı Church, have been abandoned since the Middle Ages. Most churches are subject to natural damage and vandalism (Figure 16, 17).

Figure 16. The Saklı Church northern wall paintingsFigure 17. The Saklı Church, north murals<br/>vandalism detail (Ertürk, 2020, p.145)vandalism detail (Ertürk, 2020, p.145)

In the proposed restoration work, it seems more appropriate to deal with an interdisciplinary architectural intervention project with the cooperation of expert teams from construction, geophysics, and geology for material and structural consolidation studies. It is recommended to carry out consolidation works to prevent damage to the structure and surrounding monastic structures. Likewise, it is recommended to examine other rock structures in the region where the repairs were made and to evaluate the processes they underwent after the repair together (Table 1).

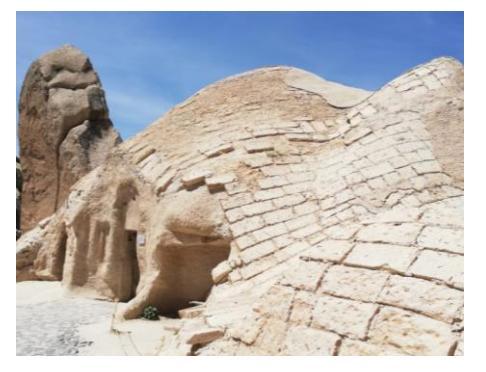
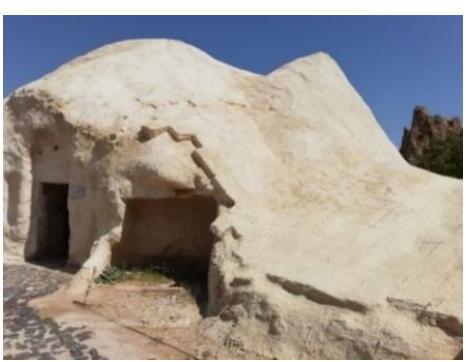
In the churches in the Göreme Valley, processes were carried out to cover the primary material in the conservation interventions. The worn parts were coated and, in the repair, and application projects of El Nazar Church and St. Barbara Church, and imitation plaster was applied to the coating (Figure 18, 19). However, it was determined that the plaster was poured on all surfaces, with gaps under it. The cut stones on which the imitation plaster was poured due to frost during winter revealed an image incompatible with the rock texture. (Figure 20, 21). Cracks and crevices formed in the plaster on the

Figure 21. St. Barbara's Church (Ertürk, 2020, p.170) Figure 20. St. Barbara's Church (Ertürk, 2019, p.170)

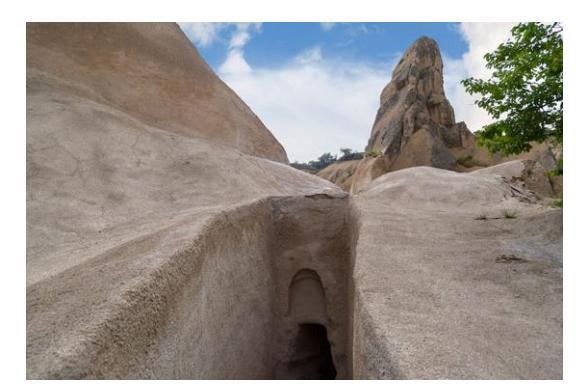
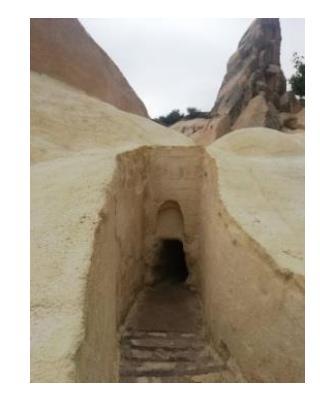
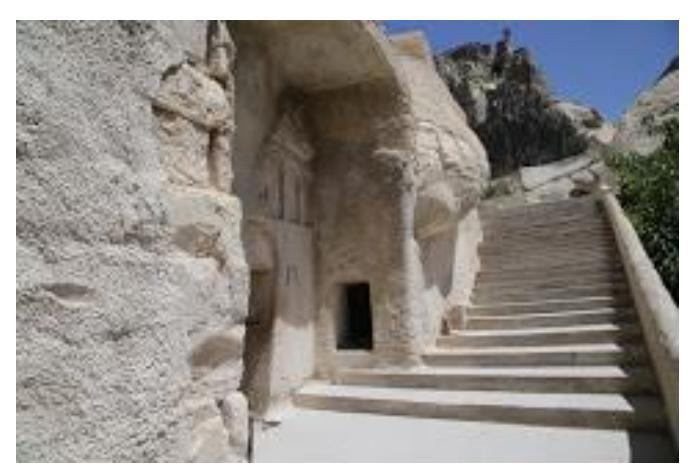
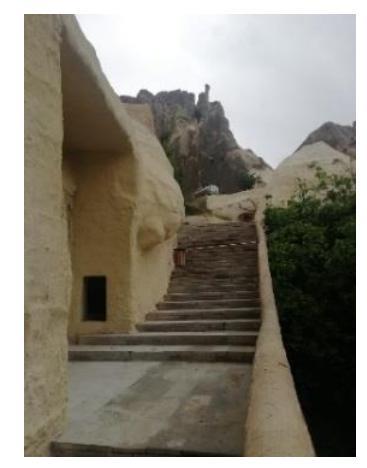
west, north, and south walls of the Elmali Church, located in the same rock as the St. Barbara Church. The protection process should be regularly maintained and re-applied every year (Figure 22, 23, 24, and 25).

Figure 22. Elmalı Church North Entrance (Ertürk, Figure 23. Elmalı Church North Entrance (Ertürk, 2019, p.171)

Figure 24. Elmalı Church west entrance (Ertürk, 2019, p.171) Figure 25. Elmalı Church west entrance (Ertürk, 2020, p.171)
