## An unusual pacemaker malposition and delayed diagnosis

### *Sıradışı pacemaker malpozisyonu ve gecikmiş tanı*

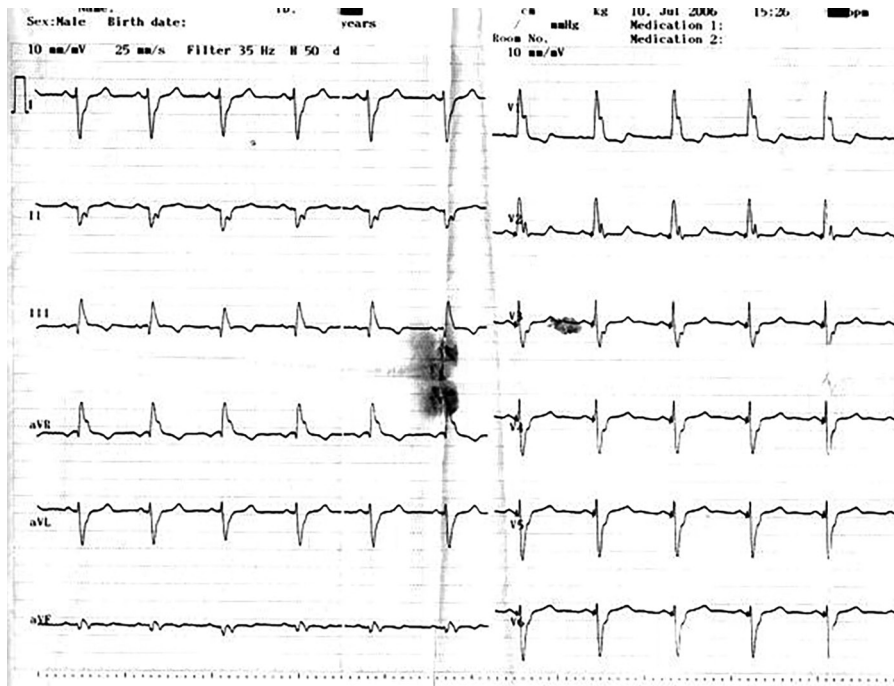
We report a case of a 71 year-old woman who underwent permanent transvenous VDD pacemaker implantation thirteen years ago and had a pacemaker battery change at another institution (four years ago). She was admitted for transient ischemic attacks (TIA). Until this time, only a few attacks were determined to have occurred. Physical examination was normal. An electrocardiogram (ECG) showed a typical right bundle branch block (RBBB) configuration (Figure 1).

**Figure 1.** Electrocardiogram showed a typical right bundle branch block pattern

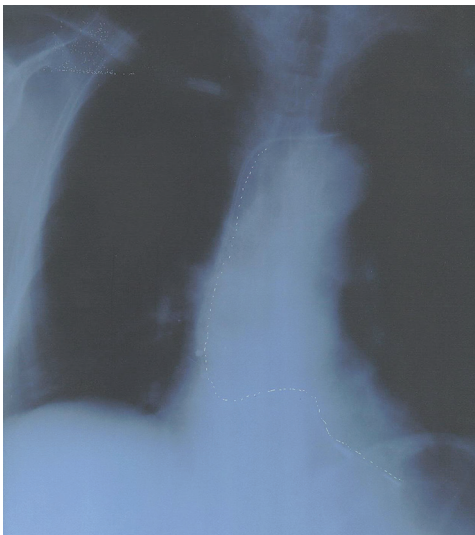
**Figure 2.** Anteroposterior chest X-ray shows a malpositioned left ventricular lead.

Even with repeated echocardiography examinations, the pathology was not noticed due to inadequate echo images. In addition, the patient could not tolerate transoesophageal echo imaging procedure to be performed under polyclinic conditions. Cranial CT was detected to be normal, and the pacing lead was found to be placed in the left ventricle in an X-Ray radiography performed for another reason (Figure 2). Transoesophageal echocardiog-

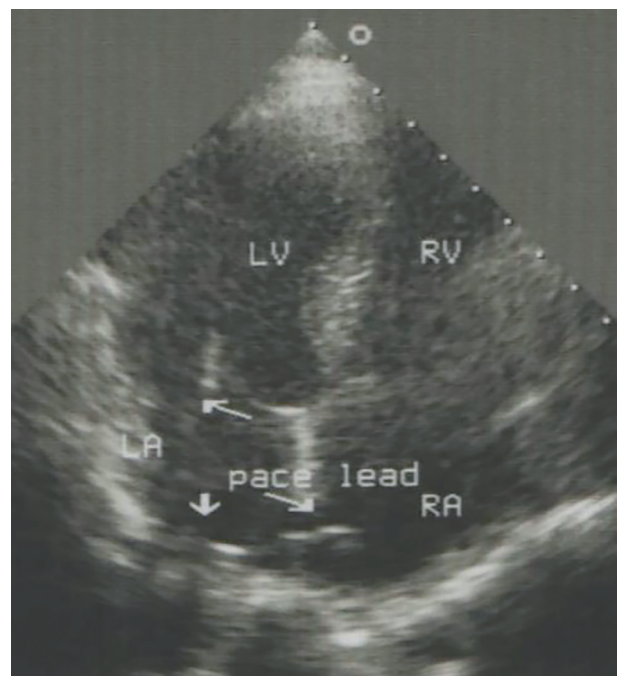
raphy performed under anesthesia showed that the lead perforates the interatrial septum going from the right atrium to the left atrium and through the mitral valve into the left ventricle (Figure 3A, 3B).

**Figure 3A.** Echocardiography shows the pacing lead going from the RA to the LA and the LV (RA, right atrium; LA, left atrium; LV, left ventricle)

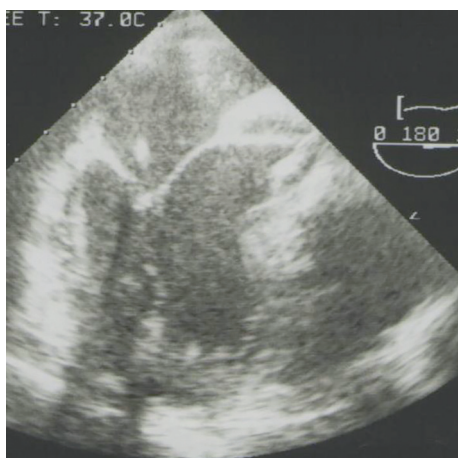
**Figure 3B.** Transesophageal echocardiography shows the pacing lead going from the LA to the LV (thick arrow). (RA, right atrium; LA, left atrium; LV, left ventricle)
