Evaluation of Different Strengthening Projects of Yenice Kalaycılar Primary School According to 2007 and 2019 Turkish Earthquake Regulations

Mustafa Esat COŞKUN¹, Şenol GÜRİSOY^{2*}, Zehra Şule GARİP²

²Karabük University, Faculty of Engineering, Department of Civil Engineering, 78050, Karabük

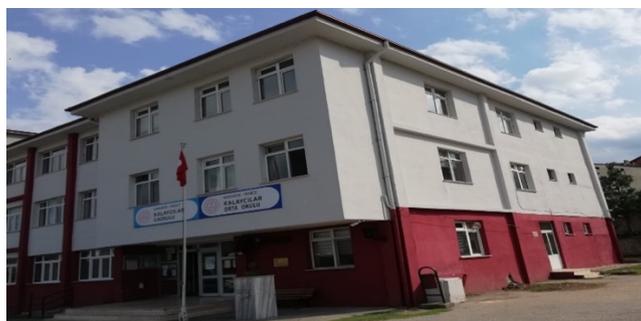
Figure 1. A view of the Kalaycılar primary school building

This study examined Kalaycılar primary school, located in the Yenice district of Karabük province. Kalaycılar primary school was chosen as the sample school building because the cost of strengthening is rational compared to the cost of rebuilding, and it has not completed its economic life. Kalaycılar primary school structural system consists of a 3-story reinforced concrete frame and shear wall, and the construction year was 2005. Accordingly, the school building consisting of ground, 1st and 2nd normal storeys is 1051,02 m² in total (see Figure 1). The ground storey of Kalaycılar primary school is 3,55 m high, and the 1st and 2nd typical storeys are 3,15 m high. Since no project exists for the mentioned school building, static and architectural survey projects were prepared [13]. On the other hand, the performance results of the said school building are more likely to be sufficient according to today's regulations. Experimental studies were carried out according to the comprehensive knowledge level of the school building whose projects were prepared. Accordingly, 4 core sampling were taken from each storey (see Table 1). From this table as a TBEC condition, when the bigger *average-standard deviation* or $0,85 * average$ values is considered as the existing concrete compressive strength, 20 MPa on the ground storey, 13 MPa on the 1st storey, and 12 MPa on the 2nd storey are considered. In addition, the detection of destructive reinforcement (peel test) was carried out with 4 structural elements on the ground storey and 3 structural elements on the other storeys. In addition, the non-destructive reinforcement detection method (X-ray) was performed on 40 structural elements throughout the building (see Figure 2~Figure 4). The studies performed on detecting destructive reinforcement in the said school building are shown in Figure 5 and Figure 6.

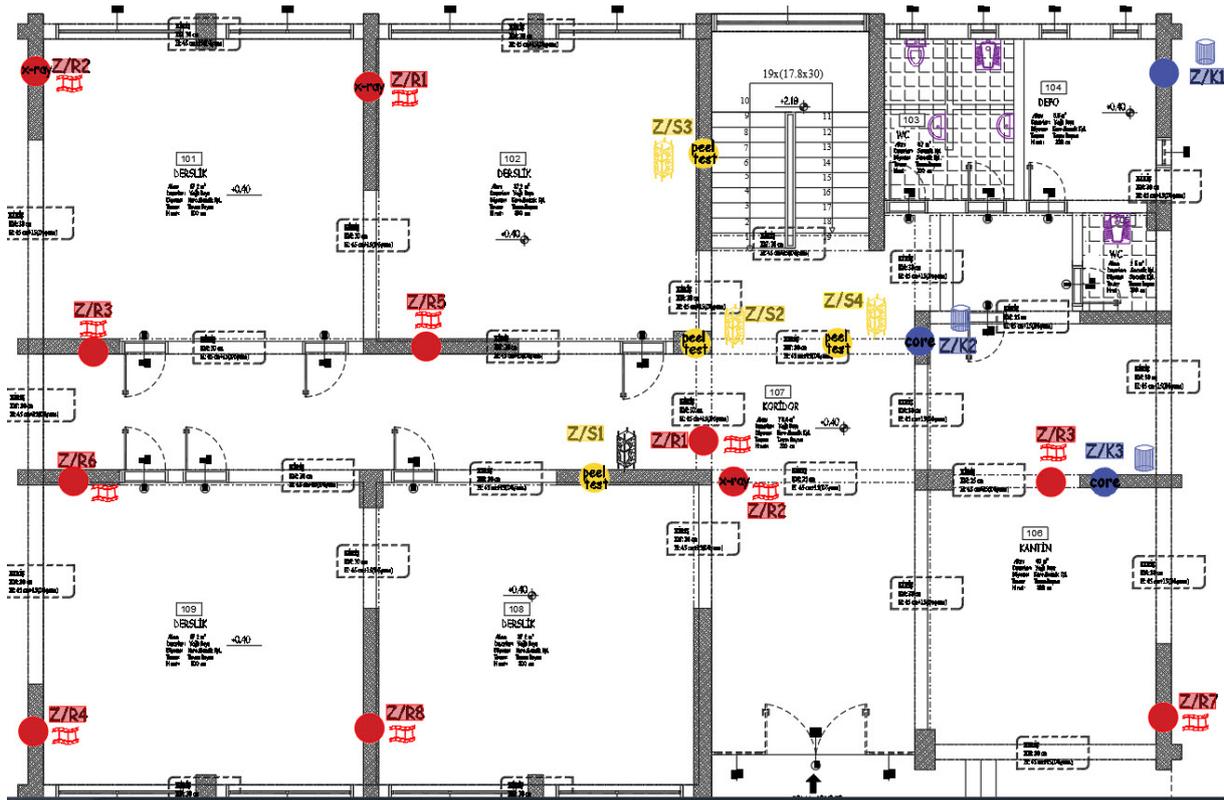
Figure 2. Structural elements where experiments are performed on the ground storey

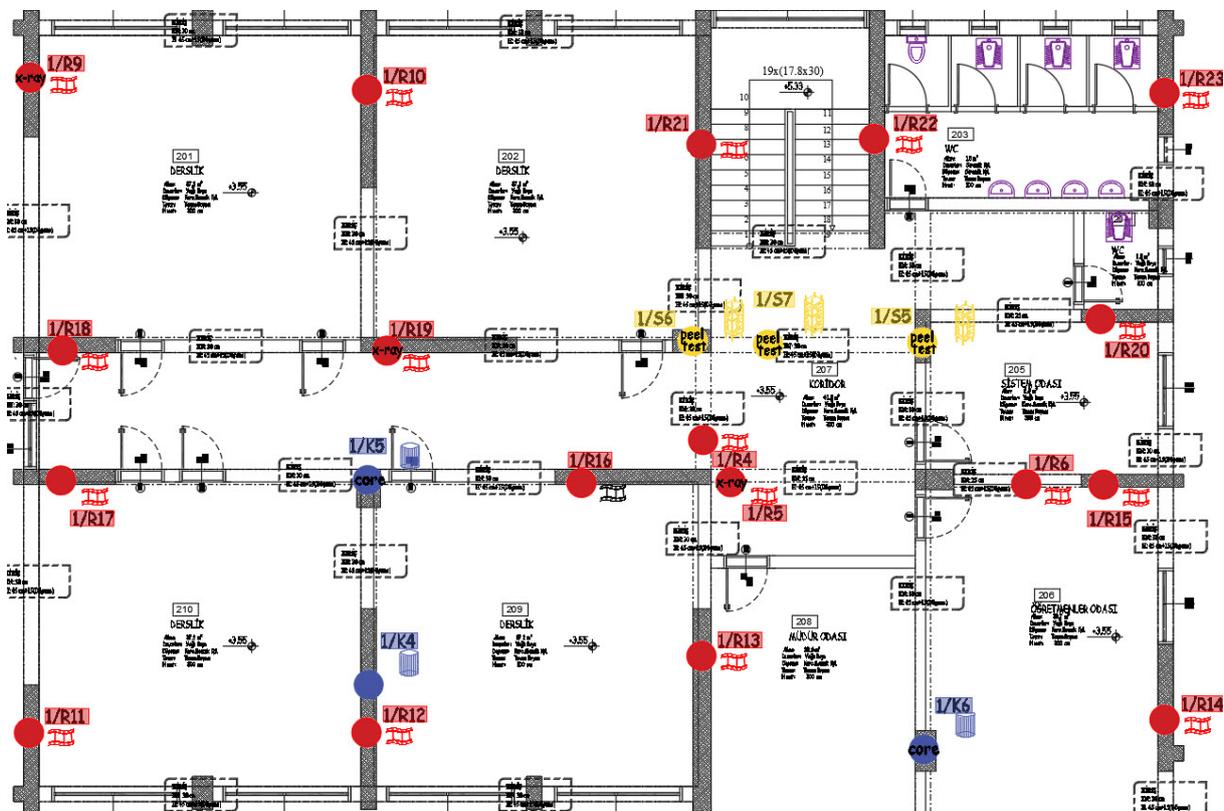
Figure 3. Structural elements where experiments are performed on the 1st storey

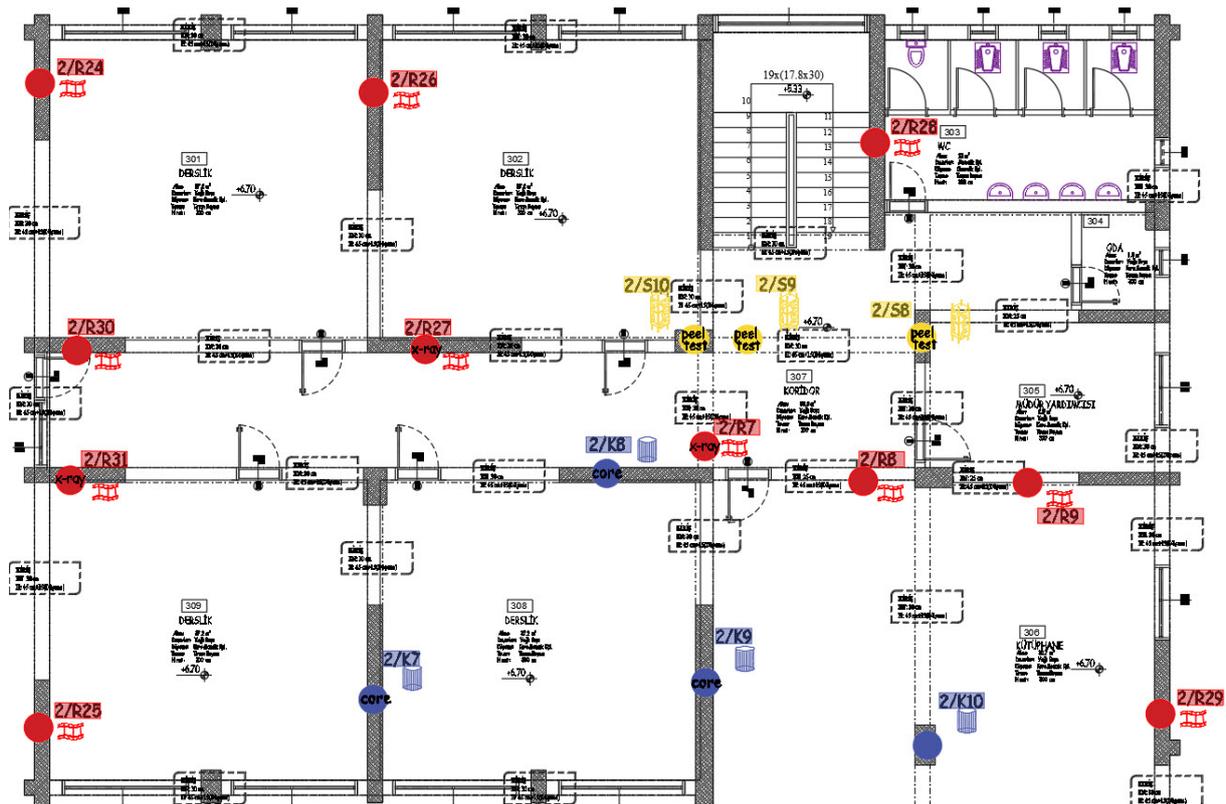
Figure 4. Structural elements where experiments are performed on the 2nd storey

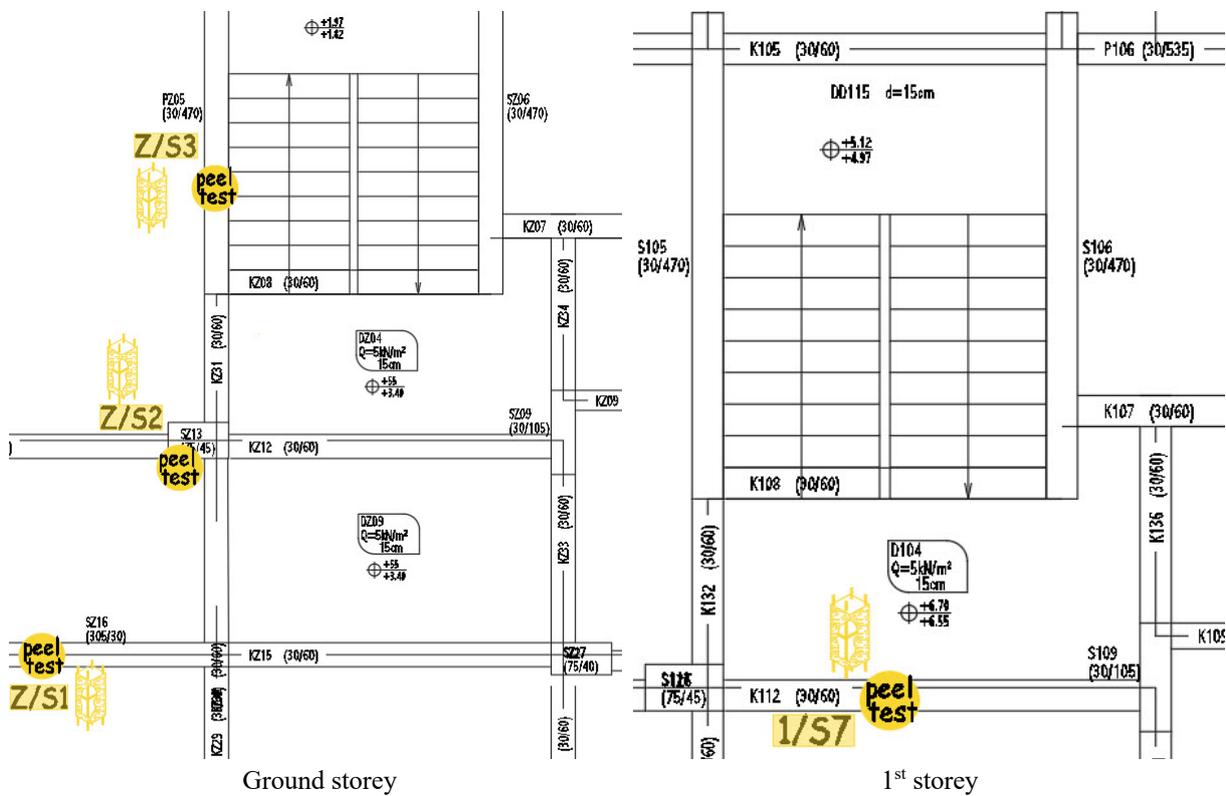
Figure 5. Locations of the peel test structural elements on the ground storey of Kalaycılar primary school

Here, it would be useful to state that the S420 type rebar is detected in the structural elements where made the peel test, that the tensile test is not performed to breaking. Because re-be adding the rebars will affect their mechanical properties, the rebar detection methods in the 2007 and 2019 Turkish earthquake codes are considered in determining the said rebars.

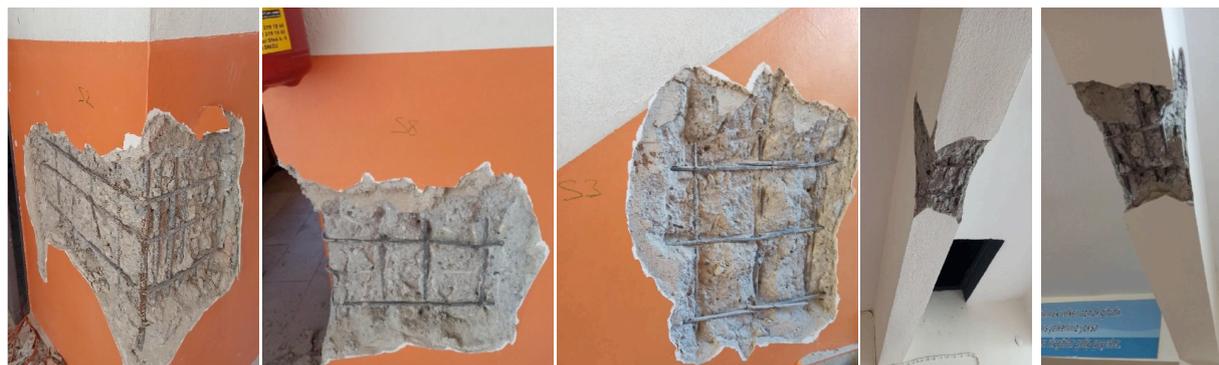
Ground SZ13 column Ground-storey SZ16 column Ground storey PZ05 shear wall Ground K112 beam Ground SZ27 beam
Figure 6. Views from the scraping process applied to some structural elements of Kalaycılar primary school

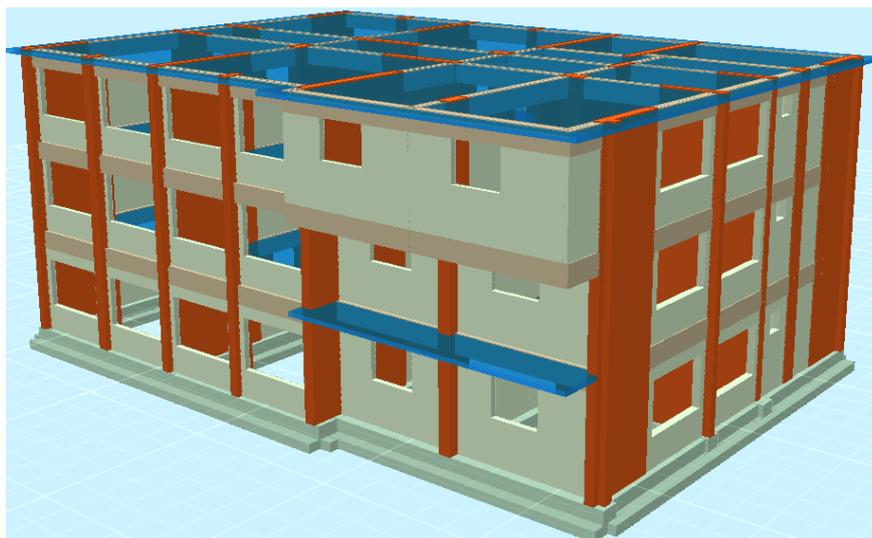
Figure 7. A view from the created model of Kalaycılar primary school

For structural analyses, the model of Kalaycılar primary school was created as in Figure 7 with the Sta4-Cad program, considering the TS498 and TS500 codes [17, 18]. An earthquake-free analysis was made, and cross-section adequacy was checked when the school building did not have application projects. As a result of the earthquake-free analyses, it was seen that there were no insufficient structural elements and that the school building had sufficient strength under service loads. Then, the existing concrete compressive strengths and rebars are defined separately for each storey. Accordingly, 20 MPa concrete strength on the ground storey, 13 MPa on the 1st storey, and 12 MPa on the 2nd storey, and existing S420 rebar information determined on-site were entered into the school building model (see Table 1). In addition, the parameters in Table 2 were considered for the structural analyses. First, performance analysis was made according to SBBSZ of the school building model in that information was entered. Accordingly, performance levels should be provided *Life Safety* (LS) for earthquake effects with a 2% probability of being exceeded in 50 years and *Immediate Use* (IU) for earthquake effects with a 10% probability of being exceeded in 50 years [15]. From structural analyses, the school building failed to provide the target performance levels (see Figure 12 and Figure 15). As a result of the performance analyses made according to TBEC, while Kalaycılar primary school provided the target performance level at the DD1 earthquake level, it could not provide

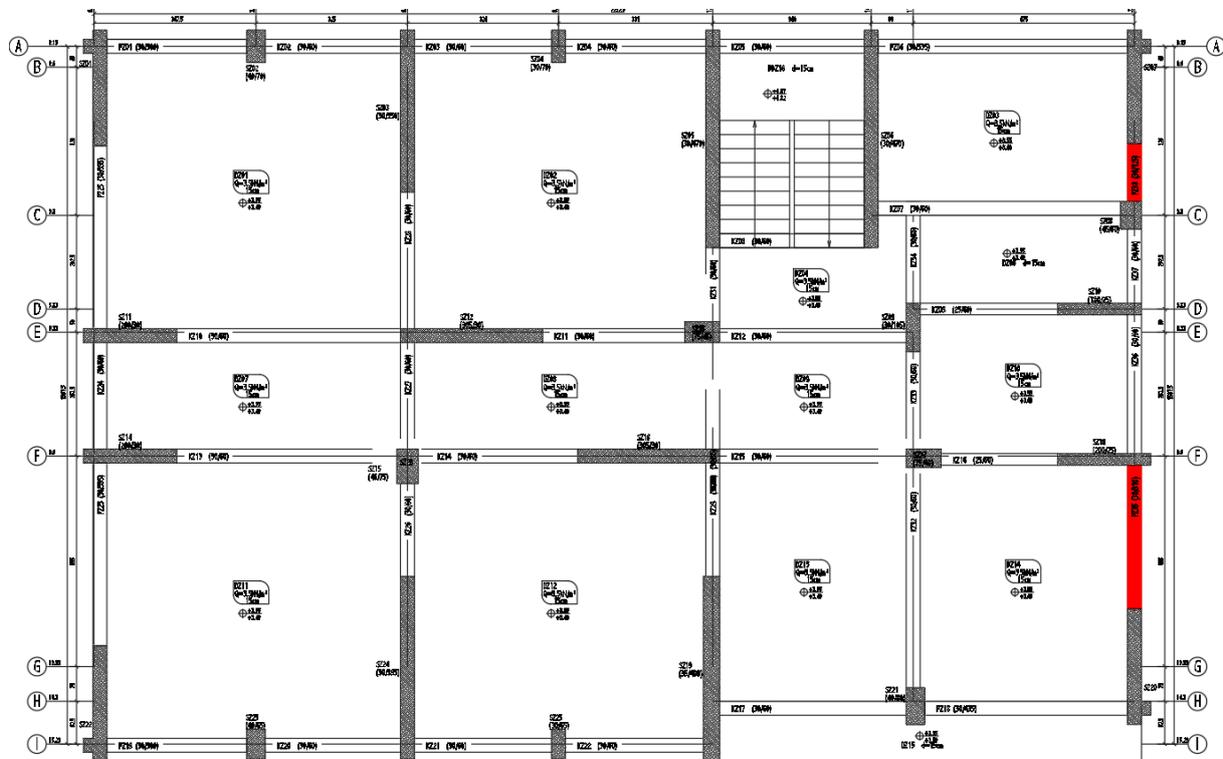
Figure 8. Locations of shear walls added to Kalaycılar primary school for strengthening purposes (model 1).

While preparing the strengthening project of Kalaycılar primary school, torsional irregularities and structural elements damaged at the DD3 earthquake level were considered. Accordingly, a shear wall was added to the polygonal columns in case of *Marked Damage* (MD) in the y-direction on the ground story (see Figure 8). Performance analyses of the strengthened school building (model 1) were made according to SBBSZ and TBEC. As a result of the analyses, while the model 1 strengthening did not provide the target performance level according to SBBSZ, it provided the target performance level according to TBEC (see Figure 12~19). In addition, it was observed that there were no brittle structural elements with the model 1 strengthening.

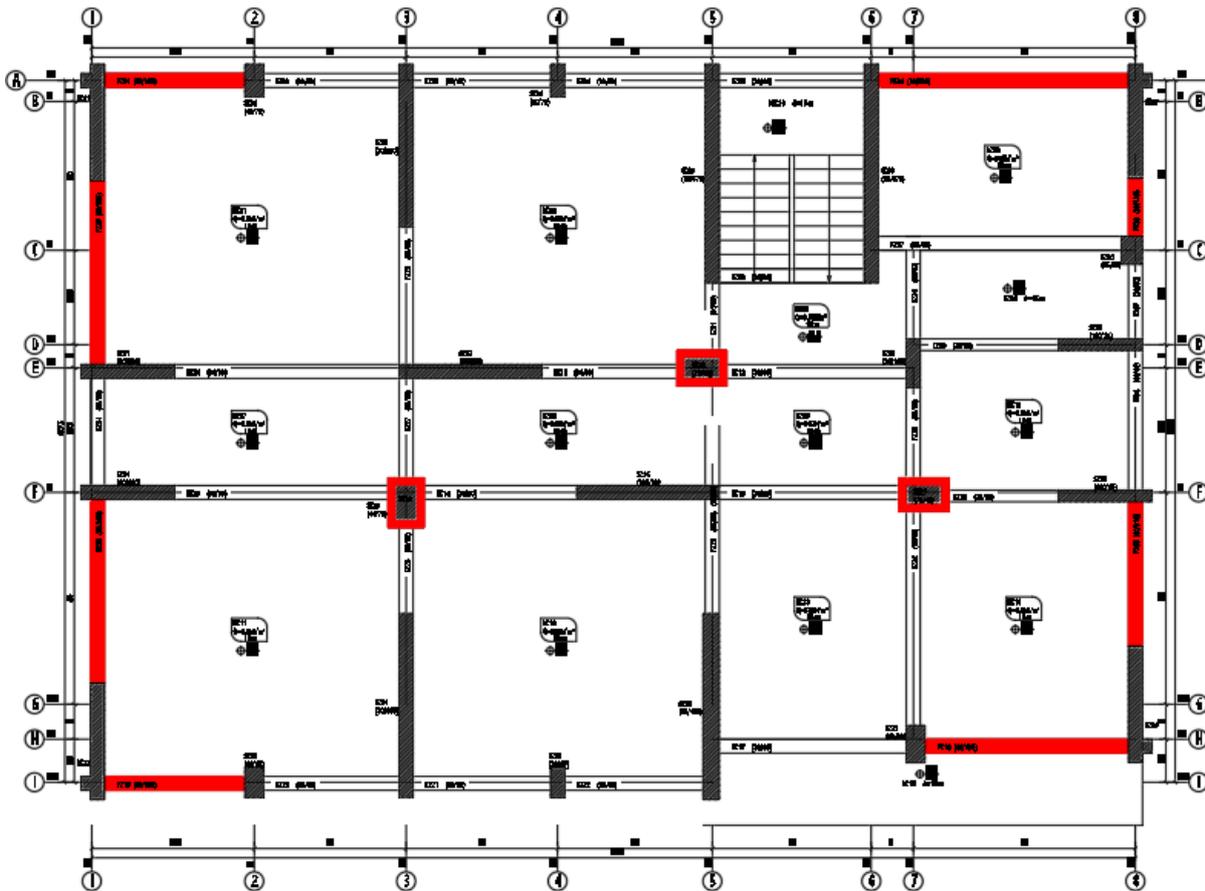
Figure 9. Strengthening applied to the ground-storey structural elements of Kalaycılar primary school (model 2).

Since the strengthening project prepared as model 1 did not provide the target performance level according to SBBSZ, the strengthening project defined as model 2 was prepared. Accordingly, the views of the structural elements to which strengthening is applied are seen in Figure 9~Figure 11, respectively. As a result of the analyses of the school building (model 2) strengthened according to SBBSZ and TBEC regulations, it is seen that the model 2 strengthening provides all target performance levels according to both SBBSZ and TBEC (see Figure 12~Figure 19).

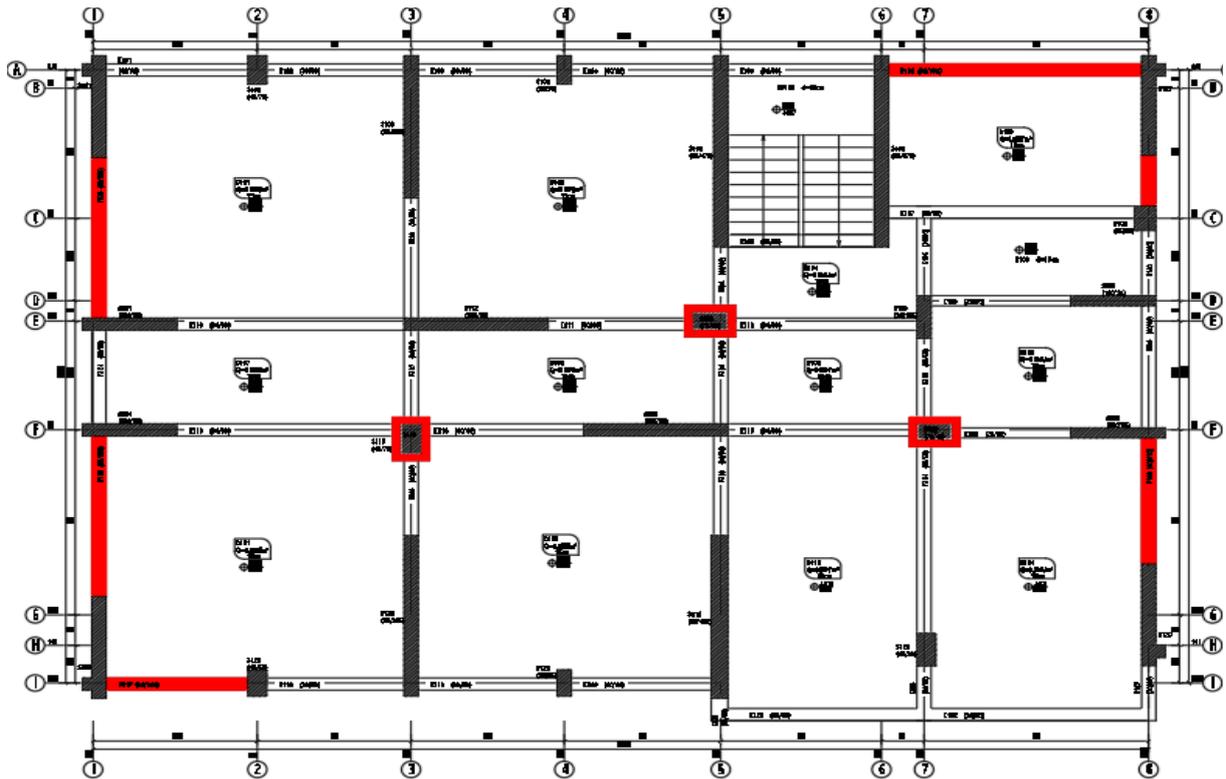
Figure 10. Strengthening applied to the 1st storey structural elements of Kalaycılar primary school (model 2).

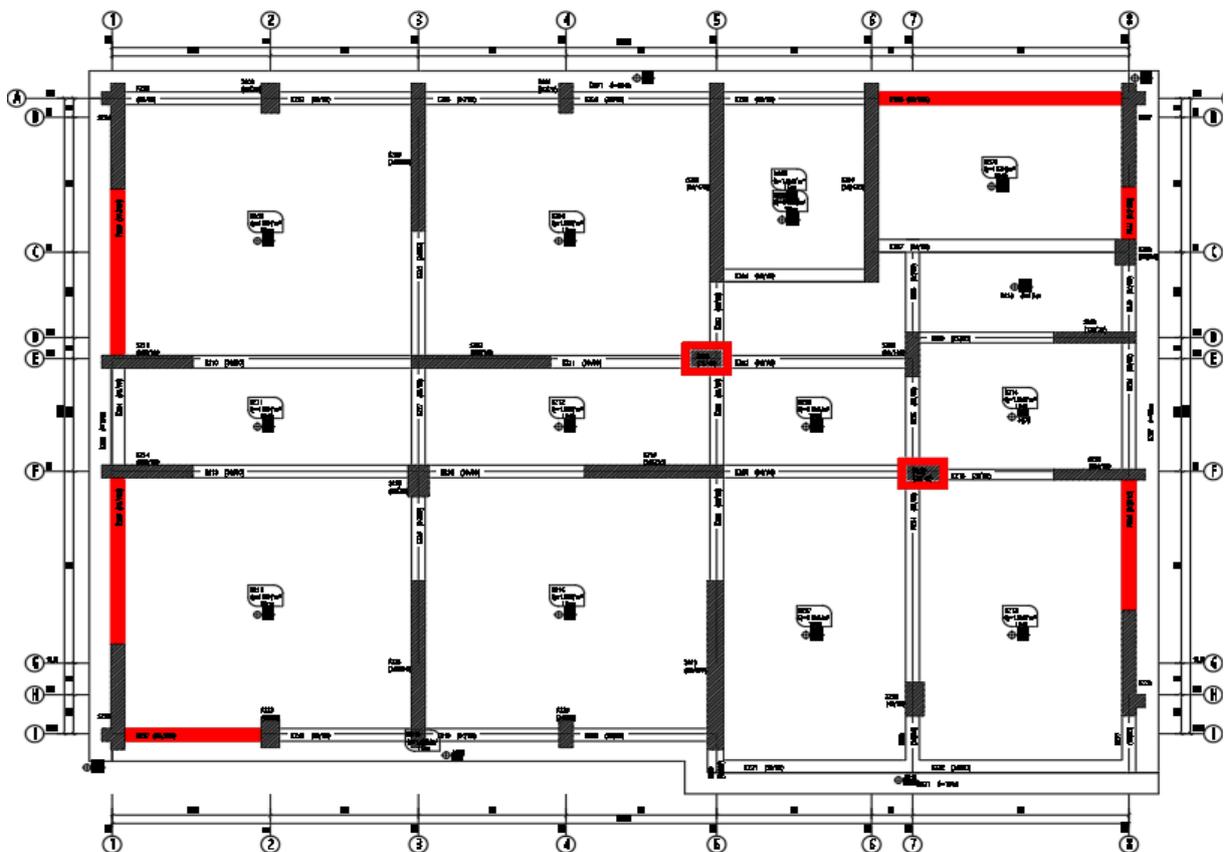
Figure 11. Strengthening applied to the 2nd storey structural elements of Kalaycılar primary school (model 2).

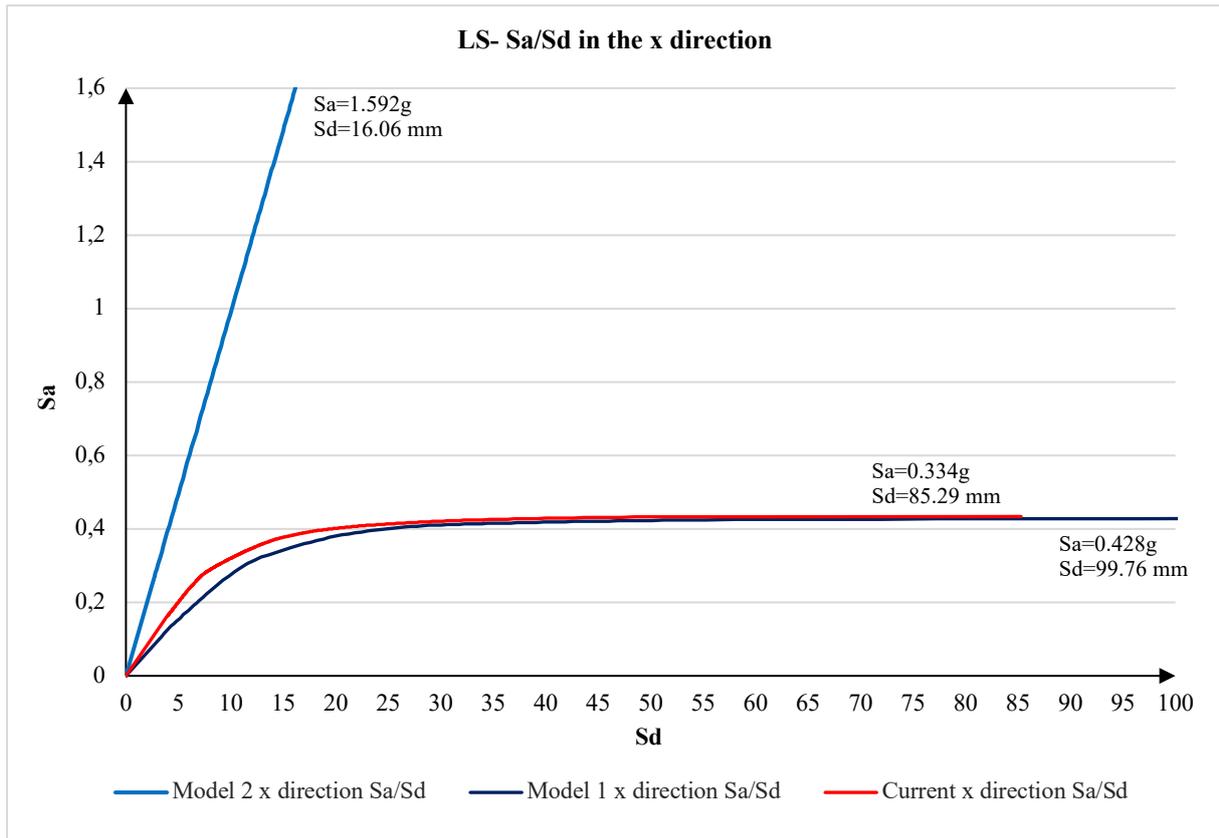
Figure 12. Performance results in LS earthquake of Kalaycılar primary school with the current situation, the model 1 and model 2 strengthening's in the x direction

From the analyses of the current and strengthened models (models 1 and 2) of Kalaycılar primary school according to SBBSZ, their performance status is given in Figure 12~Figure 15, respectively. These figures show that the required performance target could not be provided when the current and the strengthened school building, according to model 1, is evaluated according to the LS and IU performance levels. Since the Kalaycılar primary school cannot be provided, target performance levels of the situation strengthened according to existing and model 1, and a better performance level is obtained when the strengthened school building according to model 2 is evaluated according to the LS and IU. In other words, the target performance level is provided when the strengthened school building, according to model 2, is evaluated according to the LS and IU performance levels.

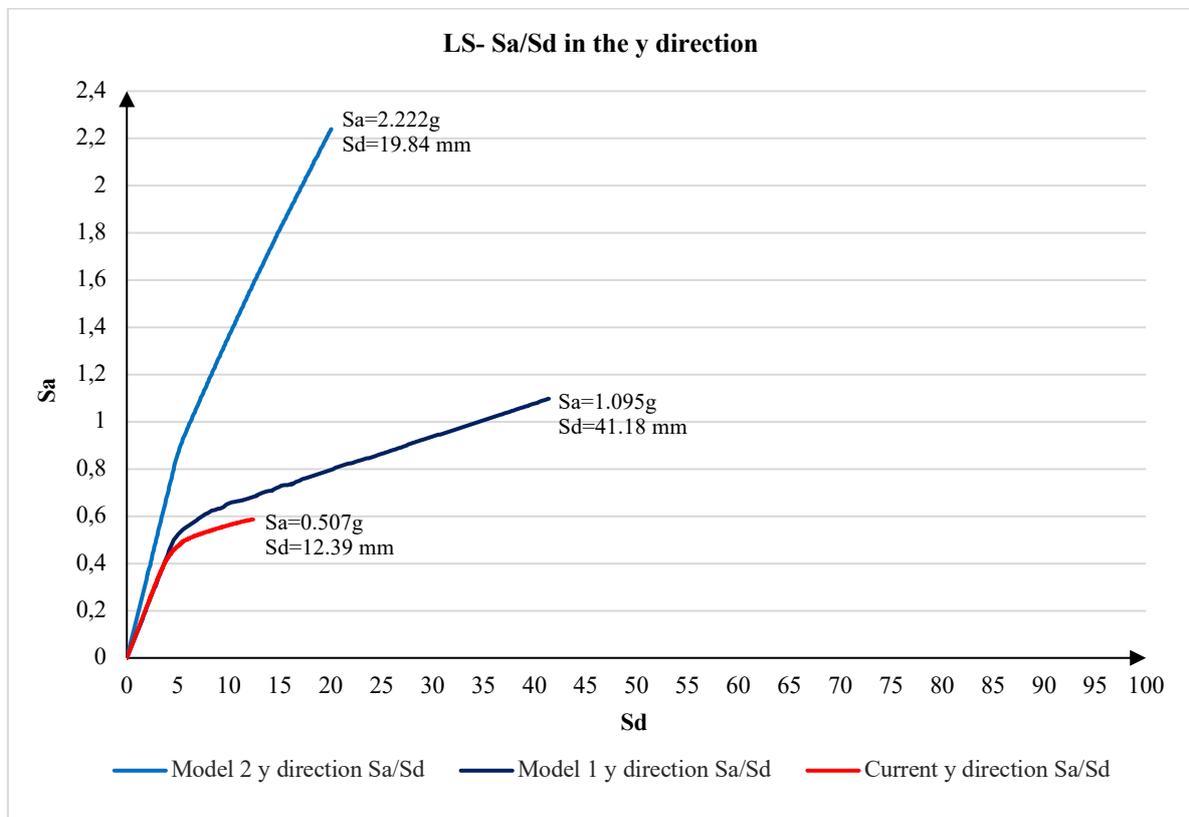
Figure 13. Performance results in LS earthquake of Kalaycılar primary school with the current situation, the model 1 and model 2 strengthening's in the y direction

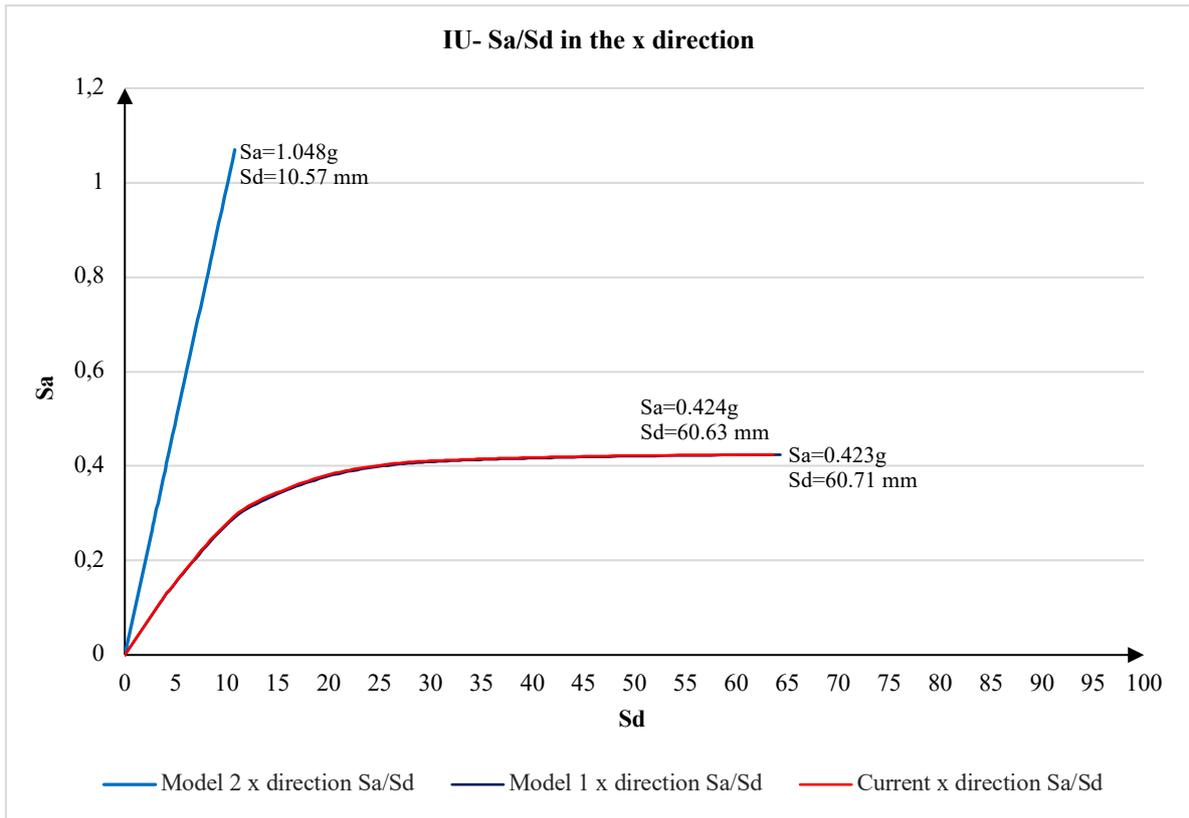
Figure 14. Performance results in IU earthquake of Kalaycılar primary school with the current situation, the model 1 and model 2 strengthening's in the x direction

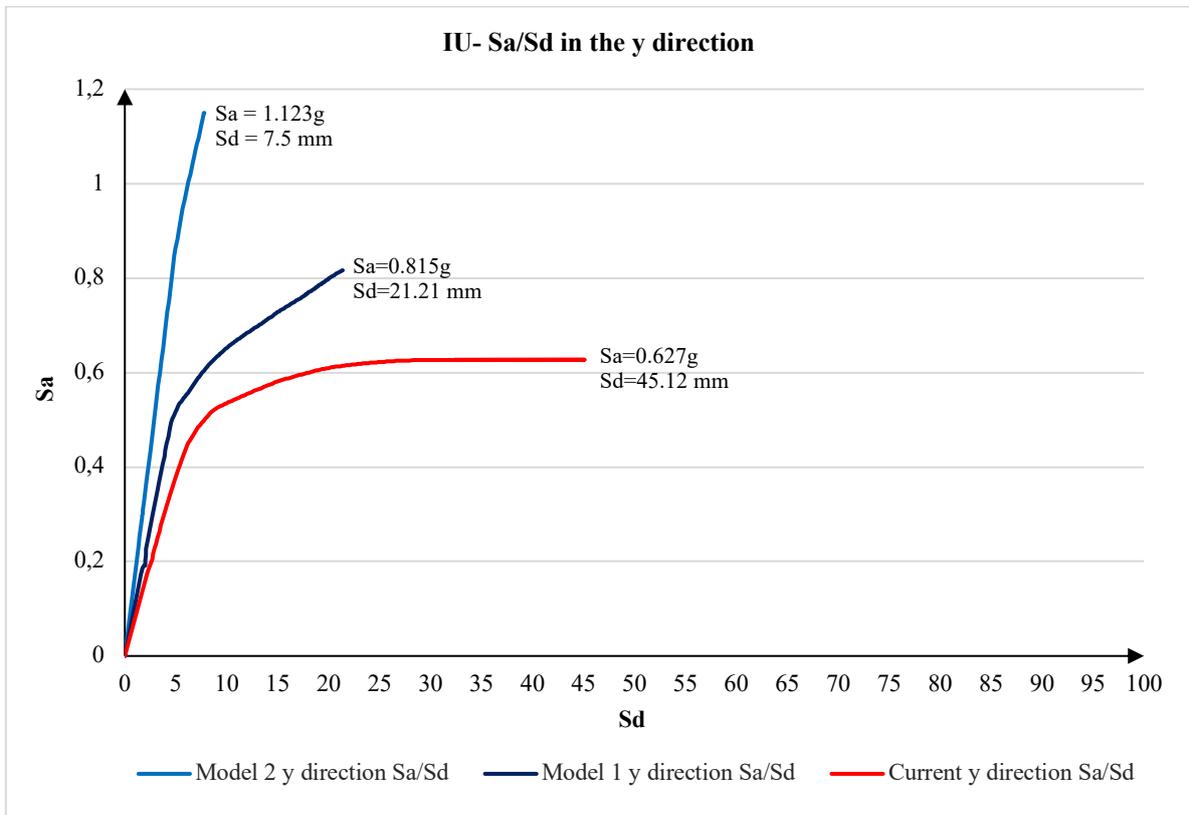
Figure 15. Performance results in IU earthquake of Kalaycılar primary school with the current situation, the model 1 and model 2 strengthening's in the y direction

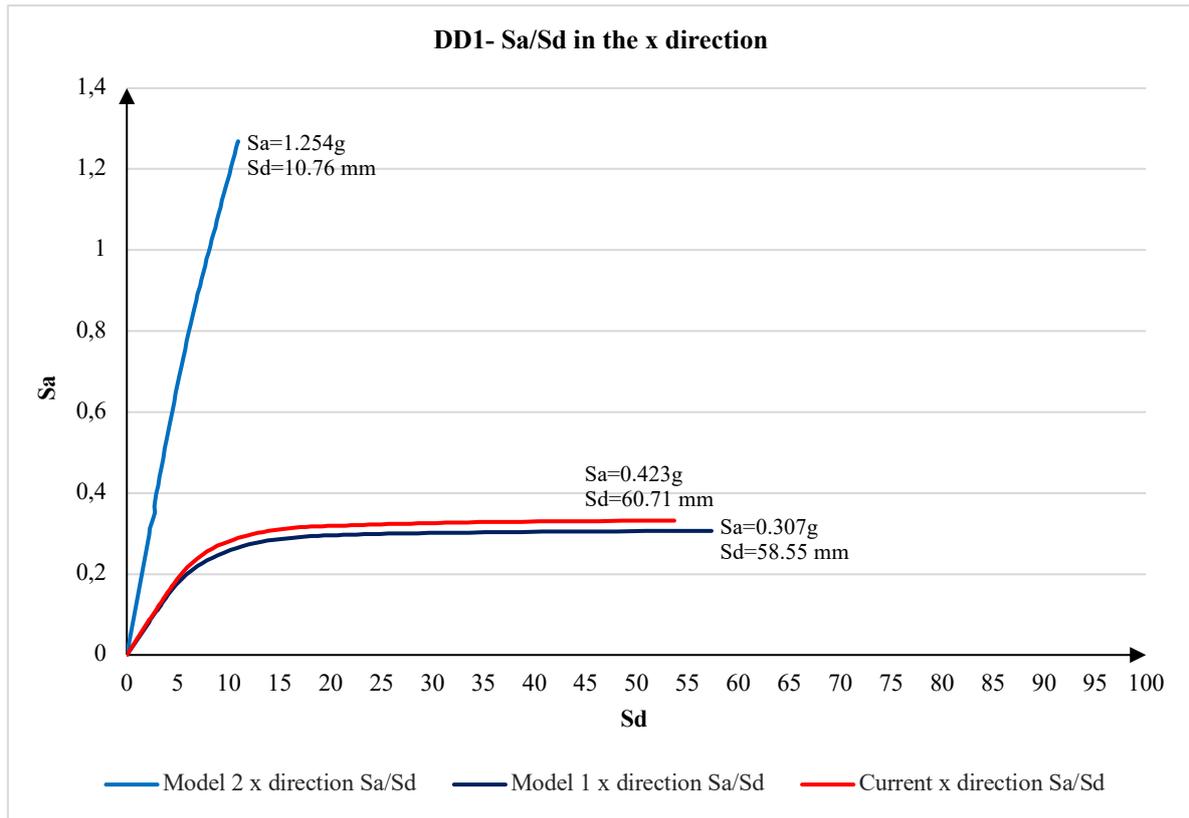
Figure 16. Performance results in DD1 earthquake of Kalaycılar primary school with the current situation, the model 1 and model 2 strengthening in the x direction

the target performance level at the DD3 earthquake level (see Figure 16 and Figure 19). In other words, this result shows that the target performance *Limited Damage* (LD) level could not be achieved at the DD3 earthquake level. In contrast, the target performance *Controlled Damage* (CD) performance level was achieved in the DD1 earthquake.

From the analyses of the current and strengthened models of Kalaycılar primary school according to TBEC, their performance status is given in Figure 16~Figure 19, respectively. According to this, it is seen that the required performance target is provided when the current and strengthened school-building models are evaluated according to the CD performance level. When the current and the strengthened school building according to model 1 is evaluated according to the LD performance level, the target performance level according to the DD3 earthquake level does not provide. By contrast, it is seen that the school building strengthened with the model 2 method provides all target performance levels.

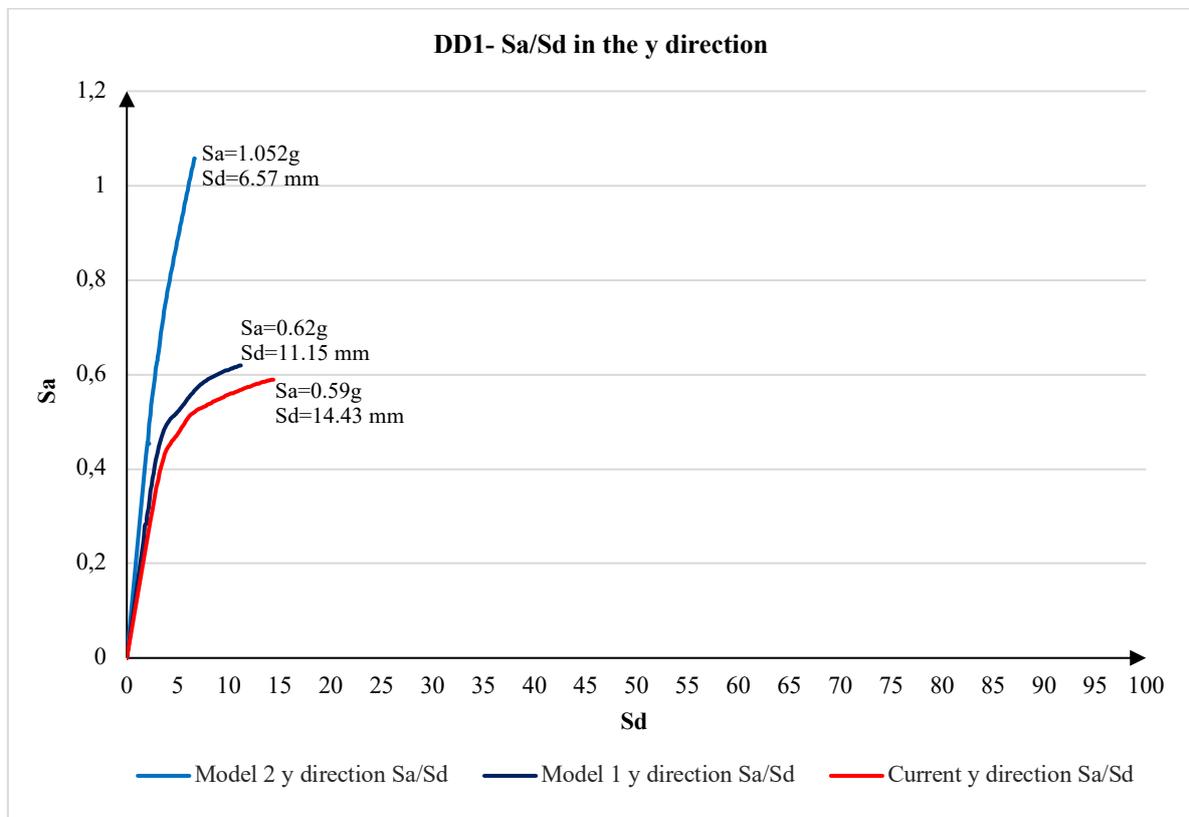
Figure 17. Performance results in DD1 earthquake of Kalaycılar primary school with the current situation, the model 1 and model 2 strengthening in the y direction

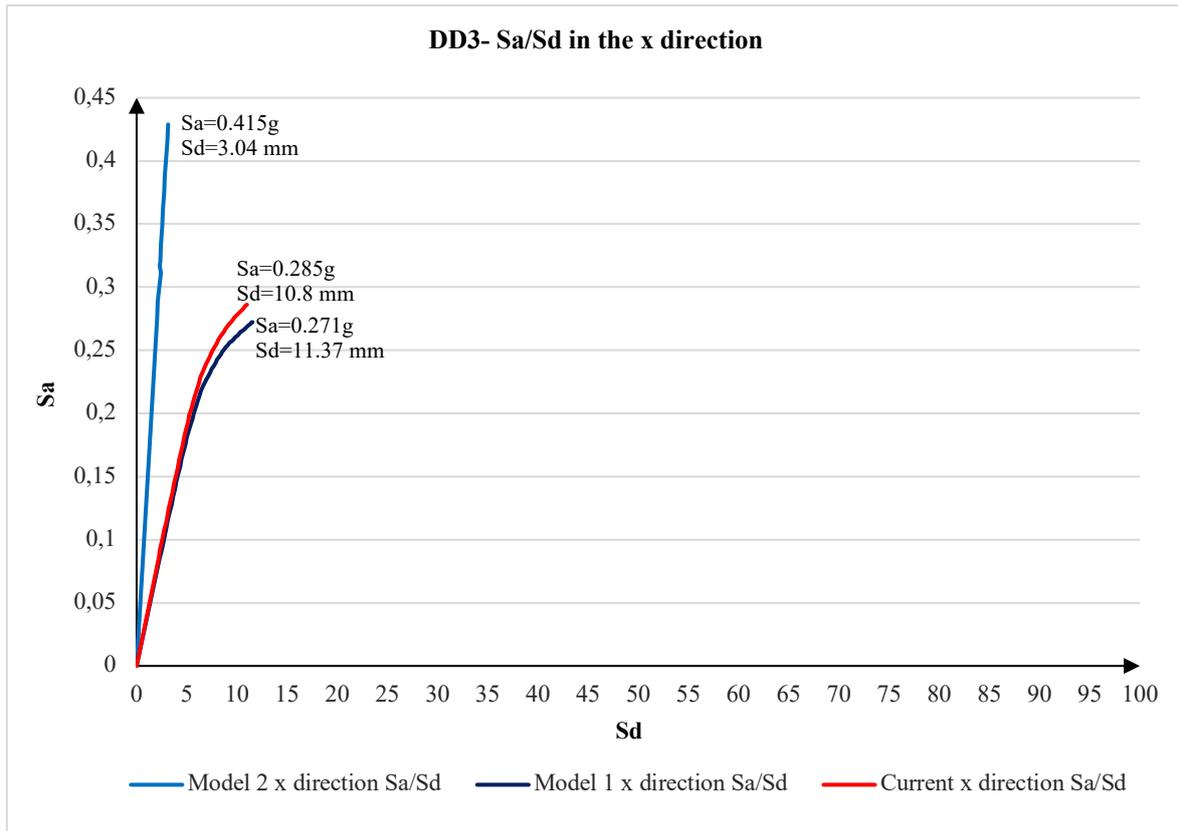
Figure 18. Performance results in DD3 earthquake of Kalaycılar primary school with the current situation, the model 1 and model 2 strengthening in the x direction

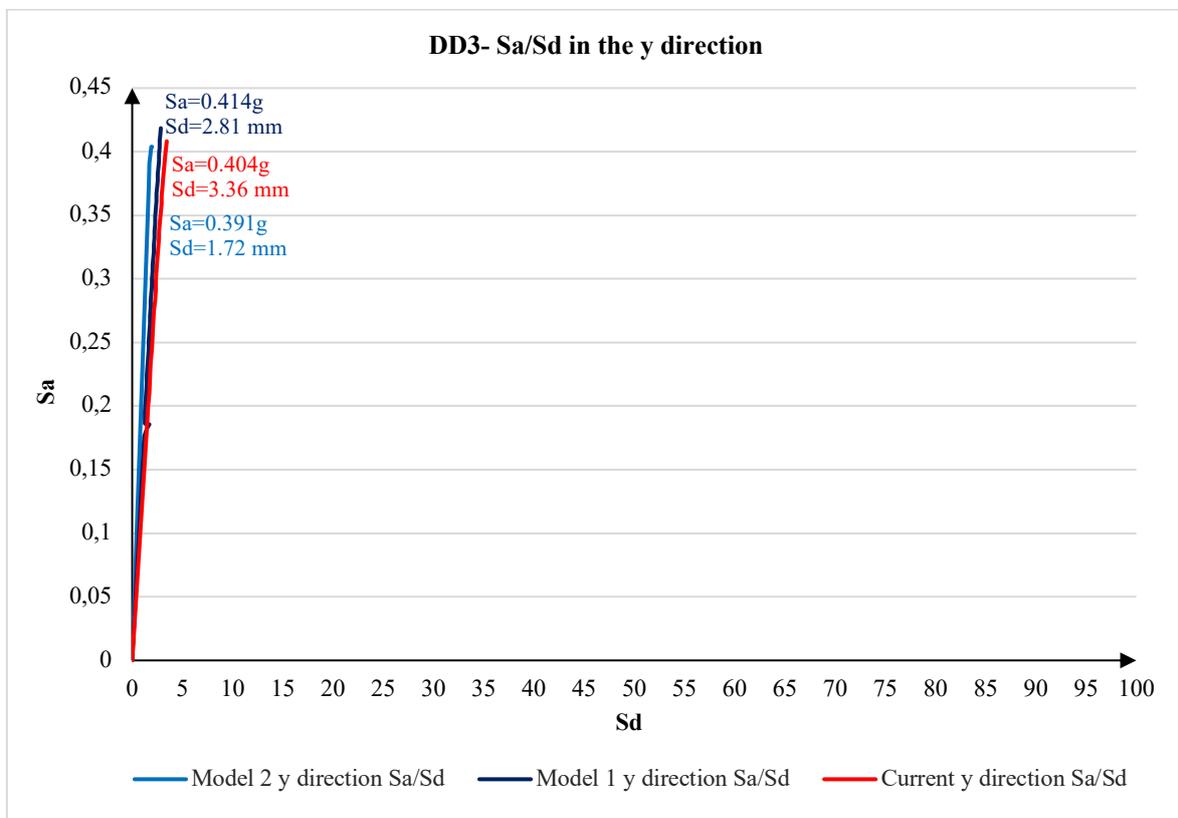
Figure 19. Performance results in DD3 earthquake of Kalaycılar primary school with the current situation, the model 1 and model 2 strengthening in the y direction

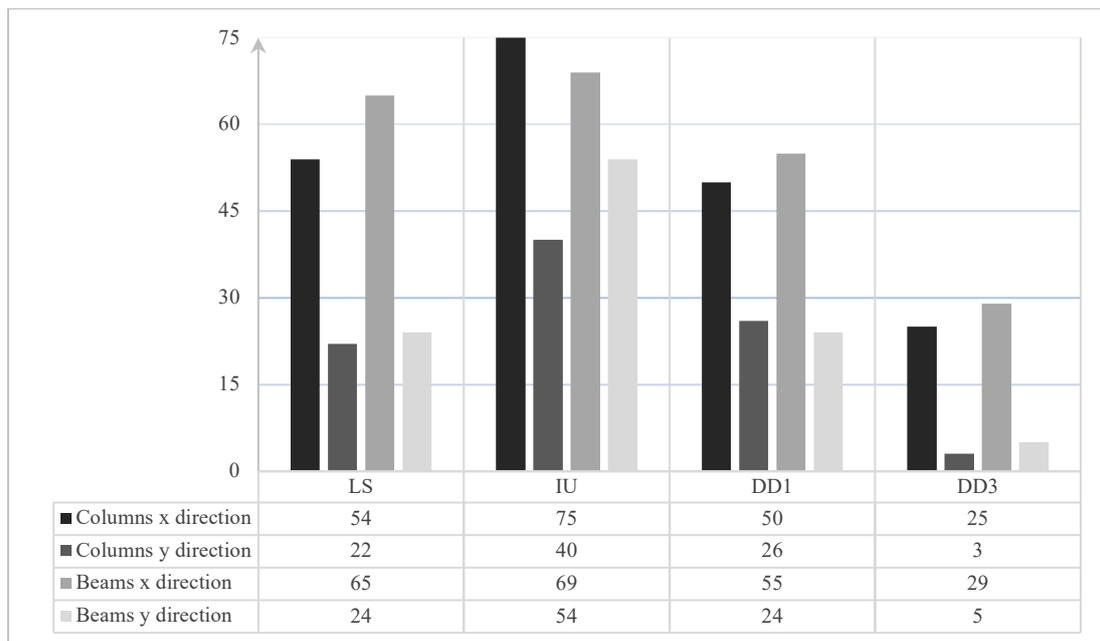
Figure 20. Number of structural elements plasticized in x and y earthquake directions of the current situation of Kalaycılar primary school

The total number of plastic hinges formed in the columns and beams according to the earthquake levels recommended in SBBSZ and TBEC for the current and strengthened conditions of Misakı Milli primary school is given in Figures 20~22, respectively. These figures show that the number of plastic hinges formed in the strengthened state according to model 2 has decreased significantly compared to the current situation. Also, for the limited knowledge level, it has been observed that there is a general increase in the total number of plastic hinges formed in the columns and beams compared to the comprehensive knowledge level.

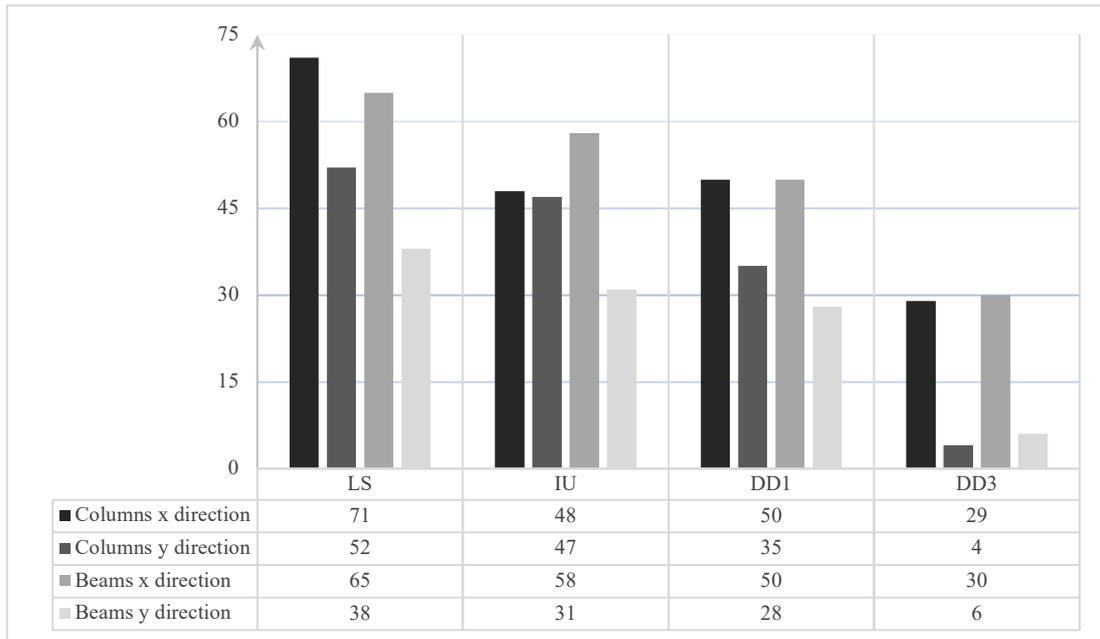
Figure 21. Number of structural elements plasticized in the x and y earthquake directions of Kalaycılar primary school model 1 strengthening

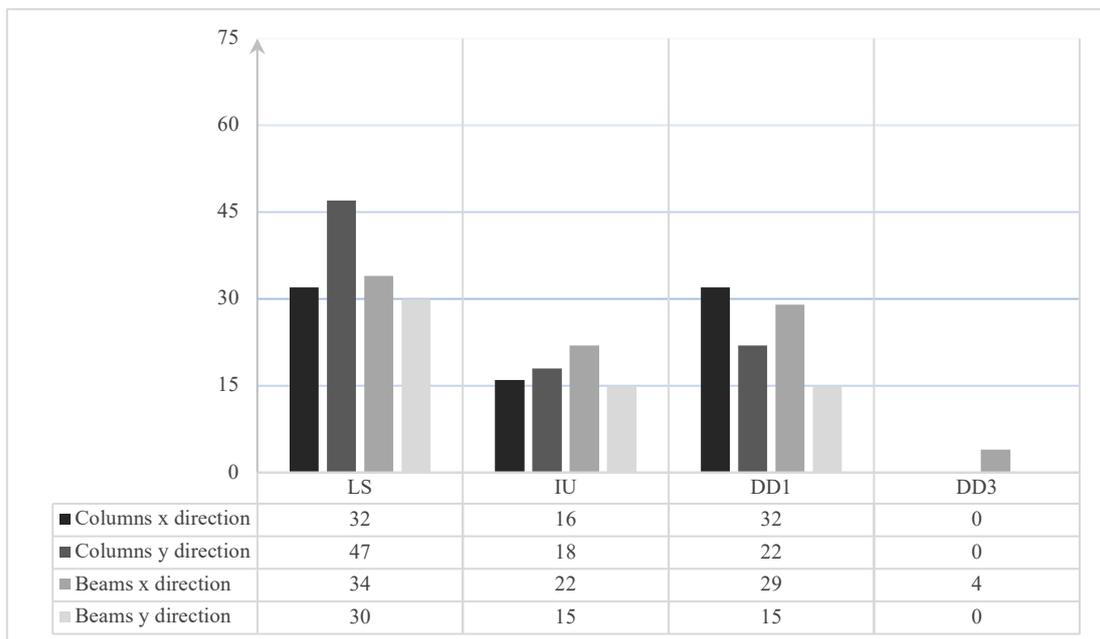
Figure 22. Number of structural elements plasticized in the x and y earthquake directions of Kalaycılar primary school model 2 strengthening
