The effect of scanning strategy on mechanical properties and delamination during brake caliper manufacturing with selective laser melting (SLM)

Author(s): Mehmet ÖZAKINCI¹, Rahmi ÜNAL²

Research Article

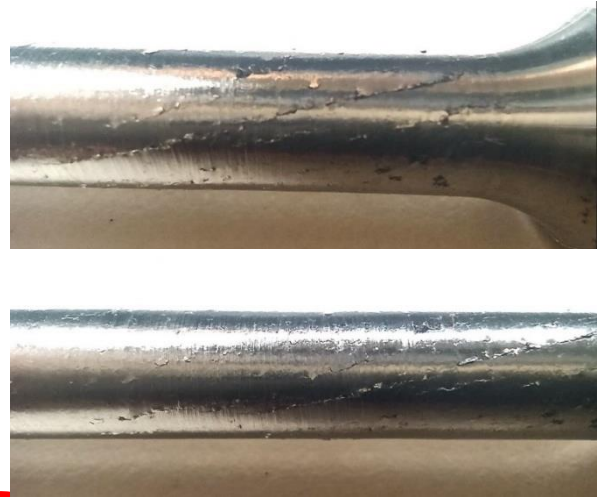
Figure 7. SSS tensile specimens with surface cracks during threading

M10x1.5 thread was drilled on tip of the specimens in order to connect them to the tensile test device. During manual threading, visible discontinuous cracks shown in Figure 7 occurred on the body surface of the cylindrical SSS test specimen due to torsion. Because of this, it was decided that nondestructive testing techniques should be used to examine the surface of the tensile samples. The penetrant test, the results of which can be seen in Figure 8a, was performed by applying fluorescent spray material on the specimens. The dark red areas seen here indicate cracks formed on the surface during the threading of the specimens. In order to determine whether the cracks continued into the body of the specimen, radiographic examination was performed on the Balteau XSD 160 X-Ray imaging device. In the radiography results shown in Figure 8b, no trace of these cracks continuing into the sample body was found.

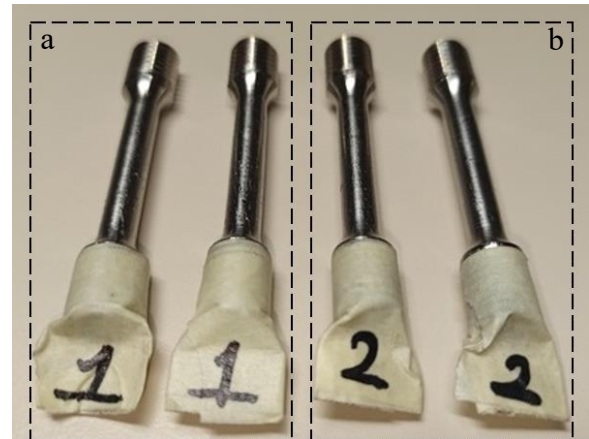
Figure 9. Samples fabricated with the (a) SSS and (b) CSS

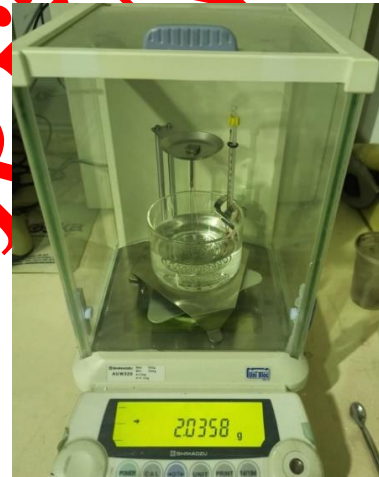
Figure 11. Archimedes' principle test equipment image during sample number 1/2

The densities and porosity ratios of the three samples produced with CSS and SSS were determined according to the Archimedes principle. The samples were obtained by cutting on the lathe from the vertically produced parts seen in Figure 10. The cut samples are numbered 3, 2, and 1 from the bottom layer to the top. The top layers, where delamination of the part was observed, were scrapped up to 3 to 5 mm for both SSS and CSS samples. According to Archimedes' principle, the Equation 1 was used to calculate the density of the samples based on the weight difference between air and distilled water. Details of the principle can be found in the ASTM B311-17 standard [18]. Test equipment for this method can be seen Figure 11.

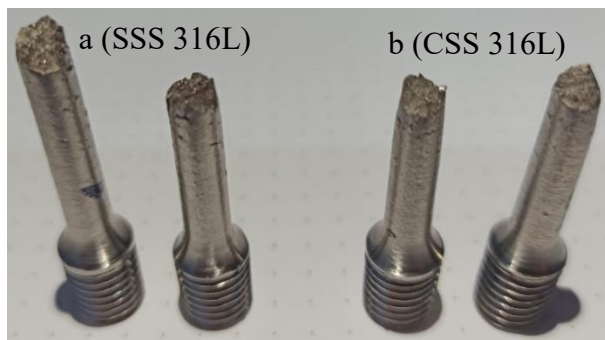
Figure 13. As a result of the tensile test, samples that rupture

Figure 13 depicts specimens that have fractured as a consequence of the tensile test. It can be seen from these images that the fractures are ductile. When both methods are compared, according to the tensile test results, the fact that the elongation value of CSS is approximately 50% higher can be seen from the sample images.

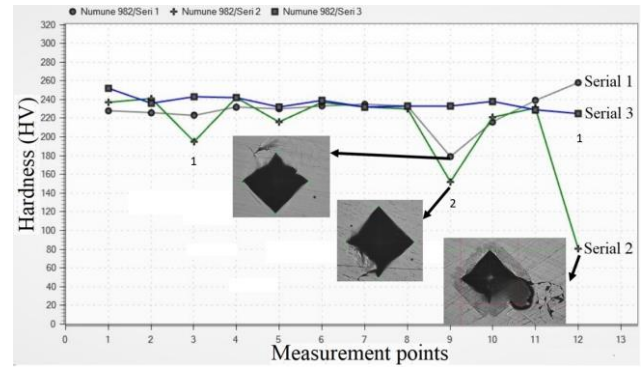
Figure 18. Vickers hardness test measurement results for CSS sample

Figure 17 and Figure 18 illustrates Vickers hardness values based on measurement points and series. On several measurement points in the illustrations, the numbers 1-3 correspond to the wrong measurement point numbers on the same horizontal axis. Figure 17 depicts the SSS sample measurement graph with Vickers hardness values from a total of 93 measurement points. 27 of these measurements cannot be obtained accurately because the indenter overlaps with the void. In the SSS sample, inaccurate measurements were changed with values obtained from the closest region, which appeared to be void-free in the horizontal direction. An example of this situation is seen in Figure 19. One side of the square shaped trace left by the Vickers indenter is approximately 60 μm . Figure 17 shows distorted indenter traces at problematic measurement points. Figure 18 of the CSS sample shows that the indenter impacted the void region in 4 of 39 measurements. In other words, the Vickers indenter coincides with the voids in 29% of the measurements from the SSS sample and 10% of the measurements from the CSS sample. The reason for this difference is that the fusion gaps in the SSS sample are higher than the CSS. The white spots seen on the sample surface in Figure 15 and Figure 16 are lack of fusion voids. These voids on the CSS sample surface, as seen in Figure 16, are substantially smaller and less numerous than those on the SSS one.

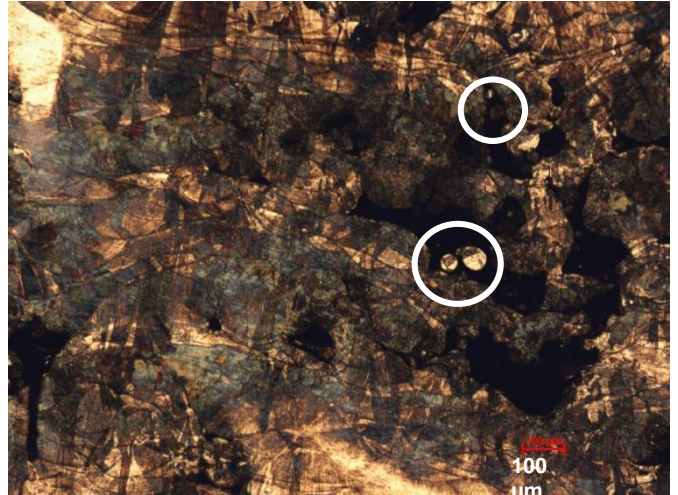
Figure 23. SSS sample; 50X magnification microscopy image of region SB as described in Figure 21

For both samples, the upper layers are the regions where delamination begins. Figure 25 and Figure 26 include detailed photographs of the SSS sample, whereas Figure 32 depicts the CSS sample. Specifically, in Figure 26 from the SSS sample, the delamination is visible on the fabricated part's outside surface.
