A comparative investigation into the impact of shop-primer coating on weldability of S235JR steel using MAG and SAW processes

A Comparative Investigation into the Impact of Shop-Primer Coating on Weldability of S235JR Steel Using MAG and SAW Processes

Araştırma Makalesi / Research Article

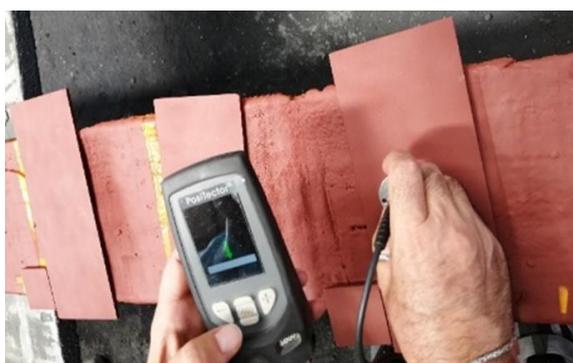
Figure 2. Photos of the samples after shop-primer application

Following sandblasting, the specimens received a shop-primer coating. This particular coating consists of an epoxy with two components; polyamide with zinc phosphate pigments, serving as effective anti-rust agent. Table 4 provides an overview of the main attributes of the coating employed in the investigations, while Table 5 presents its chemical composition. Additionally, Figure 2 depicts images of the samples after the application of the shop-primer coating.

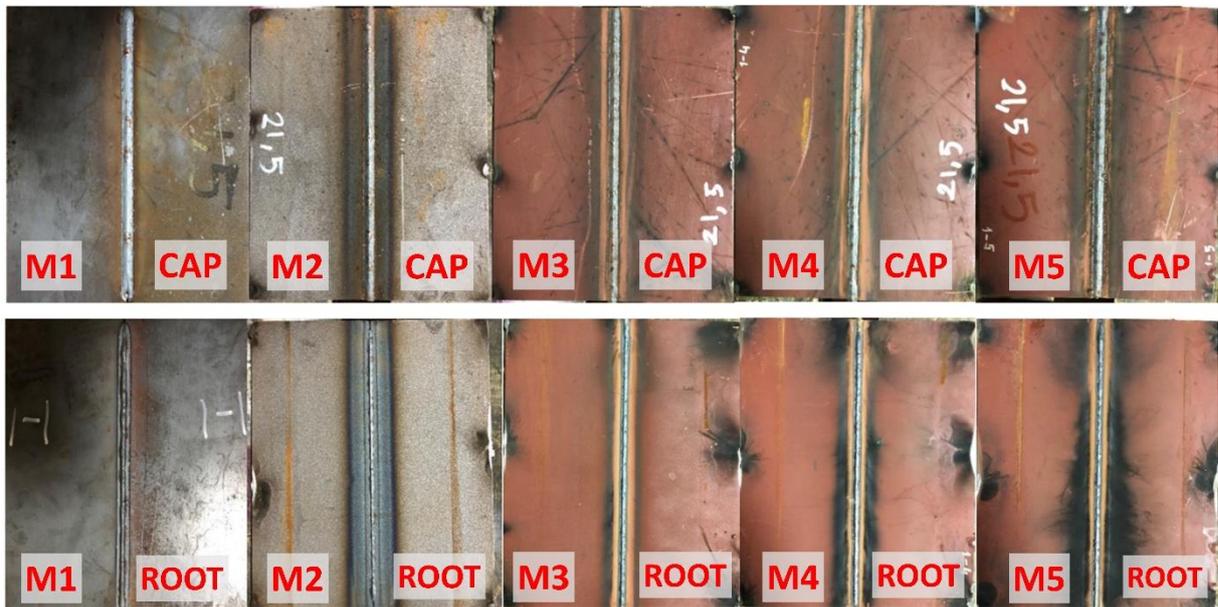
Figure 3. Photos of MAG welding cap and root passes.

The presence of weld defects such as insufficient penetration in the weld, the collapse of the root, and cracks was not observed in the other samples, except for the T5 sample, as a result of the visual inspection. However, due to the high current intensity and high welding speed, it was determined that partial undercut areas were formed in the samples, and these defects were within the limits of the acceptance criteria.

While welding of M3, M4, M5, T3, T4, and T5 specimens, a noteworthy correlation emerged where the emission of weld fumes exhibited an upward trend in tandem with the escalation of coating thickness. Additionally, upon meticulous examination of the post-welding rear surfaces of the coated specimens, a conspicuous intensification of black soot was observed, particularly in cases of higher coating

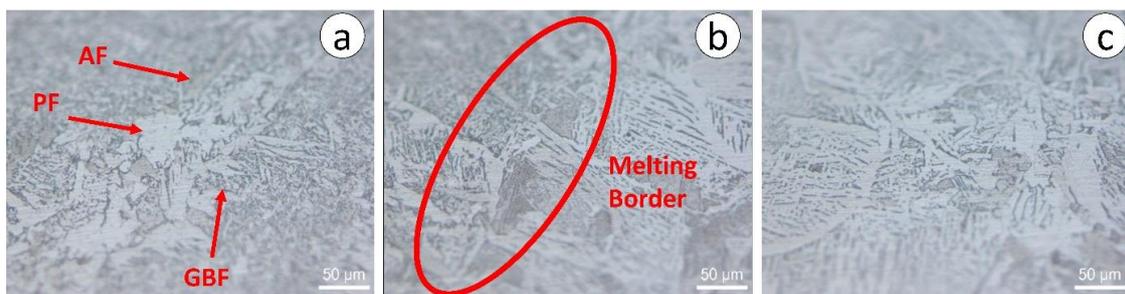
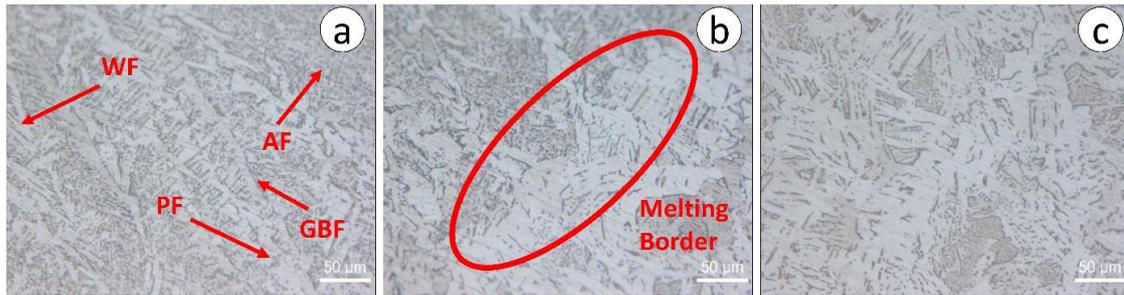
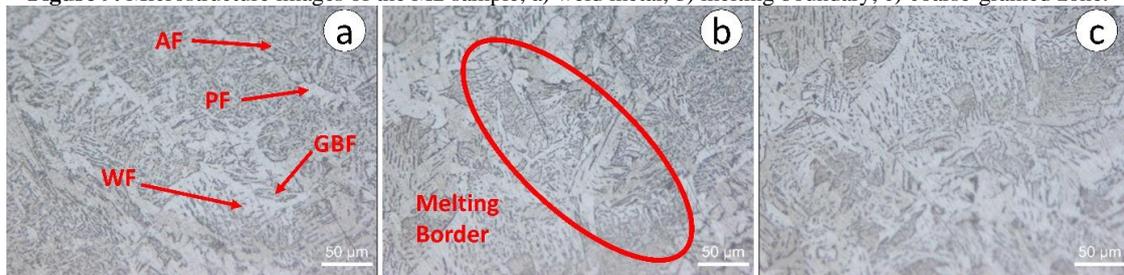
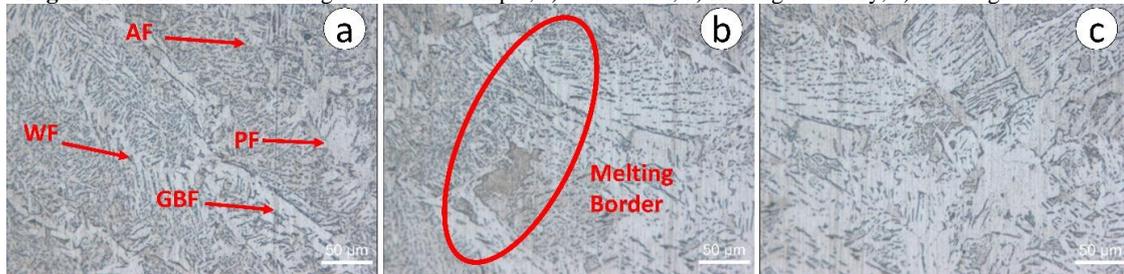
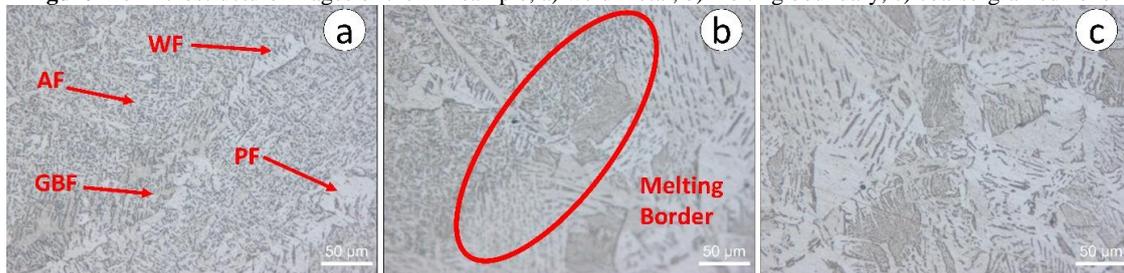
Figure 8. Microstructure images of the M1 sample, a) weld metal, b) melting boundary, c) coarse-grained zone.

Figure 9. Microstructure images of the M2 sample, a) weld metal, b) melting boundary, c) coarse-grained zone.

Figure 10. Microstructure images of the M3 sample, a) weld metal, b) melting boundary, c) coarse-grained zone

Figure 11. Microstructure images of the M4 sample, a) weld metal, b) melting boundary, c) coarse-grained zone

Figure 12. Microstructure images of the M5 sample, a) weld metal, b) melting boundary, c) coarse-grained zone

Micrographs of the specimens are given in Figures 8-17, respectively. The weld metal microstructures of the M and T group samples, which were welded using MAG and SAW methods respectively, exhibited the presence of the following structures; acicular ferrite (AF), Widmanstatten ferrite (WF), grain boundary ferrite (GBF), and polygonal ferrite (PF). Acicular ferrite, which

Microstructure investigations conducted on both coated and uncoated samples joined by MAG and SAW revealed that, except for the T5 sample, the shop-primer coating had an insignificant impact on the microstructure. It is understandable to have differences in grain structure and size as a result of different heat inputs due to different welding methods. Sandblasting did not result in any discernible positive or negative effects on the microstructures of the M2 and T2 samples. Nonetheless, within the subset of M3, M4, M5, T3, T4, and T5 samples, featuring a range of shop-primer thicknesses at 25, 50, and 75 μm , it was only in the case of the T5 sample that discernible influences stemming from the coating thickness were detected. In the coarse-grained region of the T5 sample, the grains were smaller than in the other samples. It was detected that the HAZ width

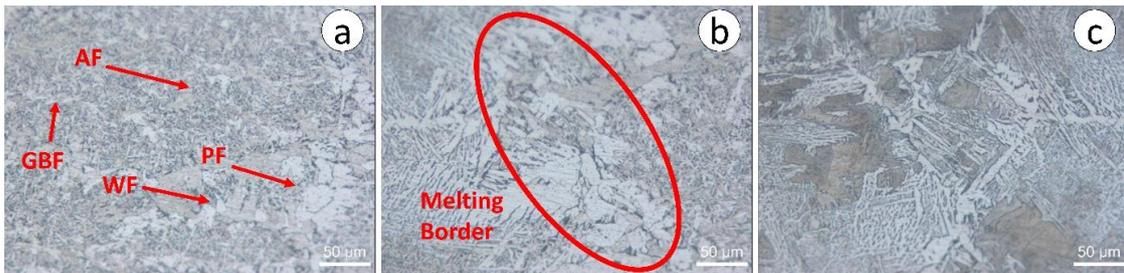
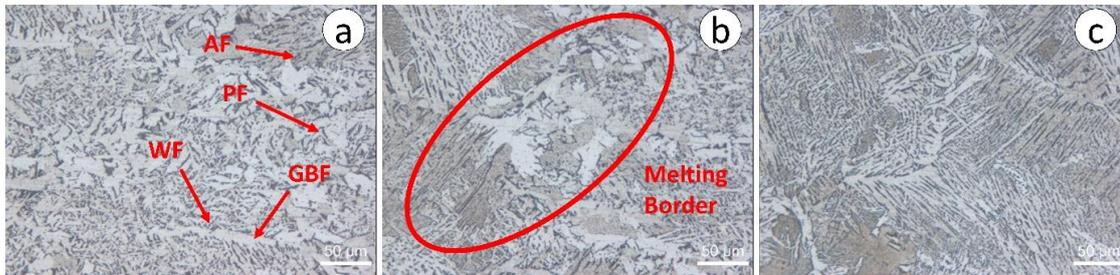
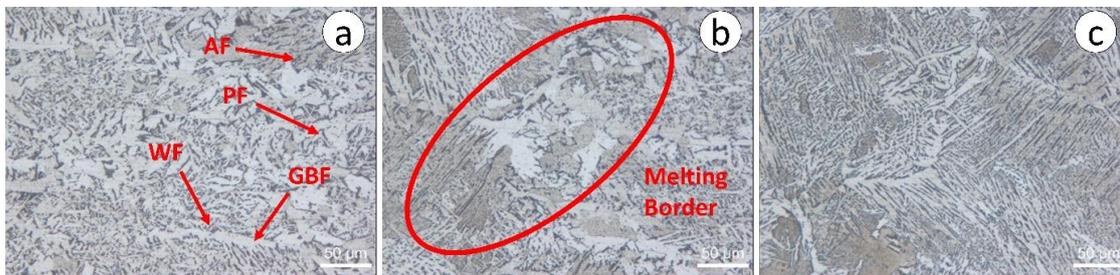
Figure 13. Microstructure images of the T1 sample, a) weld metal, b) melting boundary, c) coarse-grained zone.

Figure 14. Microstructure images of the T2 sample, a) weld metal, b) melting boundary, c) coarse-grained zone.

Figure 15. Microstructure images of the T3 sample, a) weld metal, b) melting boundary, c) coarse-grained zone.

Figure 16. Microstructure images of the T4 sample, a) weld metal, b) melting boundary, c) coarse-grained zone.

Figure 17. Microstructure images of the T5 sample, a) weld metal, b) melting boundary, c) coarse-grained zone.

Grains of the samples welded with the SAW method were found larger in the weld metal. Durgutlu et al. explained the reason for this differentiation with the high heat input in the SAW method [19]. It was observed that coarse-grained regions containing ferrite and pearlite are
