The Historical Water Systems of Istanbul and Their Preservation Problems: The Case of The Kırkçeşme Water System

2.1. Kırkçeşme Water System

2.2. Types and causes of deterioration (damage) occurring in water structures of the Kırkçeşme Water System

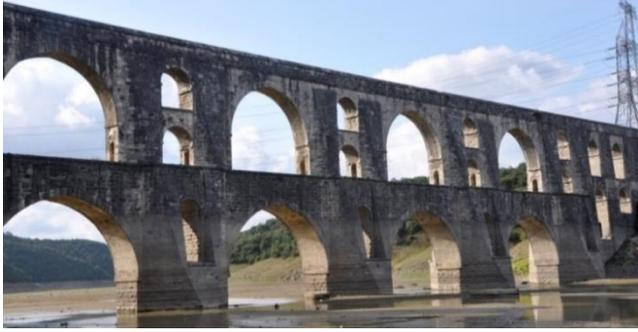
Figure 2. *Mağlova Aqueduct [8]*

In this system, there are 33 aqueducts, four dams and seven water intake places and sedimentation pools. The most important ones in terms of engineering and architecture in the Kırkçeşme Water System are the Mağlova Aqueduct, 258 m in length, (Figure 2); the Uzunkemer Aqueduct, 710 m in length; the Gözlücekemer (Güzelcekemer) Aqueduct, 165 m in length; and the Kovukkemer Aqueduct (Eğri Kemer), 342 m in length. A part of the latter is thought to have existed in the Roman Empire because of the different arches used. Apart from these arches, there are important one-storey arches that can not be considered monuments including Ayvad Kemer Aqueduct, 195 m in length; Kurt Kemer Aqueduct 305 m in length; Karakemer Aqueduct, 62,60 m in length; Balıklı Kemer Aqueduct, 125 m in length; and Valide Kemer Aqueduct, 38,80 m in length [4, 7].

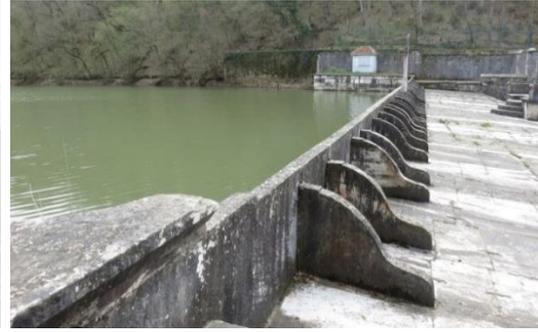
Figure 3. *Kirazlı Dam [8]*

When the Kırkçeşme Water System was built in 1563, there were none of the current dams, and the water supply decreased in August and September due to the lack of water storage facilities. For this reason, a total of four dams were built to store water in times of abundance in order to use it during the periods when the supply decreased: Topuz Bendi (Karanlıkbent), Büyükbent, Kirazlıbent (Figure 3), and Ayvad Bendi [4].

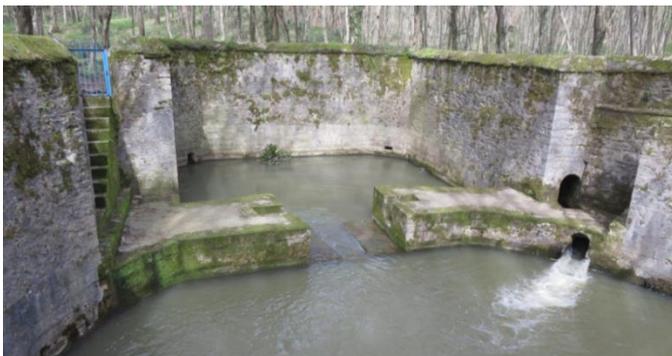
Figure 4. *Çifte Havuz [8]*

When the Kırkçeşme Water System was being constructed, it was predicted that water would be taken from the bottom, so, after the water level had risen because of water flowing in from a connecting stream, it was drained from the side by water intake point with a grid located immediately behind each one; here, there were sedimentation pools for the settling of solid materials such as sand and gravel to the bottom of the water [3, 4]. This system involves the Çiftehavuz Intake (Figure 4), the Kirazlıdere Intake, the Ayvad Intake, the Middle Water Intake, the Bakraçdere Intake, and the Kurt Kemer Pool.

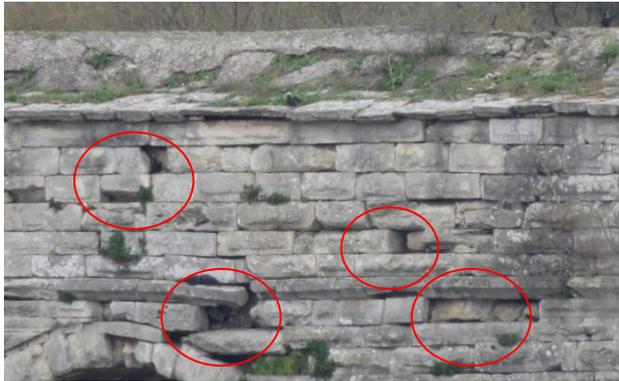
A.1. Changes and deteriorations based on long-term nature cycles; Humidity, frost, rain, vegetation, microorganisms, insects, waves, and under ground water are natural phenomena that cause deterioration over time, and the aqueducts have been exposed to many of these. These natural forces sometimes cause surface impairment only in the material, but sometimes they also affect the entire load bearing structure. Expansion of the materials in hot weather and shrinking in cold weather stresses these materials, causing cracks to grow and breakages to occur (Figure 6).

Figure 6. Damage and fragmentation in stone on façade of the Eğri Aqueduct [8]

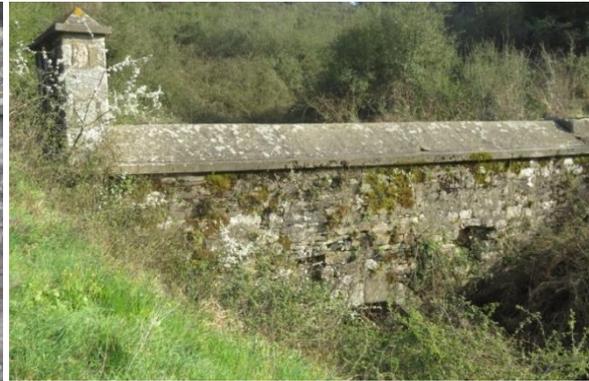
The wetting and drying cycle on the walls exposed to rain water causes the mortar to lose its binding properties. Rainy weather and moisture lead to the growth of plants which are biological pollutants causing physical and environmental damage in the structures (Figure 7). Flying pollen penetrates the joints in the aqueducts and then plants grow, harming the material with growing plant bodies and roots. These plantings can be are in small size but they can grow in the form of vines or even trees (Figure 8).

Figure 7. Vegetation in the Çiftlikönü surfaces [8]

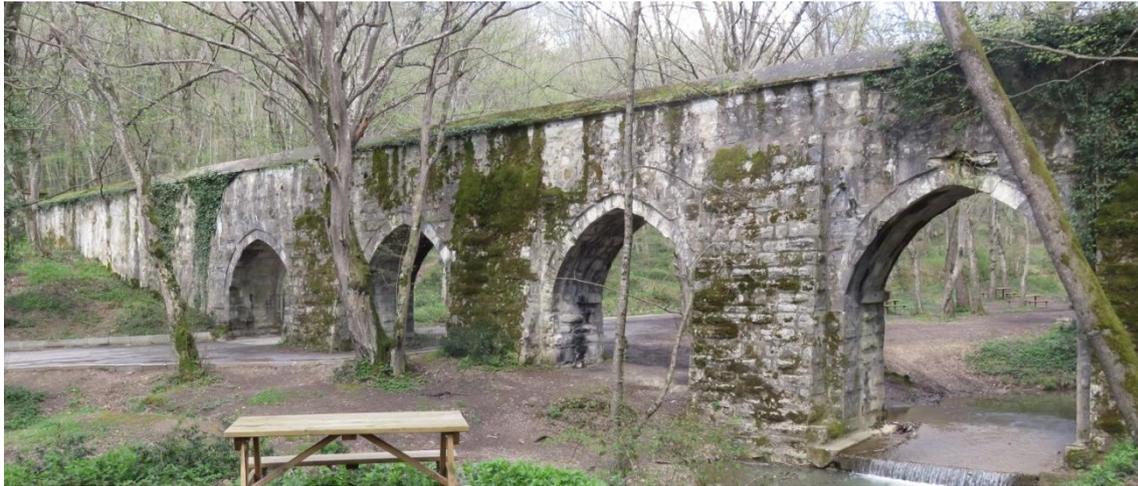
Organisms such as algae, lichen, and fungus are other causes of deterioration in aqueducts (Figure 8). These factors prevent the building from breathing by wrapping the façade and impacting its visual beauty. Air pollution is another cause of deterioration in aqueducts. This is due to the fuel consumption of the surrounding buildings as well as the exhaust of passing vehicles. The surface of the material is darkened, forming a patina (Figure 9). In addition, the acid formed by the precipitation of the gases in the air causes the stones to crumble.

Figure 8. *Algae and vegetation on the façade of the Karakemer Aqueduct [8]*

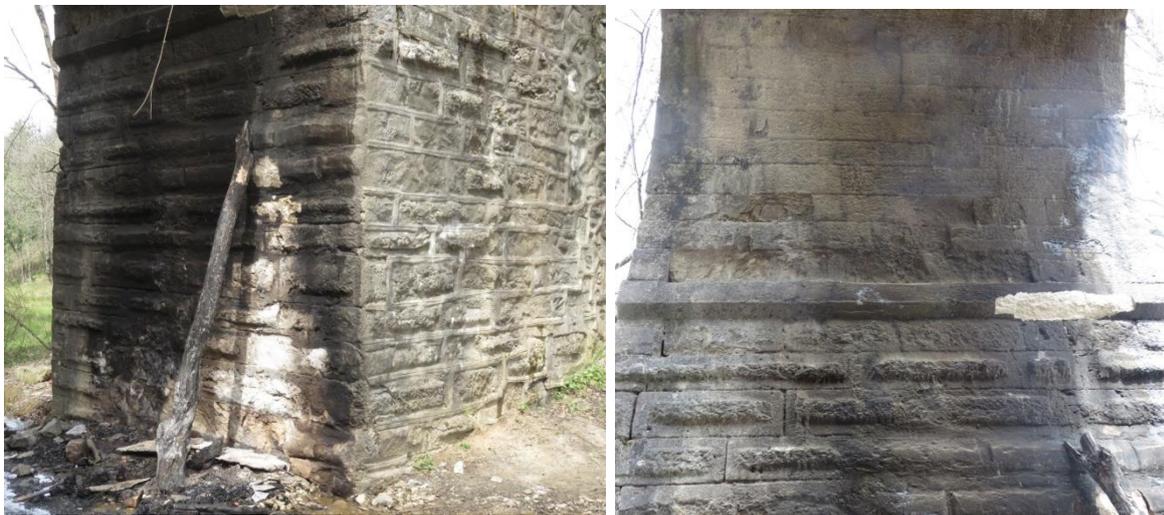
Figure 9. *Pollution and blackout on the Karakemer Aqueduct [8]*

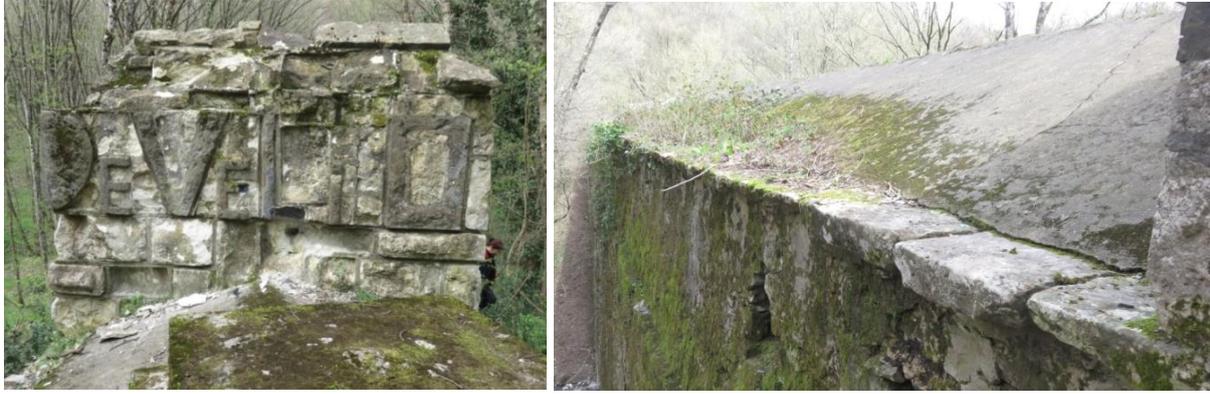
- Individual sources: Incorrectly done repair or restoration work together with improper of construction and vandalism are evaluated in this context. Vandalism is defined as "consciously harming works of art " (Figure 10) [9].

Figure 10. Destruction by people in Develioğlu Aqueduct [8]

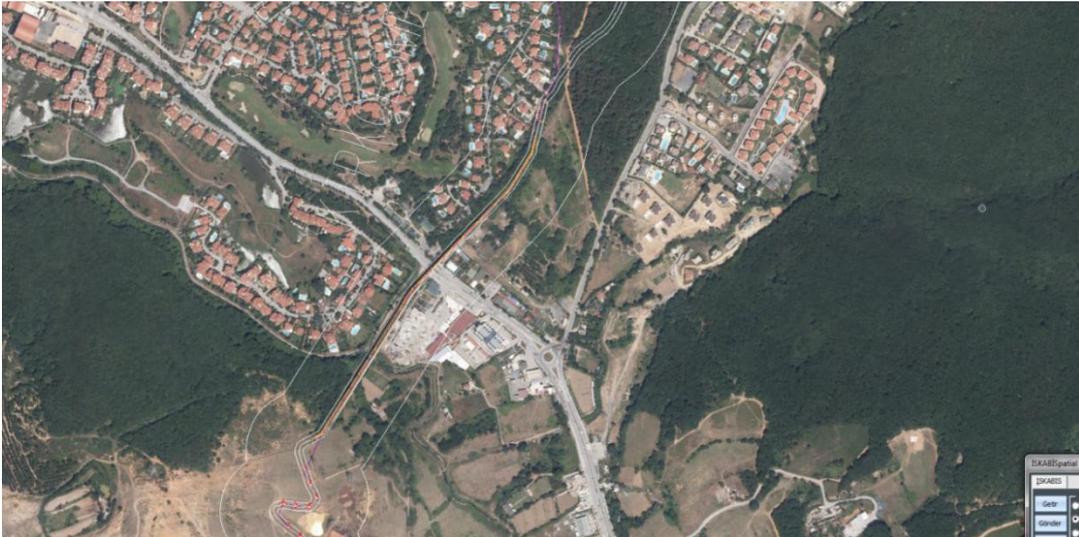
The water structures remain in an environment exposed to intensive construction with an increasing population. Due to the growth of the city, many of these structures are stuck between roads and buildings in the city although they were outside of town originally (Figure 12-13). Since there has been no consciousness developed in this direction and correspondingly, construction plans for conservation have not been prepared, the construction has continued in this way for years.

Figure 13. Villas near Uzun Aqueduct [8]

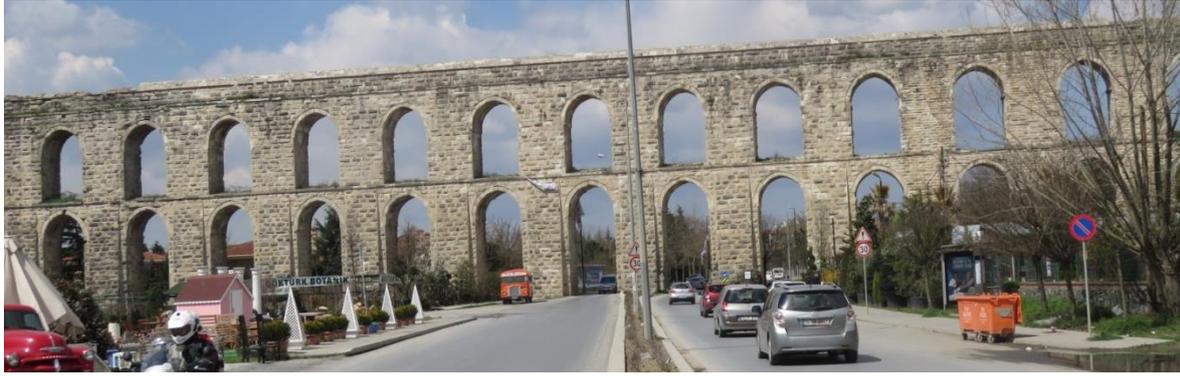
Water structures are damaged during infrastructure work. Reinforced concrete implementations damaged the original material of the water structures, causing structural and environmental damage. Traffic passing through the arched openings is another cause of damage to the aqueducts (Figure 14). The vibrations created by heavy-duty vehicles, especially when passing along these roads, have been damaging to the aqueducts.

Figure 14. Passing through the arched openings of Uzun Aqueduct [8]

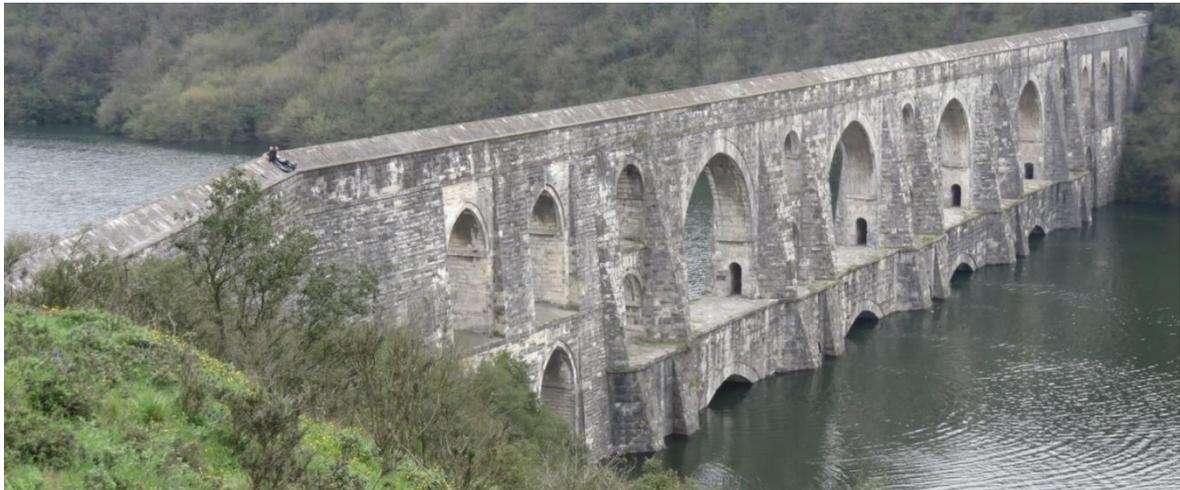
The aqueducts under the water of the Alibey Dam are the Mağlova Aqueduct and the Güzelce Aqueduct (Figure 15). The water, which runs to the interior parts of the original building stones, caused moisture to build up inside the building. The deterioration of building materials occurred due to freezing and dissolution effect, particularly in winter. Surface and material losses occurred due to the water expanding while freezing in joints inside the aqueducts.

Figure 15. Mağlova Aqueduct under the water of Alibey Dam [8]
