Damage Types and Repair Techniques in Seljuk Period Stone Architectural Monuments: Konya Alaaddin Mosque

Selçuklu Dönemi Taş Mimari Eserlerinde Hasar Türleri ve Onarım Teknikleri: Konya Alaaddin Cami

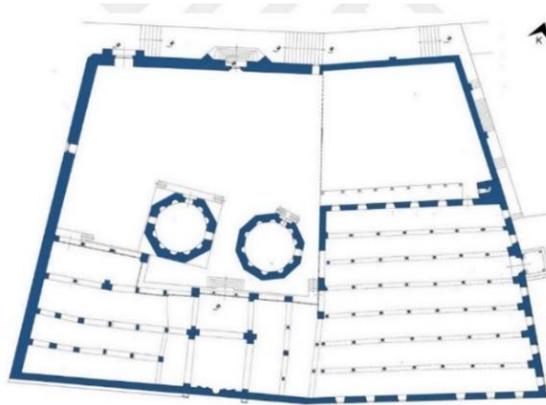
Figure 2. *Alaaddin Mosque Plan*⁶⁴

The polygonal mosque has a kufe plan (Figure 2). The courtyard to the north of the building contains the tomb of the sultans, a half tomb and tombs. The prayer section is located in the southern part of the building. The entrance to the mosque is provided from the gate on the east facade or from the courtyard on the north facade. There is a door opening to the courtyard from the place of worship. In the northern corner of the mosque, there is a brick minaret with 29 stone steps. On the walls of the mosque, stone slabs, bricks or stone bricks were used together. Marble is used on the north wall of the courtyard, interior columns, crown door decorations and some inscriptions.⁶³

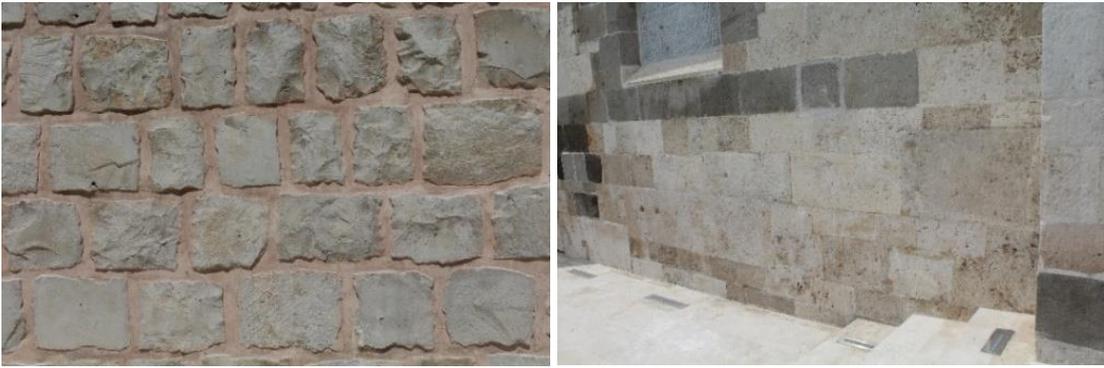
Figure 3. *Facade cleaning carried out on the mosque's east facade and north courtyard facade rough masonry stones*

Low-pressure precision facade cleaning (Figure 3) and stone-brick rotting (Figure 4) were carried out where necessary on the stone surfaces of the mosque. The joints holding the stone and brick materials together were renewed with hydraulic lime added Horasan mortar (Figure 5). The natural stone pavements on the floors surrounding the building were renewed. Water damage to the stone walls was prevented by finishing the wall surfaces with capstone with stone roofs (Figure 6). The raised travertine pavements around the mausoleum were dismantled and the stone pavement was re-coated after the level was lowered. Low-pressure precision surface cleaning was performed on the marble columns in the interior (Figure 7) and the reinforcement belts and bracelets on the columns were sandblasted and painted with anti-rust (Figure 8). The mosque doors were surface cleaned and rehabilitated (Figure 9).⁶⁷

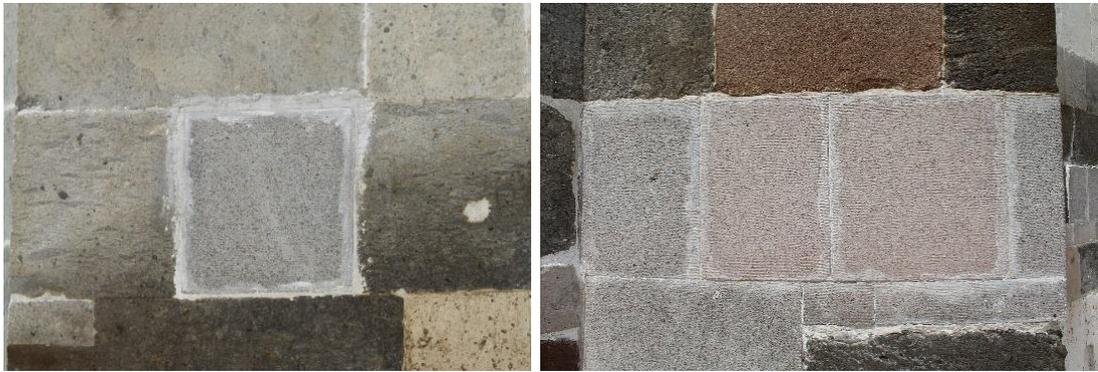
Figure 4. *Stone decomposition*

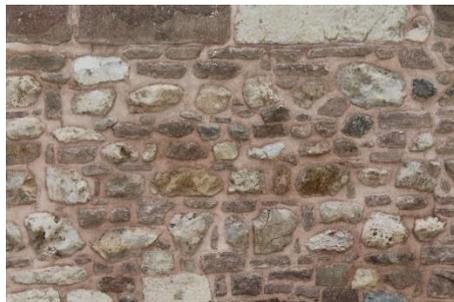
Figure 5. *Grouting with hydraulic lime added horasan mortar*

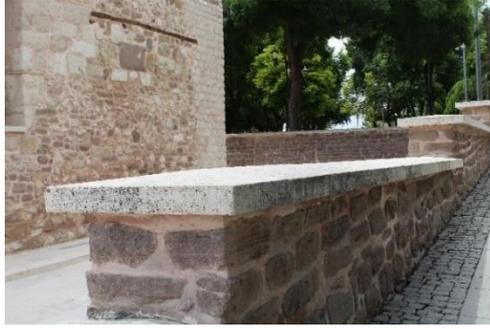
Figure 6. *Addition of roofed capstone to rubble stone wall*

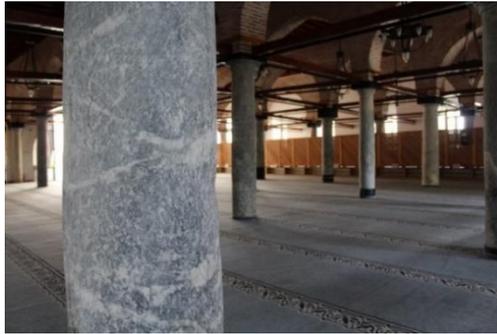
Figure 7. *Surface cleaned marble columns*

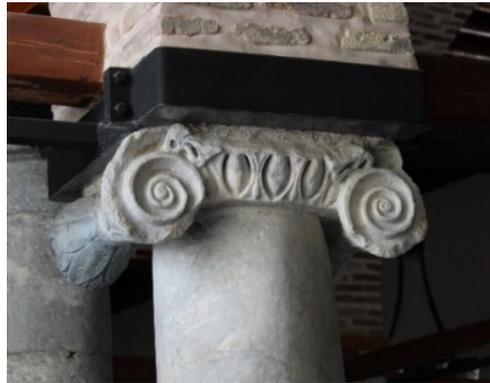
Figure 8. *Column headers after repair*

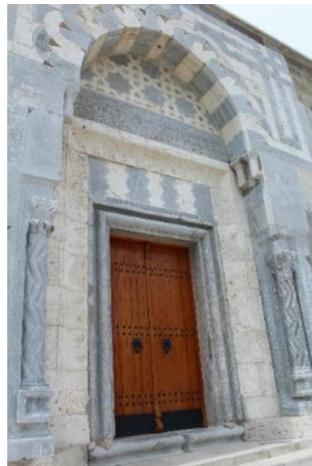
Figure 9. *North courtyard gate after repair*

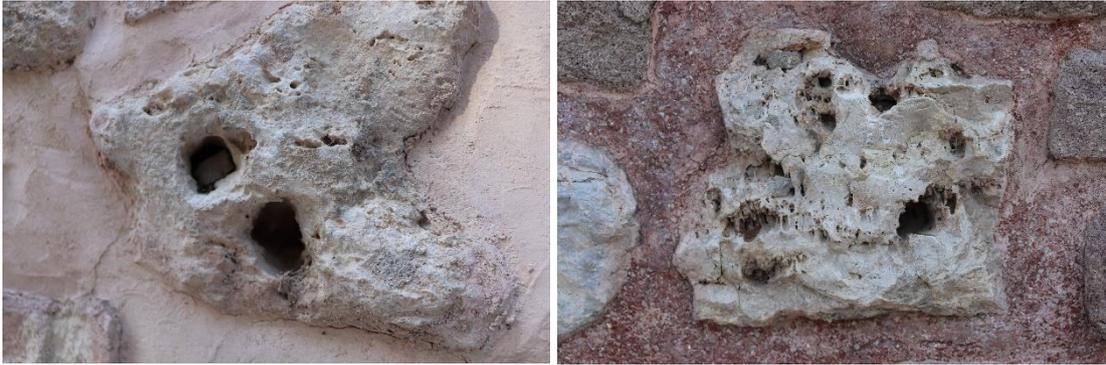
Holes (Figure 10) were observed on different stone surfaces during observations in the area. The holes, which may sometimes be caused by the formation of the stone and sometimes by the effect of living organisms, may expand over time. Holes caused by the mineralogical formation of the stone are physically and chemically affected by exposure to atmospheric conditions. This effect will cause the stone to get sick, crumble and disintegrate. Filling the holes with material that is suitable for the properties of the stone and that will enable it to work together will prevent the damage from growing.

Figure 10. *Macropores that occur in the formation of the stone appear as holes on the surface*

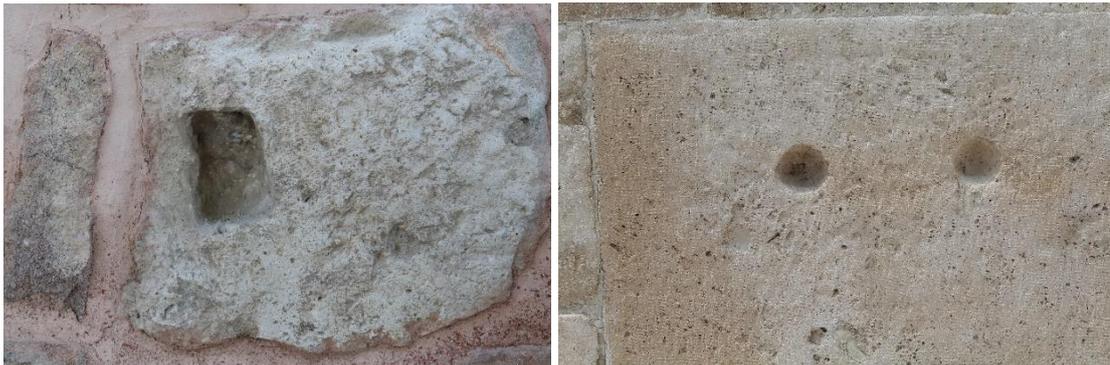
On the surfaces of the stones, cavities with regular geometry (Figure 11), which are understood to have been made by human hands, are sometimes opened for assembly operations to the historical building. In some buildings, interventions such as scaffolding, air conditioning, electricity, etc. cable installations, plumbing and rain drainage pipe installations are made. While these interventions create undesirable images in the building, it is also possible that the cavities may cause the damage to increase.

Figure 11. *Man-made holes in the stone surface*

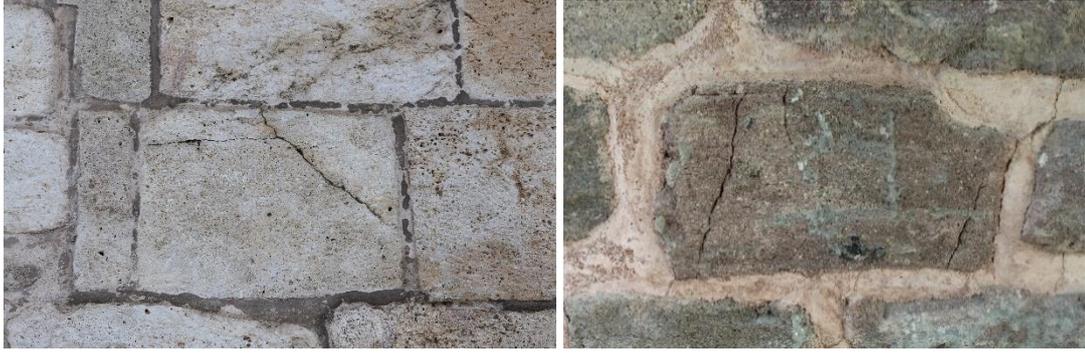
Fractures and cracks reflected on the surface of the stone may occur due to mechanical effects as well as physical effects such as expansion and contraction due to heat, swelling and contraction due to water, and exposure to pressure due to frost. Capillary cracks in the stone grow especially with the effect of freezing-thawing and appear as enlarged fractures and cracks as shown in Figure 12.

Figure 12. *Crack - fracture formations on the stone surface*

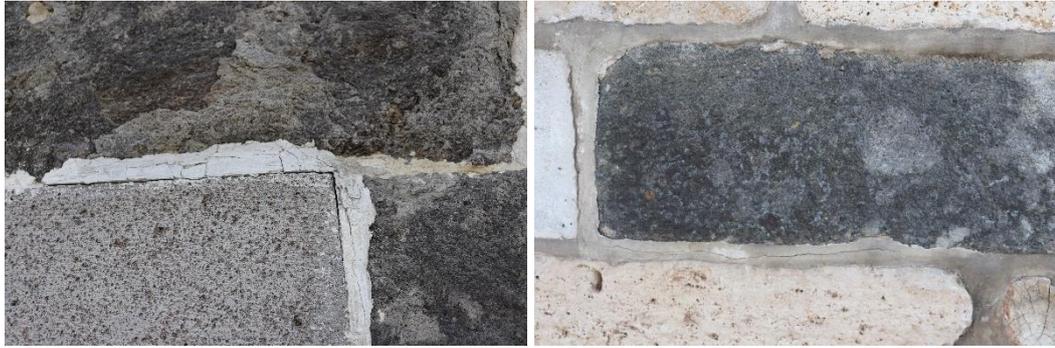
Expansion differences should be taken into account when combining different building materials. Otherwise, due to different elongation shortening coefficients, damage in the form of cracks occurs in the joint areas or in the material that cannot tolerate this physical phenomenon, as shown in Figure 13.

Figure 13. *Crack formation in joints due to thermal expansion*

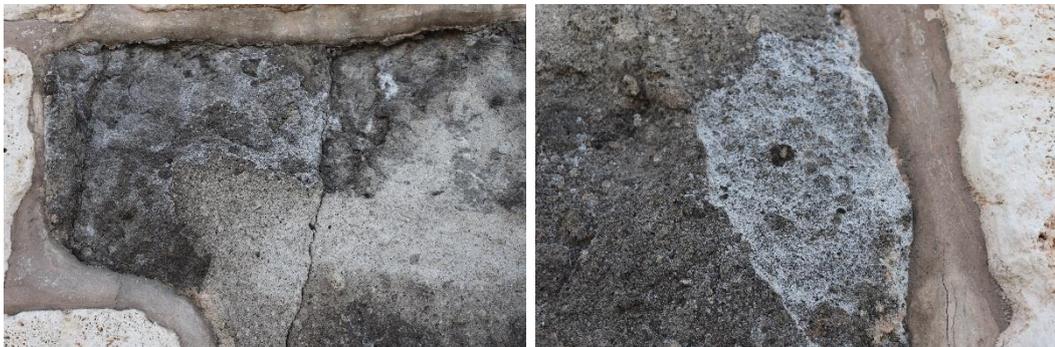
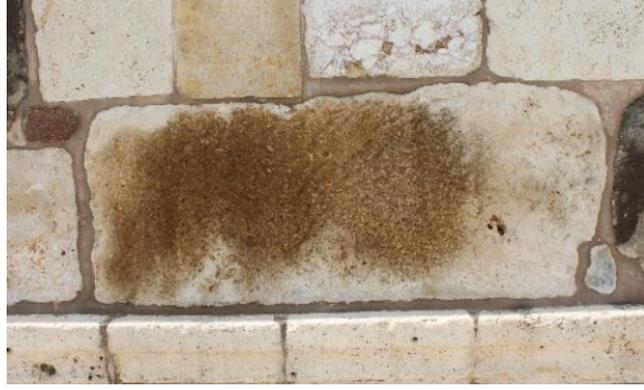
The main cause of defects that appear as dark-colored soot on historic stone surfaces is air pollution from vehicles, industry and heating. Pollutant gases undergo chemical reactions on the surface of the stone and appear as the blackened surface shown in Figure 14-15.

Figure 14. *Defects caused by air pollution and exhaust gases*

Figure 15. *Abrasion on stone surface due to chemical effects*

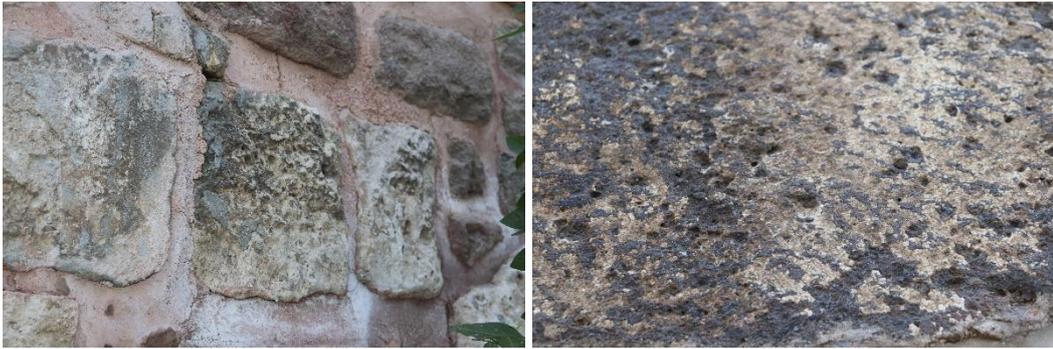
Another formation seen as contamination on stone surfaces are biological formations such as moss, algae, lichen, bacteria, etc. They have a bad odor as well as a bad appearance. Biological elements that settle in the micro and macro pores on the stone surface cause the stone to look dirty as shown in Figure 16.

Figure 16. *Biological (Moss, Lichen etc.) formations on stone surfaces*

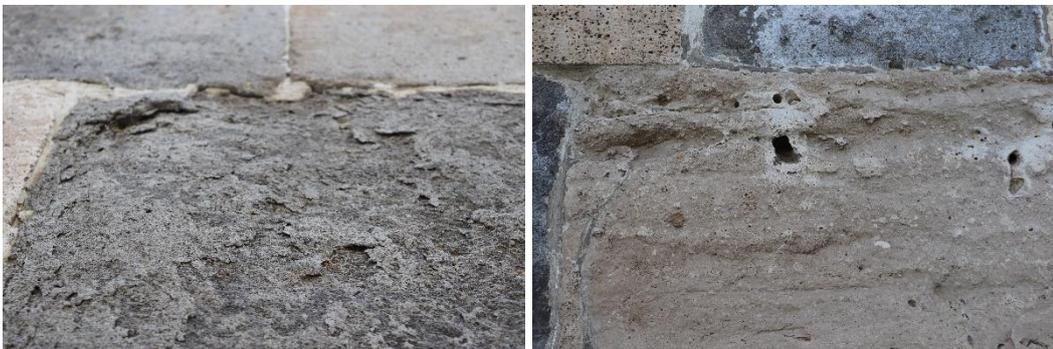
Damage in the form of abrasion on the stone surface is generally seen as the growth of capillary cracks over time and the abrasive effect of dust and particles carried by strong winds, as shown in Figure 17. Exfoliation due to the disease of the stone and large losses in volume may be the next type of damage.

Figure 17. *Abrasion on stone surface*

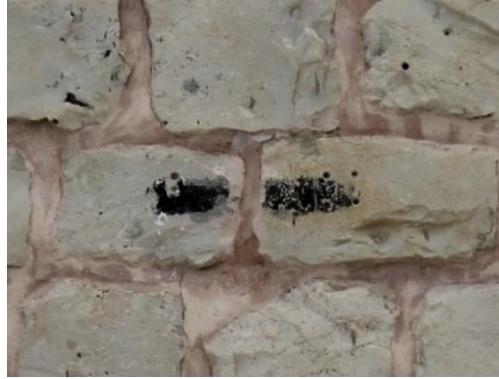
Traces made consciously or unconsciously on the surface of the sample structure damage the natural appearance of the stone (Figure 18).

Figure 18. *Pollution caused by paint and similar marking tools*
