Fracture surface investigations of API pipes welded with parameters determined by Taguchi method

Abstract

Keywords: API 5L X65, fracture surface, SEM, Taguchi method

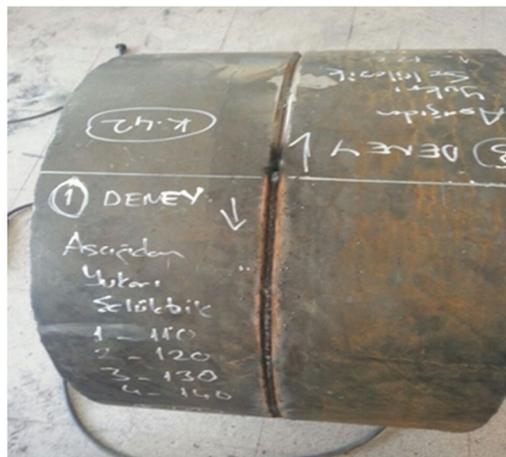
Figure 3. Pipes prepared for welding operation

Figure 2. Schematic image of welding operation
As seen in Figure 2, each experiment was subjected to welding operations from top to bottom and bottom to top so that half pipes were joined. The pipe material prepared for welding operation is given in Figure 3.

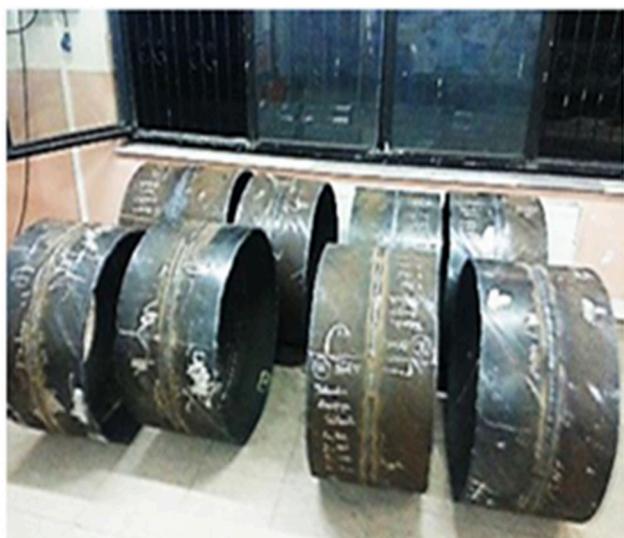
Figure 4. Completed welding operations

Welded joints were carried out in accordance with the parameters given in Table 8 and completed welded pipe joints are shown in Figure 4.

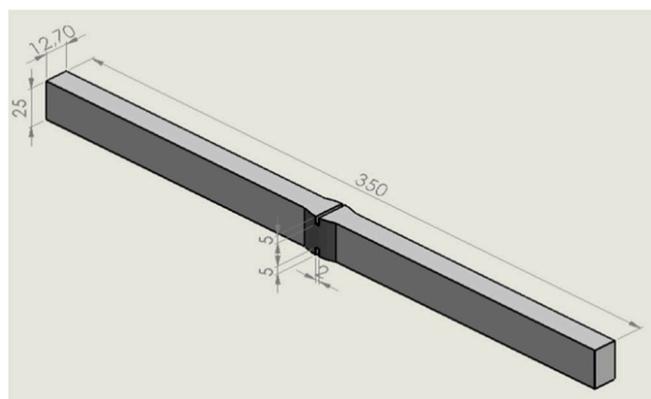
Figure 5. Schematic view of a nick break test sample

Nick break tests were performed to visually examine defects such as inadequate fusion, porosity, slag remnants, etc. in the weld metal and periphery of the materials and to determine fracture behavior under mechanical loads which could cause fracture of welded joints. For this purpose, nick break test samples were taken from 16 welded materials in accordance with API 1104 standard. A schematic view of the nick break test samples and photographs of the samples taken according to these criteria are shown in Figures 5 and 6, respectively.

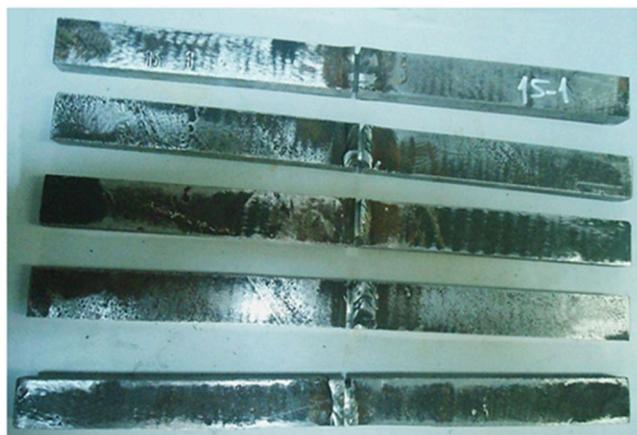
Figure 6. Nick break test samples

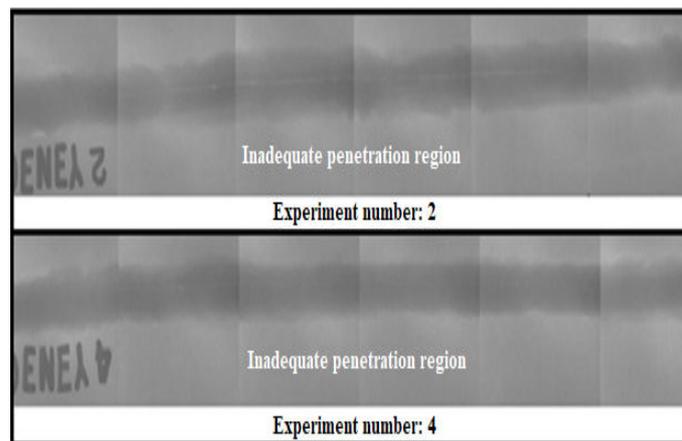
Figure 7. Radiography views

When radiographic images of Experiments 2 and 4, given in Fig. 7, where welding was performed in downward direction and macrostructure images, given in Fig. 8 were examined. Lack of fusion defects due to insufficient penetration were seen. At this point, the results obtained within the scope of nick break tests were also confirmed by radiographic and macrographic analyses.

When the results of the nick break tests given in Table 9 were examined within the scope of visual inspection, welded joints in Experiments 2 and 4 were not accepted due to Lack of fusion or inadequate penetration, but all other welded joint results were regarded acceptable. This suggests that the strength of current applied in Experiments 2 and 4 where welding was performed in bottom to top direction was inadequate. The results obtained from radiographic and macrographic (Figure 7-8) examinations carried out in parallel to our study further support this argument.

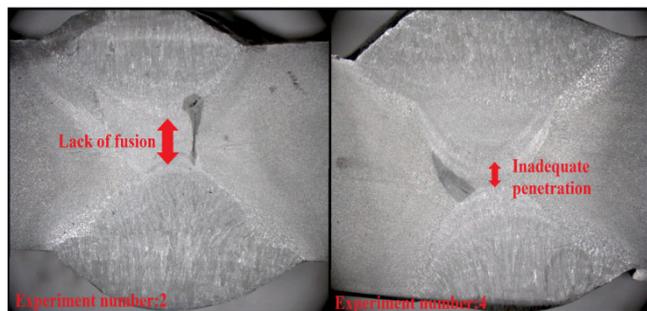
Figure 8. Macrographic images (Experiments 2 and 4)

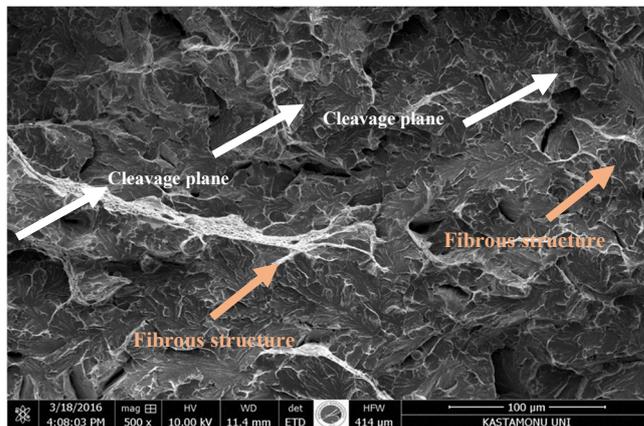
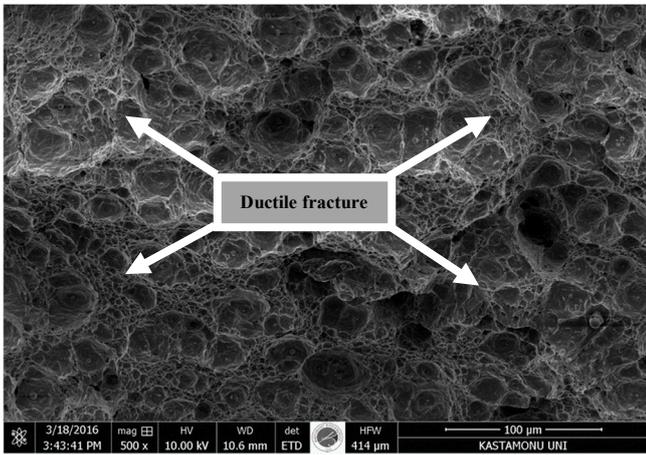
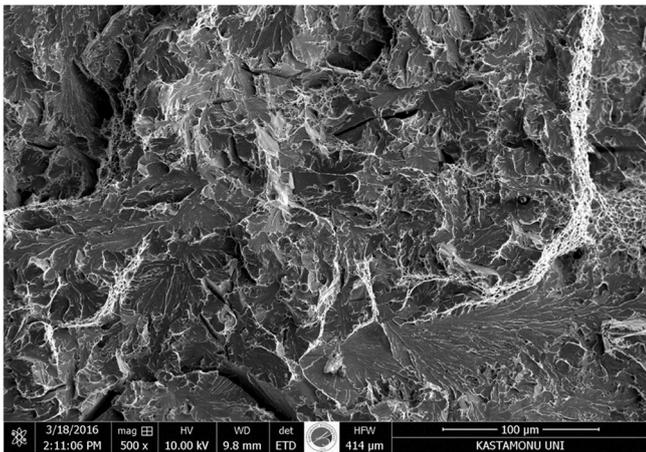
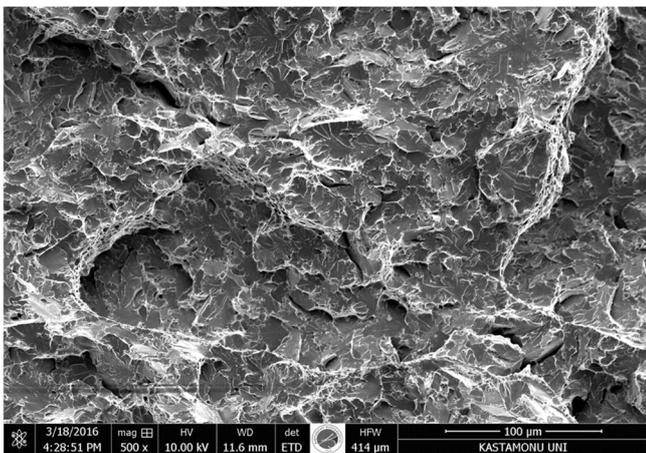
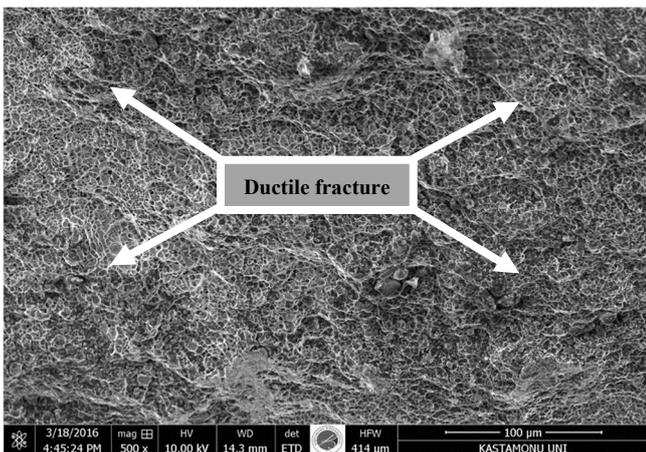
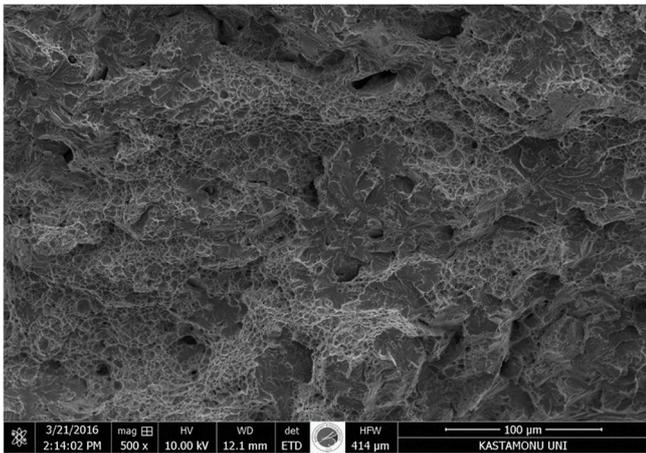
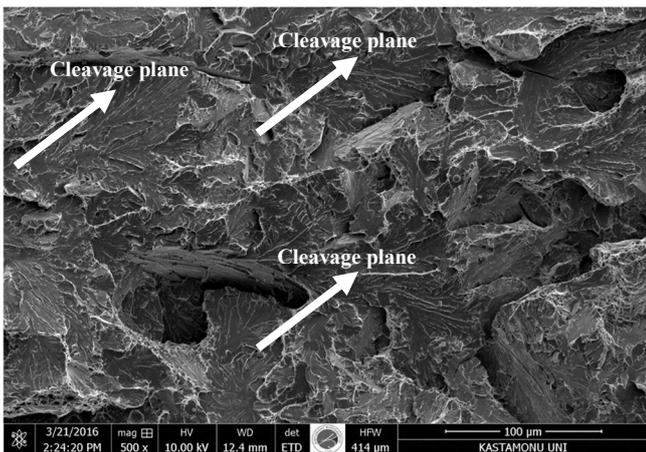
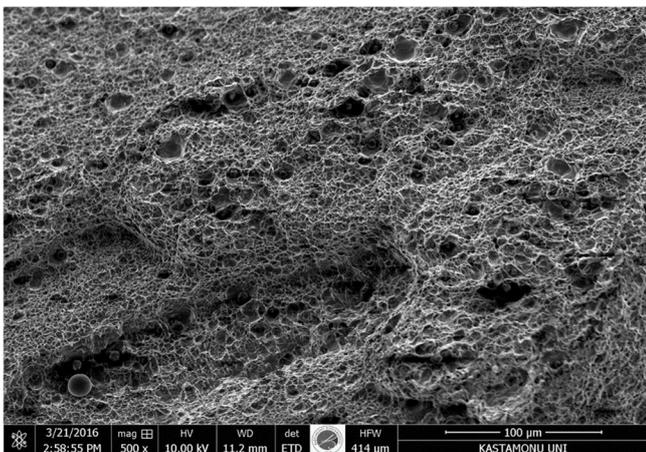
When SEM images of the fracture surfaces were examined, the elongations and orientations exhibited by the grains indicated that there were generally ductile fractures in all of the joints that were welded from bottom to top. Since the fractures occurred both inside the grain and at the grain boundary in the joints (1, 3, 5, 7, 9, 11, 13 and 15 joints) welded from bottom to top, fracture elongations took place on the entire surface of the material, therefore fracture surface exhibited a ductile behavior. The breakage of the aforementioned samples generally occurred as a result of sliding fracture. In addition, fractures were generally ductile as they occurred with the effect of plastic deformation. In a study, İrfan Ay [13] stated that dislocation movements had terminated at remains and grain boundaries, and in these regions, firstly cavities had formed, then these cavities had expanded by merging and fracture surfaces had formed in a matt and fibrous structure. It is thought from the fractures occurring in a single piece, fibrous structures and equiaxed honeycomb like views that fractures occurred by exhibiting a ductile behavior. Fractures of the aforementioned joints having is seen as a natural result since the heat input is high in the upward direction. ductile and honeycomb like structure. In

addition, bridges were formed between voids when they got large enough and a honeycomb appearance occurred. Therefore, it is possible to see a honeycomb like appearance along with a fibrous structure in the images.

From the above expressions, it is possible to say that fracture behavior varies depending on the welding direction. Excessive heating and slow cooling in the upward direction, which naturally has a more intense heat input, allowed formation of coarser grained structures in these joints, resulting in a more ductile fracture of the materials in the nick break tests. On the other hand in the welded joints made in downward direction, since the heat input was less, the joints were down faster and relatively fine-grained structures were formed. This revealed, in the fracture surface images obtained from the welded joints, the presence of cleavage planes indicating brittle fracture along with fibrous structures indicating ductile fracture. The microstructure of API 5L X65 pipe steel used in the experiments consists of as low pearlitic, ferritic matrix. Size of the microstructure, perlite volume ratio and microalloy element ratio have an effect on fracture behavior. As ferrite volume ratio increase, properties of fracture mechanics improve. X65 steel has superior properties in terms of both small grain size and high ferrite volume ratio. The most effective method for toughness, strength and weldability is to reduce grain size. The increase in the toughness of a fine grained structure is explained by the increase of the flow limit; as grain size is reduced, onset of plastic deformation is put off to higher stresses. For this reason, in the breakages of the samples, onset of deformation was put off to higher stresses and properties of fracture mechanics were improved [14-16].

- When SEM images of the fracture surfaces were examined, the elongations and orientations exhibited by the grains indicated that there were generally ductile fractures in all of the joints that were welded from bottom to top. In the joints that were welded from top to bottom, on the other hand, although fibrous structures indicating ductile fracture were seen in places in the images together with cleavage planes indicating brittle fracture were observed.

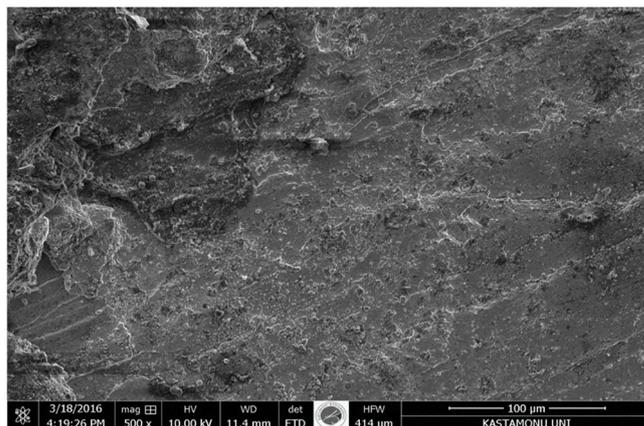
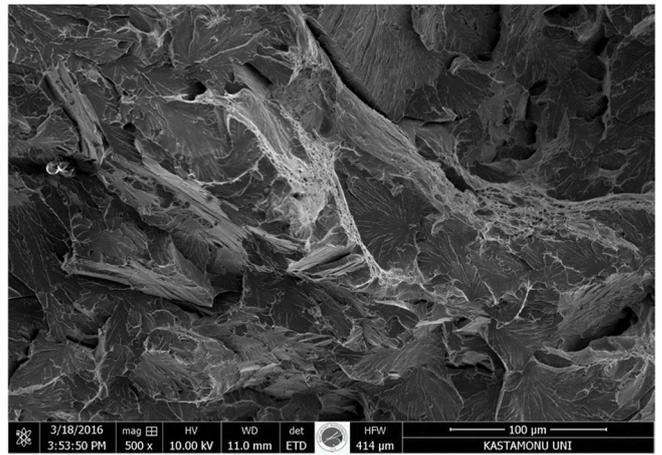
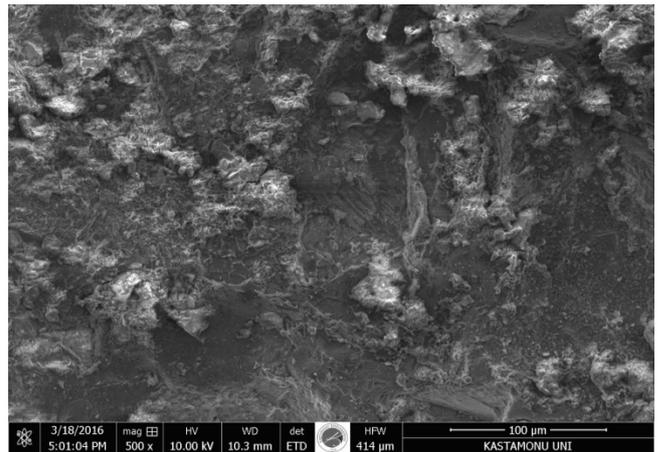
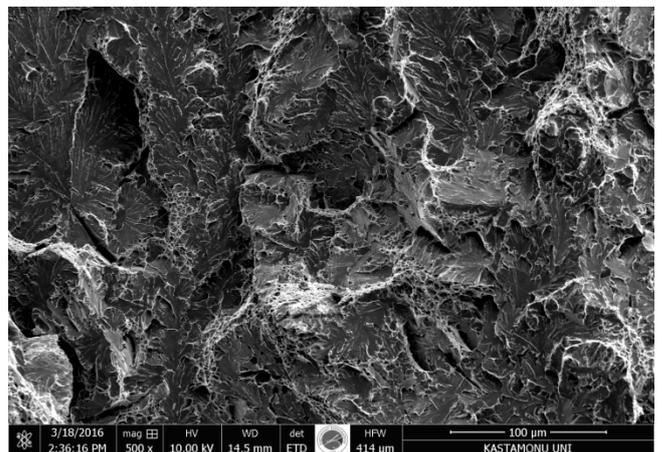
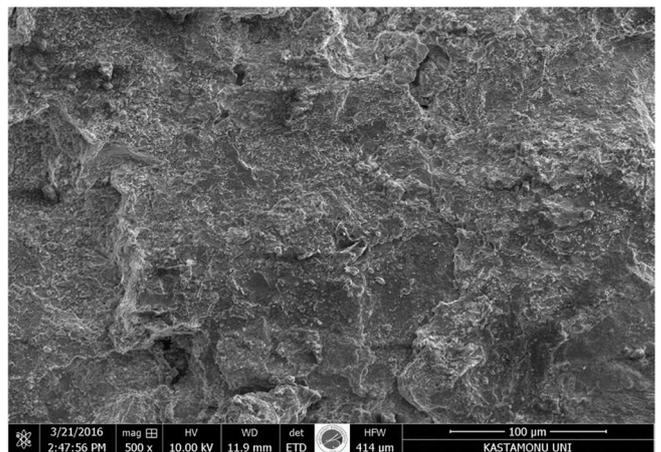
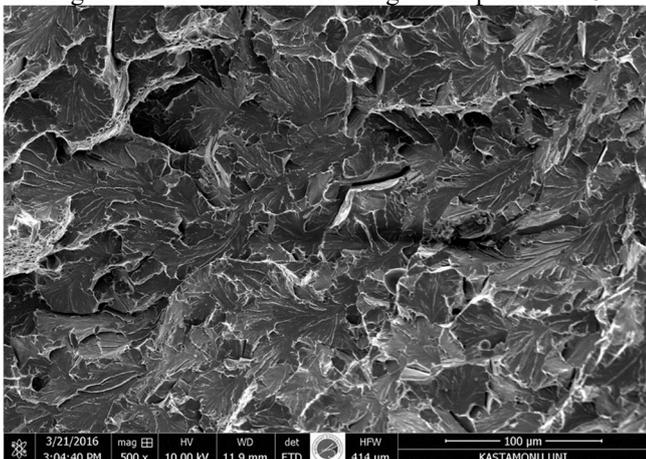
Although in the joints (2, 4, 6, 8, 10, 12, 14, 16) that were welded from top to bottom, although fibrous structures that exhibited ductile behavior from place to place were seen in the images, it was observed that the fractures generally exhibited a brittle behavior and occurred on cleavage planes. Joints from top to bottom are joints that are less of heat input and cooling time due to welding direction. As the heat input is less at these junctions, cleavage planes were formed along with fibrous and fibrous structures in the main matrix. This points to brittle fracture.

- In the joints welded in downward direction, on the other hand, the heat input was less, the joints were heated less, cooled down faster and relatively fine-grained structures were formed, when compared to the experiments conducted in upward direction. This revealed, in the fracture surface images obtained from the welded joints, the presence of cleavage planes indicating brittle fracture along with fibrous structures indicating ductile fracture. In the joints welded in downward direction, both ductile and brittle fracture types were observed.
