# APJHAD

Journal of Natural Hazards

**Volume: 2**  
**Issue: 1**  
**Year: 2021**

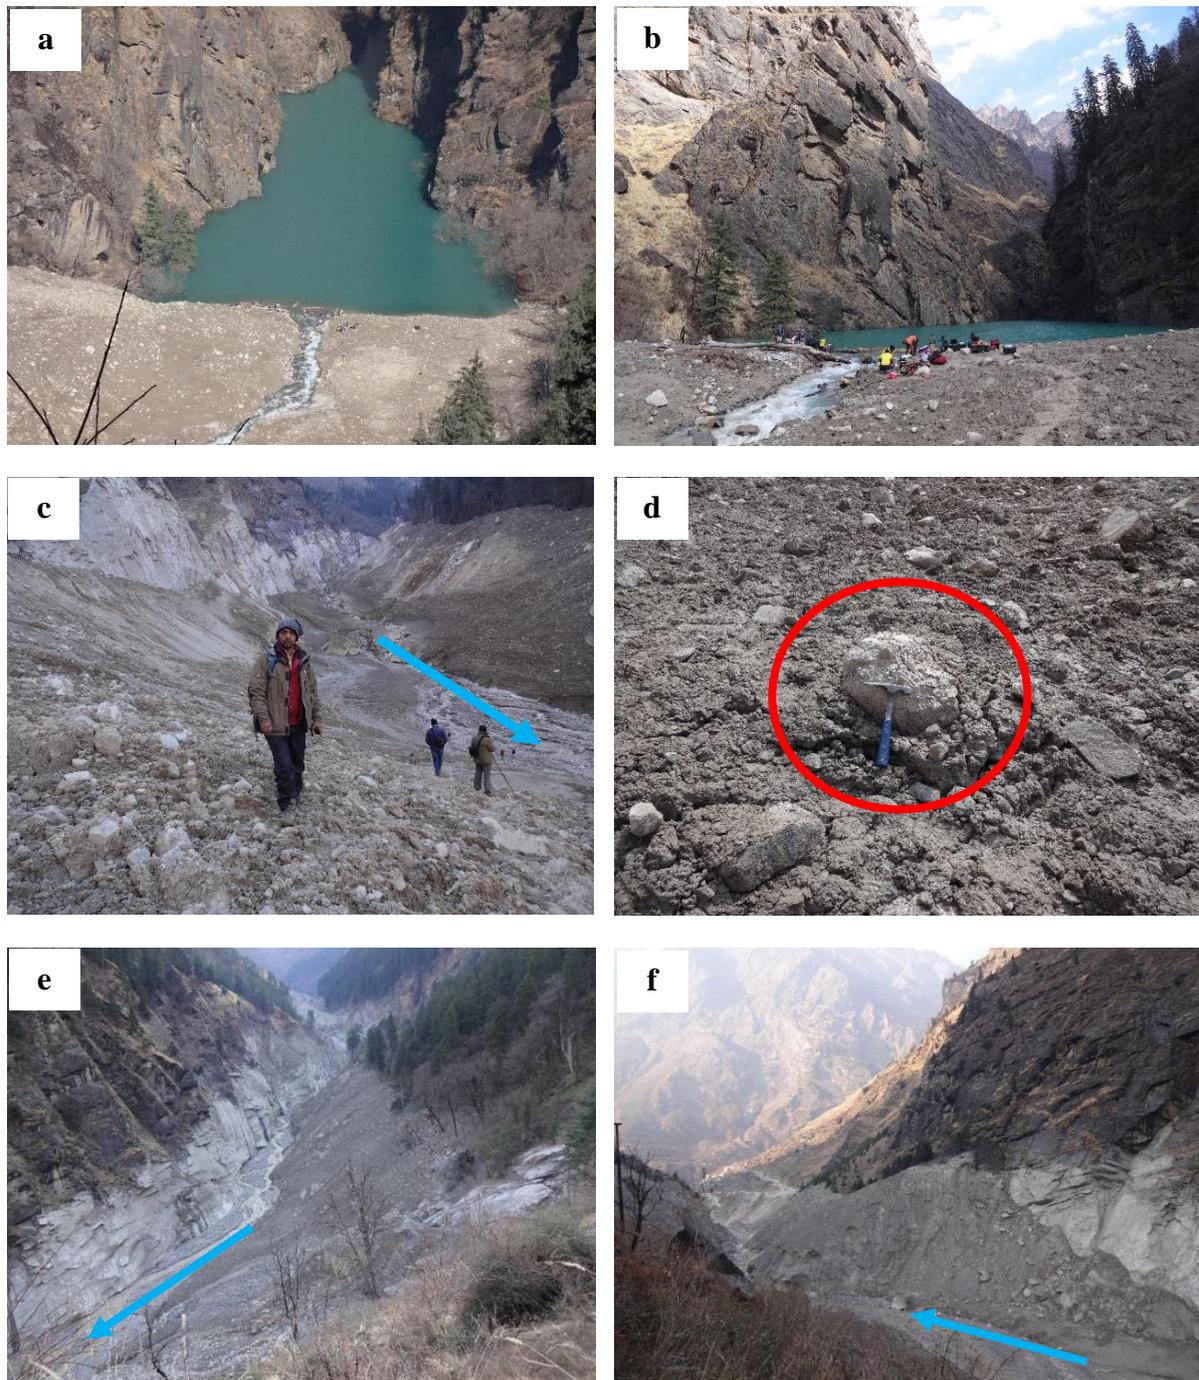
**Figure 2:** Changes in river morphology on the aftermath of flash flood; (a) lake formation over Rishiganga; (b) physically widen the channel and cleared of obstructions of logs; (c) eroded left bank while aggradation on the right bank of Raunthi Gadhera; (d) ice block observed in the transported debris materials; (e) badly eroded slope materials on the left bank of Rishiganga river; and (f) eroded debris cone and old landslide mass on the right bank of Rishiganga at Rini

It was also observed that the Rishiganga curved out around 8 m wide channel by the erosion of the natural embankment in the center portion till dated February 19, 2021. As directed to personnel of ITBP and SDRF, physically widen the channel and cleared of obstructions of logs (Fig. 2b). The channel was thus widened up to 20 m between February 22 and March 2, 2021 to ensure proper draining out water from the lake. Just upstream to confluence of Rishiganga with Raunthi Gadhera, huge slope materials was eroded on the left bank of Raunthi Gadhera while thick pile of sediments was deposited on the right bank of the same because of the flooding (Fig. 2c). This sediments comprising of a mixture of ice blocks, rock fragments, morainic material and boulders of quartzite, granitic gneiss and mica schist with silty-clayey matrix (Fig. 2d).

route was also completely washed away which was located on the same materials (Fig. 2e). Thereafter, debris cone and old landslide mass were also badly eroded on the right bank of Rishiganga up to confluence of Rishiganga with Dhauliganga at Rini (Fig. 2f).

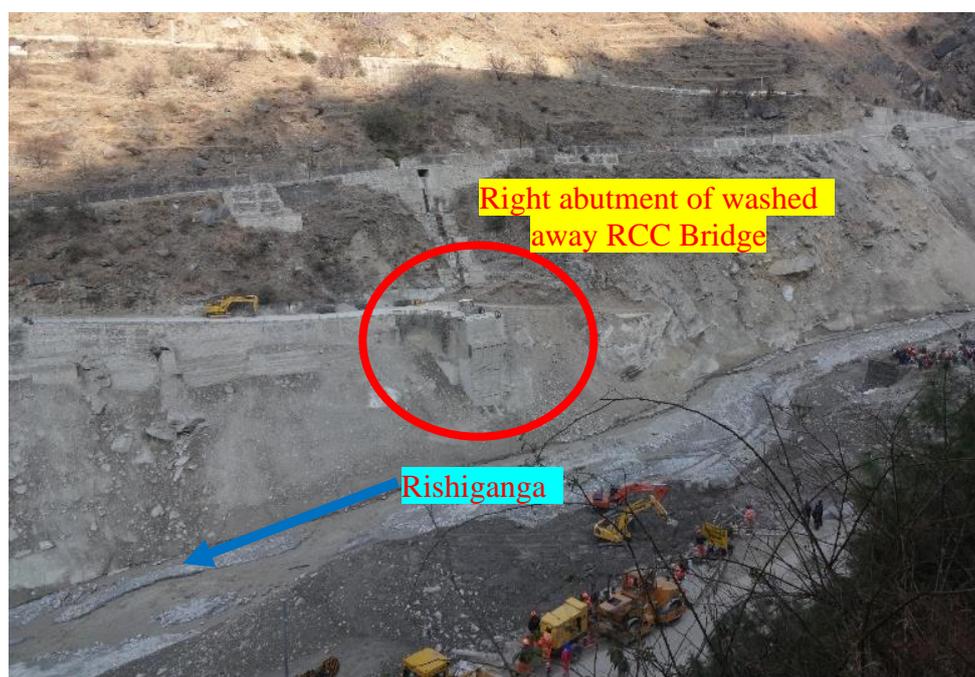
**Figure 3:** Washed away a motorable RCC bridge over Rishiganga river on Joshimath – Malari State Highway at Rini

As many as 204 persons went missing while 12 persons injured in the flash flood incidence and except for 9 local inhabitants of these 5 of Rini, 2 of Tapoban and 2 of Ringi villages and 2 Police personnel others were from amongst those engaged by the hydropower projects that were devastated in the incidence. Out of total, 77 bodies could be recovered while 184 farm animals were lost in this incidence (Data source: State Emergency Operations Centre (SEOC), Uttarakhand). According to Hydroelectric project Authority, about 30-35 persons were reportedly working in a tunnel that was choked with silt and debris transporting by flooded water of Dhauliganga river. Total of 6 bridges were swept away by the floodwaters of which 5 pedestrian bridges which were located on the Dhauliganga river at Rini, Bhangyul, Juwagwad, Tapoban and Vishnuprayag while one motorable RCC bridge over Rishiganga river on Joshimath – Malari State Highway at Rini in which disrupted connectivity for the residents of 13 villages (Fig. 3).

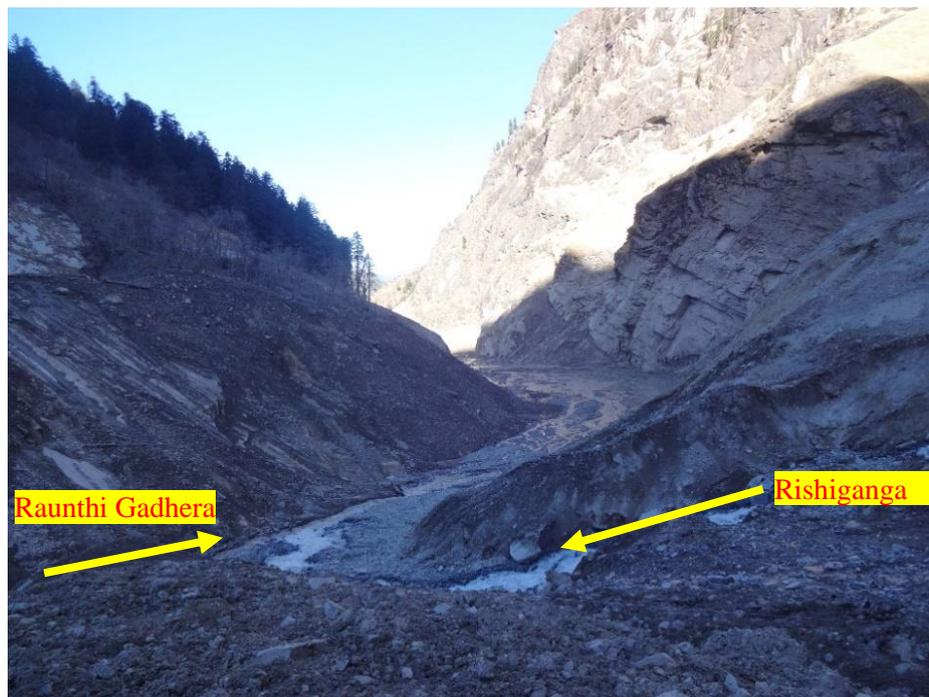
**Figure 5:** At the confluence of Raunthi Gadhera with Rishiganga where key damming was observed

A massive rock fall along with hanging glacier avalanche took place during the winter on February 7, 2021 when the discharge of glacier fed rivers is minimum. The affected area however witnessed precipitation on February 4 and 5, 2021 with experienced snowfall in the higher reaches. Subsequent damming and sudden breach of the same caused flash flood in the Raunthi Gadhera which gushing down wherein thick overburden covers was badly eroded on the left bank of Raunthi Gadhera. At the confluence of Raunthi Gadhera and Rishiganga (Fig. 5), flooded water saturated bouldary debris of Raunthi Gadhera directly hit the valley wall and damming the same place for a while wherein back flowed of sediment laden discharge along the course of Rishiganga up to 500 m. Increasing hydrostatic pressure result in this temporary dam was breached and to left behind a huge sediments along with boulders and ice blocks over the course of the Rishiganga and created an artificial barrier. This completely blocked the course of Rishiganga and after filling of water left behind the same materials formed a lake. This has totally changed the river morphology of the Rishiganga valley.

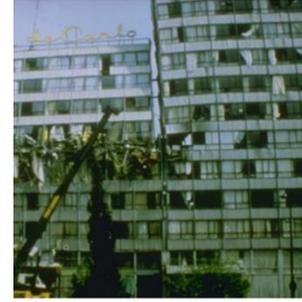
c) global collapse [21]

**Figure 2.** Damage pattern due to pounding effect

The separation distance that mitigates the collisions between adjacent buildings is required by several design regulations [13], however, most existing buildings are found either with no separation distance or with insufficient separation [10]. As such, a collision between the adjacent buildings is expected during earthquakes. Depending on the relative dynamic characteristics of the adjacent buildings (e.g., fundamental period, mass, height, stiffness, orientation, geometry, etc.), the intensity of the collision can be classified into two scenarios as shown in Figure 1. In which for buildings with similar dynamic characteristics, the developed later displacement of the adjacent buildings will be synchronized (in-phase), therefore, no collision is expected. However, given the building-to-building variability, the adjacent buildings most likely develop different lateral responses (out-of-phase), as such, collisions between adjacent buildings with insufficient separation distance are inevitable. This collision between adjacent buildings results in different damage levels which vary from local damage at the contact locations during moderate seismic excitation or significant damage or even global collapse for more severe earthquakes as shown in Figure 2.
