Assessment of deflection-based and seismic non-destructive methods to identify delamination of HMA pavements

F. Selcan Ozen^{a,*}, Manuel Celaya^b, Soheil Nazarian^c, Mehmet Saltan^d

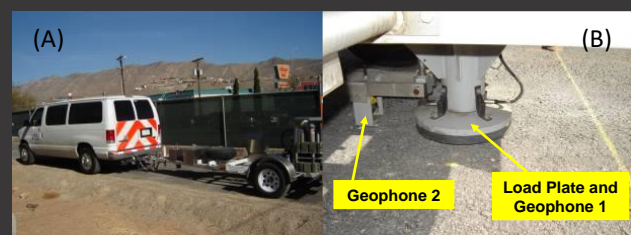
Figure 1. Falling Weight Deflectometer on Small Scale Study; (A) FWD, (B) Loading Plate

As well as maximum deflections up to nine and the maximum load applied, the FWD readily provides deflection values for detailed analysis (Figure 1). In the study, 4.45 kN loading and the deflections measured by seven sensors (placed at 30.5 equally cm intervals) were used. After a comprehensive study, the most reliable analysis of debonding by using deflection data obtained from FWD was found to be provided by either the deflection under the load or the modulus of the asphalt layer after backcalculation process [23, 24].

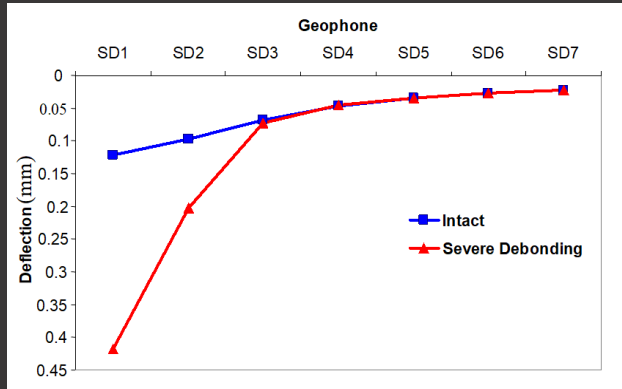
Figure 5. Typical deflections basins from FWD Tests

Deflections measured for the study the at the site locations are shown in Figure 5. Deflections measured with Geophones 1 and 2 (labeled as SD1 and SD2) are noticeably greater at the severely debonded location. For the others, small differences were measured between intact and debonded deflections.

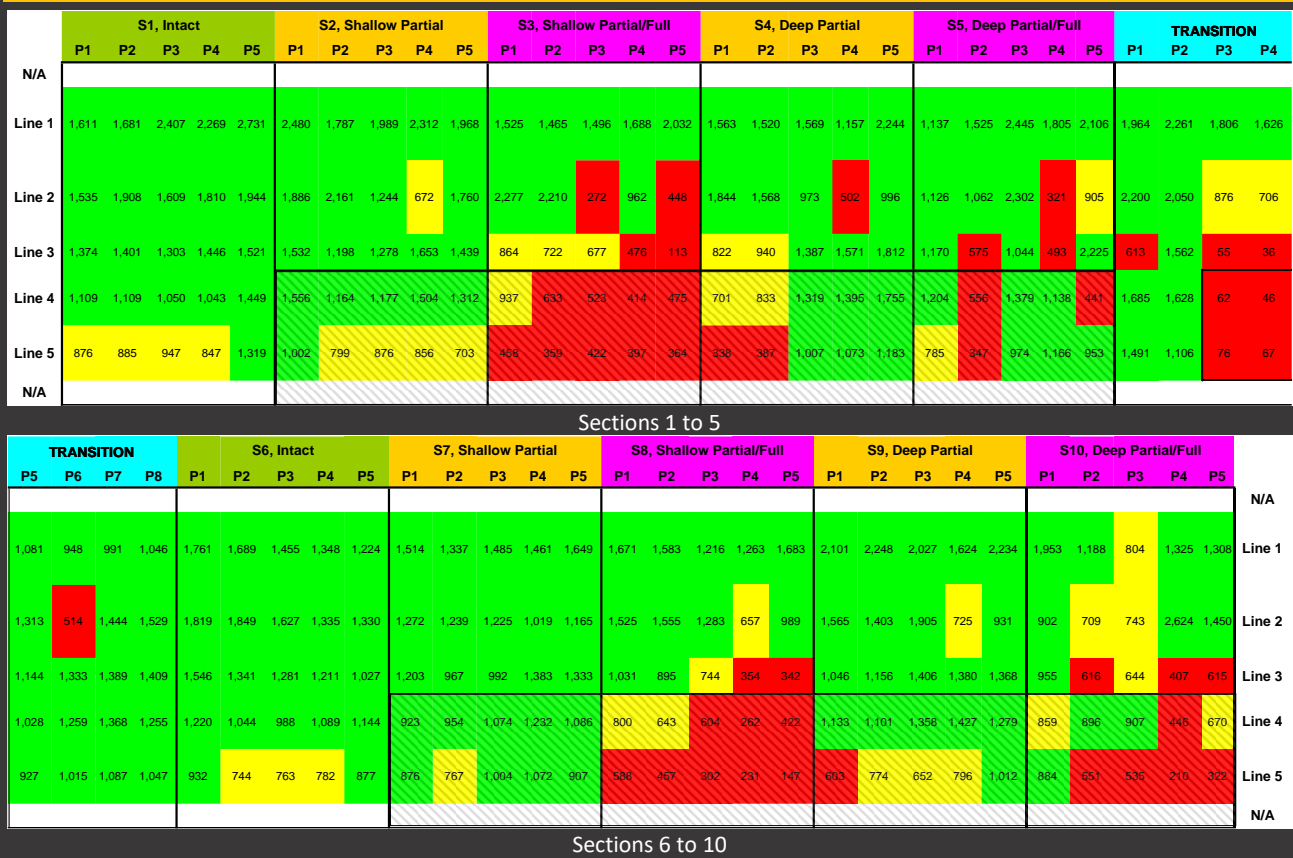
Figure 7. Temperature-Adjusted Contour Maps of FWD Moduli in Cool Weather based on Revised Statistical Criteria

Since the FWD deflections are strongly affected by the subgrade modulus value, the next step was to test the variation in the asphalt layer modulus value as a means of detecting debonded sites. The asphalt layer moduli were backcalculated by using MODULUS 6.0 software [29]. A two-layered analysis that considered the entire asphalt layer thickness (200 mm) as one layer over a subgrade was used. The temperature adjusted modulus contour maps are shown in Figure 7.

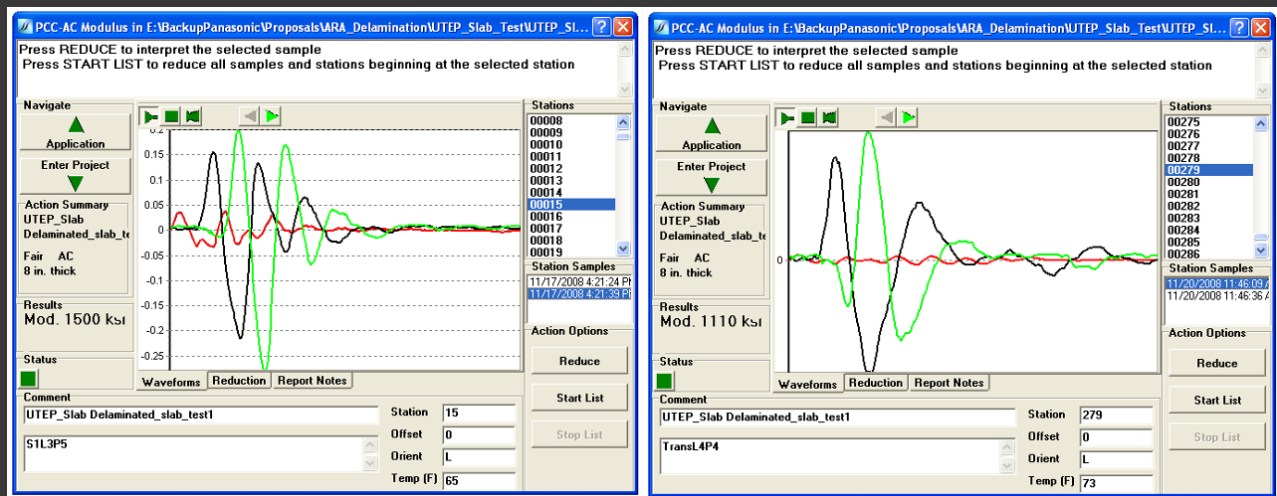
Figure 8. Time Records Results with PSPA on Small Scale Study: Intact (Left), Severe Debonding (Right)

USW tests were conducted by using PSPA device. For an intact and a severely debonded area, examples of the typical voltage outputs of the three PSPA sensors as seen by the operator in the field are shown in Figure 8. The time records obtained from the two receivers (the black and green traces) are considerably different from the two tests. The pulses are wider for the debonded record, and when the minima of the records between intact and damaged areas were compared, it can be seen that the intact areas are closer to one another.

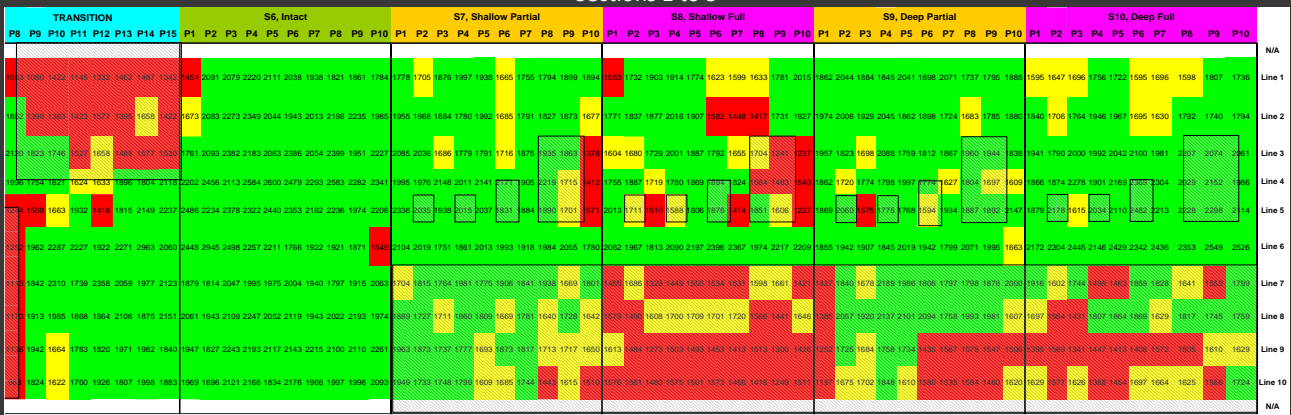
Sections 1 to 5

Sections 6 to 10

Figure 10. Temperature-Adjusted Contour Maps of PSPA Modulus

The variations in the average moduli along the ten sections after temperature adjustment are compared in Figure 10 by using the color-coding convention as described for FWD. The contour plot of the average moduli of the top lift (top 63 mm) for the ten sections tested in cool weather is shown in Figure 11. It is observed that there are reduced moduli for particularly Sections 3 and 8 (shallow and full debonding). Sections with the shallow and partial debonding also showed some reduction in the moduli. This pattern indicates that when the two adjacent layers are not bonded, quality of the asphalt layer (in terms of the stiffness) may be endangered.

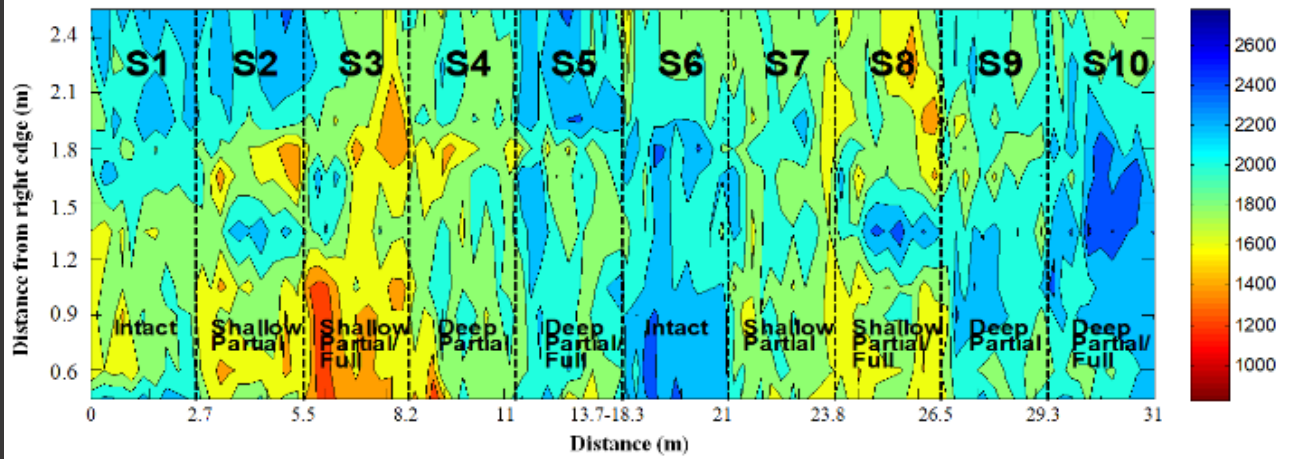
Figure 11. Modulus Contour Plot of Top 6.4 cm

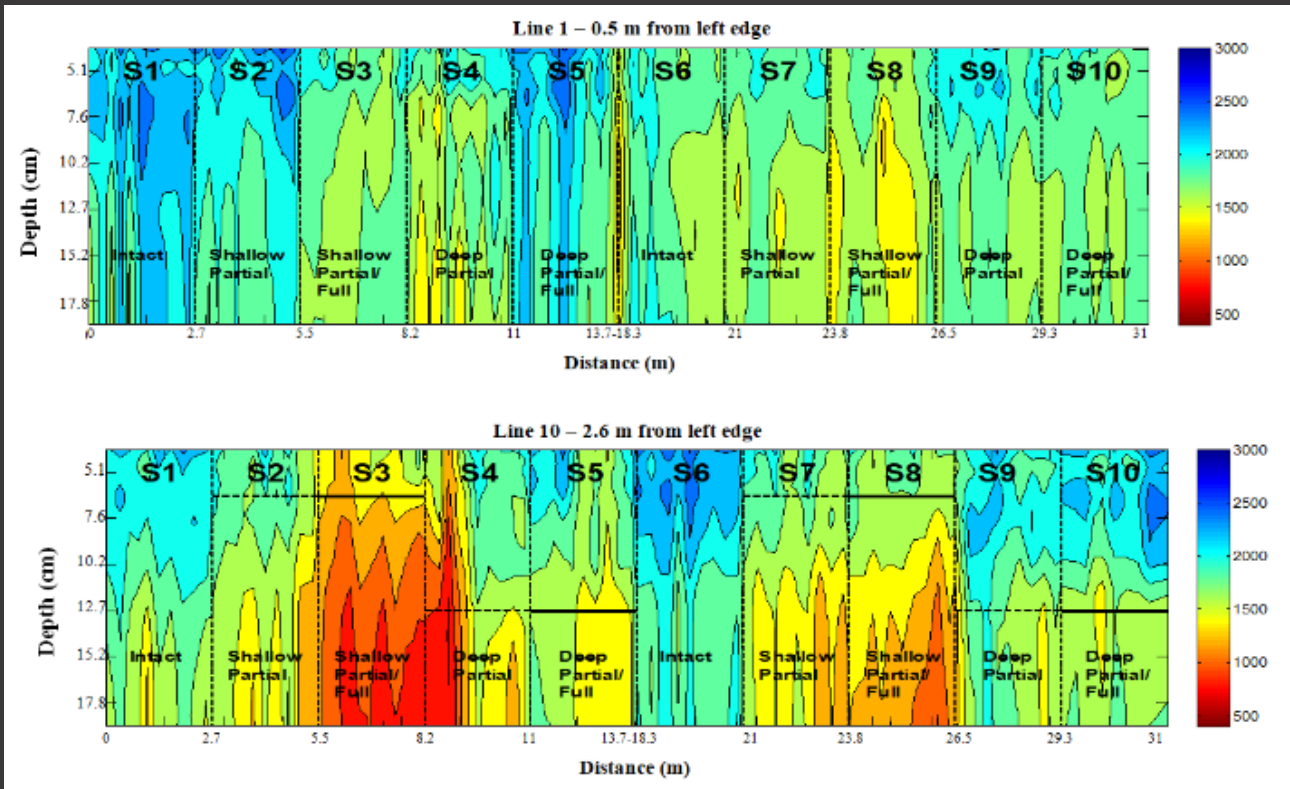
Figure 12. Dispersion Curve Contour Plots for Lines 1 and 10

Detailed dispersion curves for Line 1 (intact) and Line 10 (severely debonded) along the ten sections are presented in Figure 12. The depths and the extent of the debonding areas are also depicted in the figures. Here, solid lines indicate the full debonding and the dashed lines mean partial debonding. It is seen that the reductions in the modulus can be observed in most debonded sections at or below the depths of defects, at least in identifying the fully debonded areas, the usefulness of the USW method is validated. One complicating (but perhaps beneficial) aspect of the dispersion curve is that in a dispersion curve, a low-quality but bonded lift may exhibit the same patterns with a partially debonded interface.
