Research Article

Int J Energy Studies, 2020;5(2):71-87

Experimental investigation of the effects of biogas source H₂SO₄ on engine oil and bearing materials in gas engines

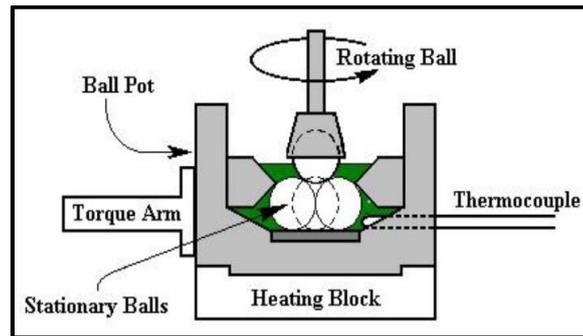
Figure 1. Four ball test

In this experiment, 1% H_2SO_4 was added to the oil in four different brands and properties and subjected to degradation. Afterwards, these oil samples were tested in the OPET FUCHS (İzmir) accredited laboratory. In the tests, the differences between the original of the same oil and the state after adding H_2SO_4 . Four ball tests were carried out using the ASTM D 4172 test method. In this test, three balls made of stainless steel are located at the bottom and one ball is located at the top basically (Figure 1). The anti-wear properties of the fluids to be tested are determined using a microscope. Apart from this, the distortion diameter and volumetric calculations occurring on the ball surface are also used [19].

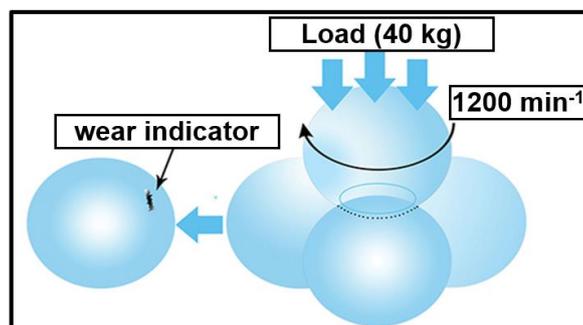
Figure 2. Principle of four ball test

In the four-ball tests, the ball at the top was rotated at the 392 N load and a speed of 1200 min^{-1} and the temperatures of the fluid lubricant samples were kept constant at $75 \text{ }^\circ\text{C}$. The test duration was determined as 60 minutes. This test was repeated for all oil samples. It has been used 8 samples with 4 original oil samples and with added 1% acid in the experiments. Before starting the tests, all test balls were thoroughly cleaned with toluene and dried with hot air. As shown in Figure 2, events such as deterioration and wear on the surfaces of the bottom balls were observed and the results were examined. Each of the oil samples belongs to different companies. Oil brands and models were kept confidential because it was evaluated that this study in the academic field was compared with the results of the experiments and the company could not comply with the ethical rules of the companies (Table 1-4).

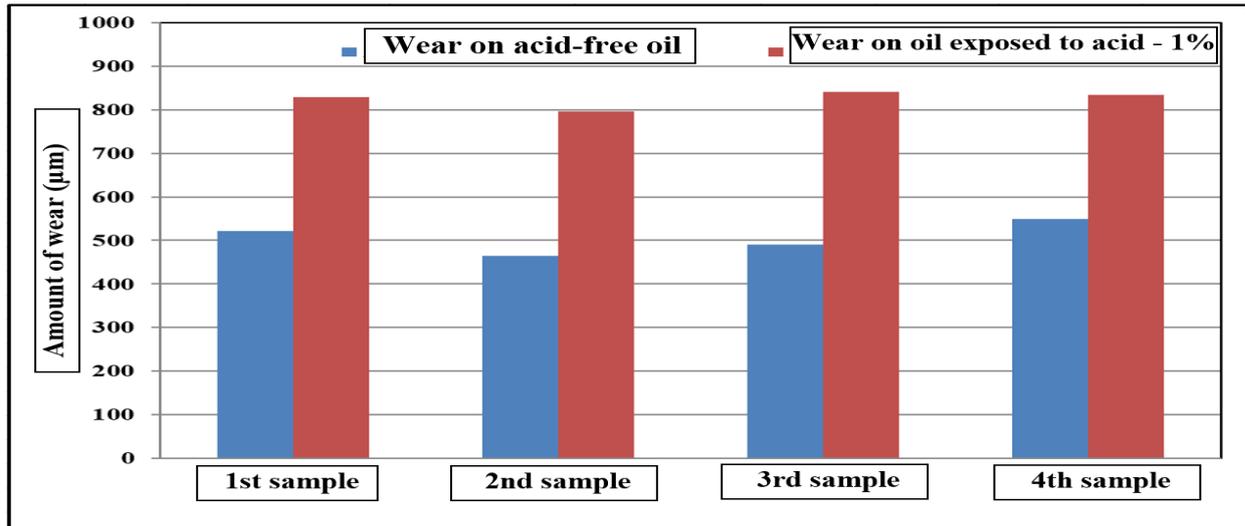
Figure 3. Effects of sulfuric acid on oil samples

As a result of four-ball tests applied to oil samples of four different brands designed for engines, original and acid-added data were recorded and the amount of erosion was shown in Table 6 and Figure 3.

As a result of the tests, the normal wear amount was measured as 522 µm in the first sample number 1 which was not subjected to the deterioration, however, this amount was 830 µm after 1% deterioration. The amount of ball abrasion, which was 456 µm before the addition of acid in second oil sample. Then it reached 797 µm after acid addition. After that, it increased from 490 µm to 842 µm in third oil sample and from 550 µm to 834 µm in fourth oil sample, respectively. In terms of the increase in wear rates, 59% in sample 1, 71.4 % in sample 2, 71.8% in sample 3, and 51.6% in sample 4 were obtained. From this point of view, it is seen that oils 2 and 3 lose their lubrication/anti-corrosion properties more quickly due to the effect of H₂S in the biogas, and thus will cause rapid wear in critical engine parts. It has been determined that 1% H₂SO₄ accumulation that may occur in the engine oil as a result of the use of biogas can cause the oil to deteriorate by 71%.

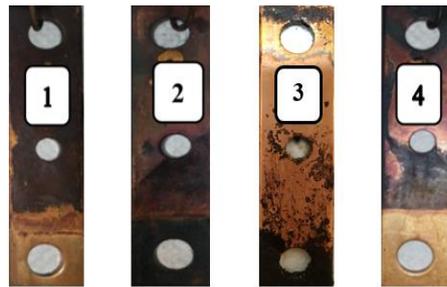
Figure 4. Copper rod samples

in determining the engine life and sustainability of the system, and trace the amounts of H_2S contained in the gas will affect the engine oil first and then the critical parts of the engine. The changes caused by the deteriorated oil in copper rods are shown in Figure 4. It is aimed to obtain information about the sulfur and aromatic oil ratios in the oil samples used in this test. Visual distortion and cracking effects occurring in the bars after the test is completed are shown in Figure 4 and the color scale is shown in Figure 5.

Accordingly, there was no significant physical change in the part of the rod in the oil which was found in oil number 1; on the other hand, it was observed that there was a significant amount of corrosive effect in the region outside the oil. In a similar way, it was observed that the stick in oil number 4 was affected, but this effect was less. On the other hand, the stick in 2nd oil sample was completely affected. In 3rd oil sample, it was determined that the coppers in 1st oil sample and 4th were in the dark orange color (1b) in the lower parts (in oil), and in the upper parts contacting the oil vapor it was colored graphite or matt black (4b). It was determined that corrosion in the form of dark black and graphite (4b and 4c) occurred in the entire rod of 2nd oil sample. On the copper rod immersed in the oil sample number 3, it was observed that the part of the oil remained dark and corroded (4a).

It is considered that the exposure of the parts other than the oil in the 1,2 and 4 rods to a faster deterioration compared to the parts of the oil is caused by the evaporation of the sulfur compound

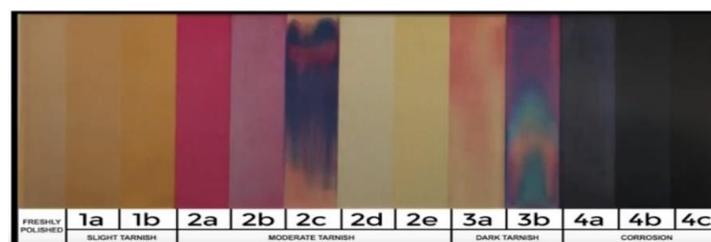
Figure 5. Colour scale

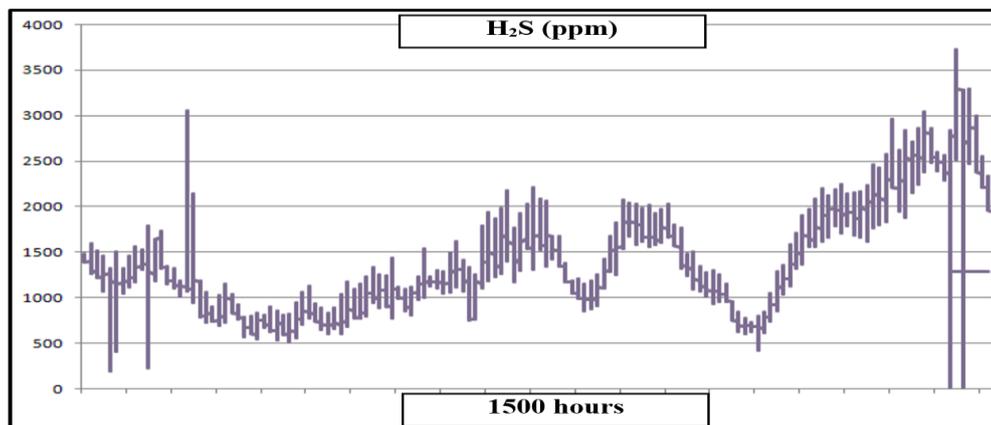
Figure 6. Change of H_2S for 1500 hours

After these laboratory tests, turbo bearings of 1 MWe biogas engine, which is powered by biogas and produced by TEKSAN Generator company, were examined. The H_2S values contained in the biogas used as fuel in this engine are shown in Figure 6. As seen in real usage conditions, this value changes daily depending on many factors such as waste content, fermentation process.

It is observed that there is a continuous fluctuating production of H_2S at an average of 500-3000 ppm within two months. This variable situation is required to be taken into account in engine maintenance and oil change.

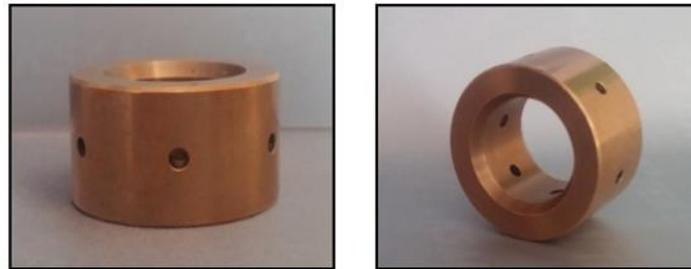
(a) Appearance of original Turbo Bearings

The original image of turbo bearing materials used in the engine is presented in Figure 7(a). In the image (b), a visible change in bed is observed as a result of 750 hours of usage. Finally, in the image (c), the final deterioration in the bearing was shown as a result of 1500 hours of use. This deterioration of the bearings occurs as a result of the chemical reaction of acids with oxides of the bearing metal. It also shows that the disruptive/corrosive effect resulting from oxidizing the oil over time or mixing the acid in any way is also noteworthy. Corrosion inhibitors in oil neutralized light corrosion sources such as incomplete combustion products thanks to the productive film layer formed on metal surfaces. However, the corrosive effect of water vapor can be vital with the oil deteriorating primarily and the inhibitors being deactivated, as the bearings become susceptible to

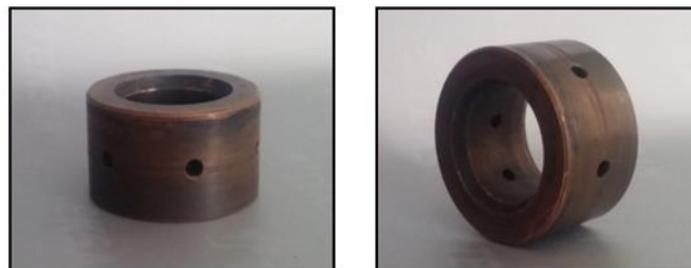
(b) Appearance of Turbo Bearings after 750 hours of operation

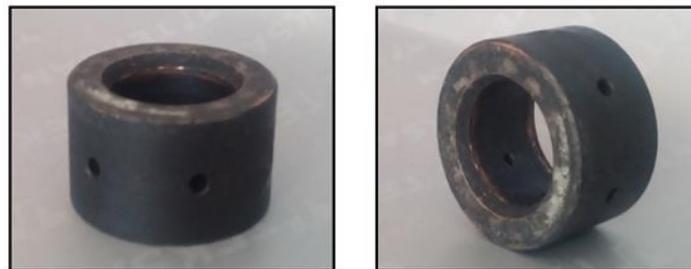
(c) Appearance of Turbo Bearings after 1500 hours of operation

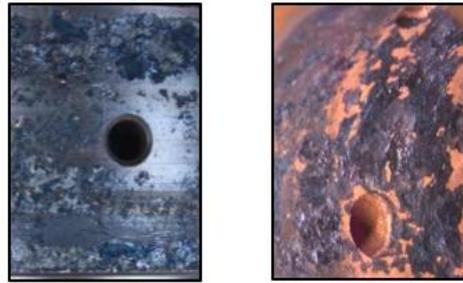
(a) Inspection by the (a) Caterpillar-Turbo charger bearing (Cat. 2015).

These bearing materials were compared to the previous field studies[24] by Caterpillar. Visual data related to the previous results are shown in Figure 8. In these tests, corrosion formation was observed in turbochargers (a) and engine oil coolers (b).

Corrosion occurring in the bearing and oil cooler exchangers were in a similar way. It is thought that this situation will result in both changing the bearings and the oil cooler in the upcoming time.

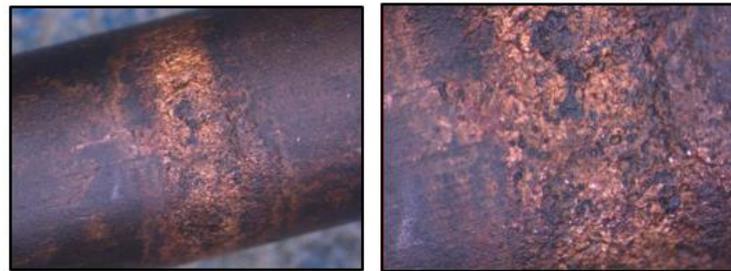
(b) Inspection by the (a) Caterpillar-Oil Cooler (Cat. 2015)
