Teknik Not / Technical Note

Saęlık District Landslide (Ordu, Turkey)

Landslides cause loss of life and property from time to time. In Turkey, the Black Sea Region is the region where landslides are seen most frequently. In this study, Saęlık District Landslide that occurred on May 15th, 2019 in the Central Black Sea Region was examined. This study aims to investigate the occurrence of landslide and its consequences. For this purpose, area was visited and measurements were performed, soil samples and photos were taken. The region which has a rough terrain, receives precipitation throughout the year. The site has volcanic bedrock and thick debris and ground cover on it. The liquefaction limit of the soil is between 45.7 and 47.8 and the plasticity limit is between 20.51 and 22. Snowmelt is the main factor that triggers landslides in the work area. Also, turning forests into agricultural areas, opening roads crossing the slopes, additional weights created by houses, water leaking from the sewer network to the ground among preparative conditions of landslides. Stress cracks that started to occur in the crown part of the landslide three years ago started to expand on the day of the in

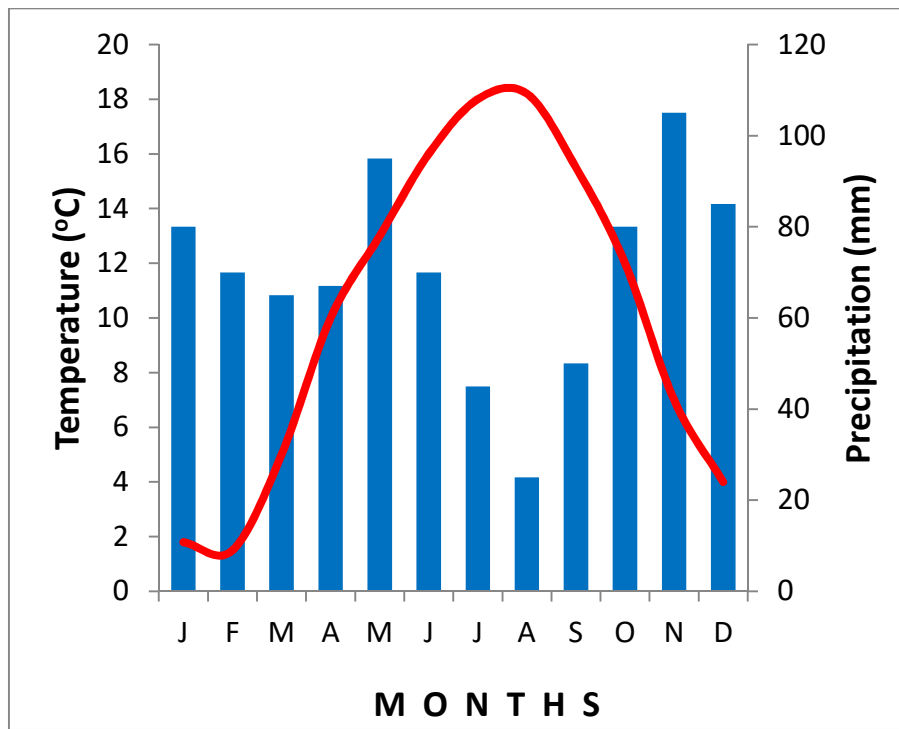
Figure 3: Monthly average precipitation and temperature values of Aybastı Meteorology Station (1978 – 1993).

The Black Sea coast has a humid and temperate climate. However, since the study area is located in higher and higher point than the shore, especially winter months are colder and snowy. The annual average temperature in the field is 9.8 °C and annual total precipitation is 827.5 mm (Table 1). Rainfall in the region is distributed throughout the year. For this reason, soil moisture is generally high. In addition, the number of snow days in the field is 33.9 days (Table 1). Snowy days start in November and end in May. This situation shows that especially towards the end of spring due to warming of weather, snow melting is also effective in saturating the ground with water. In this way, the water weakens the bond strength by infiltrating the

ground (Figure 3). Thus, the field becomes very suitable for landslides. The fact that the ground is saturated with water and the land is divided by deep valleys has led to the emergence of numerous springs. Both rain and melting snow waters and waters coming from springs to the ground are drained by Aybastı Creek. The creek joins Bolaman Creek in the north of Kabatař District center and pours into the Black Sea in the east of Fatsa city center.

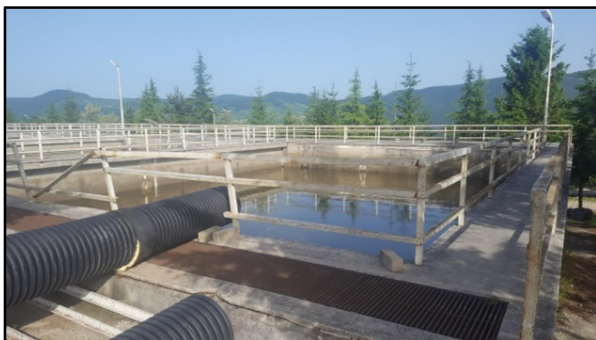
Figure 4: Aybastı Drinking Water Treatment Plant at the top of the landslide area.

The natural environment features of the landslide area and its surroundings support the formation of landslides even though there are no human effects. However, drastic changes in land use and building activities also support landslide formation. One of major facilities that stand out in this context is the drinking water treatment plant built 250 meters above the landslide main scarp (Figure 4). According to residents, the first movements at the landslide site started after the construction of this facility. In addition to the weight of this facility in the hillside, water leaks to the ground may have supported the formation of landslides.

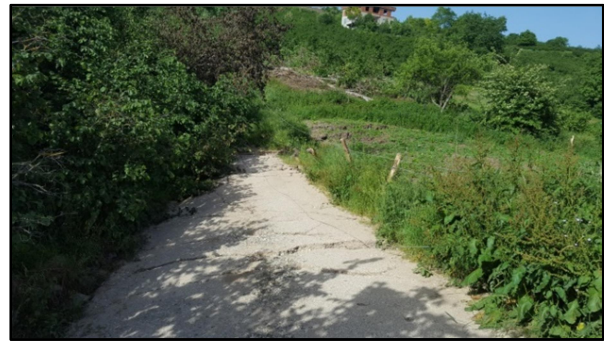
Figure 5: One of roads that cross the slope of the landslide. The road was closed to traffic after the landslide.

One of the factors supporting the formation of landslides is roads that cross the slope of the landslide. In the region, several roads (e.g. the Aybastı - Reřadiye highway passing through Saęlık District) that cut the landslide slope from seven places have been opened. On the other hand, three of these roads were damaged during Saęlık District landslide (Figure 5).

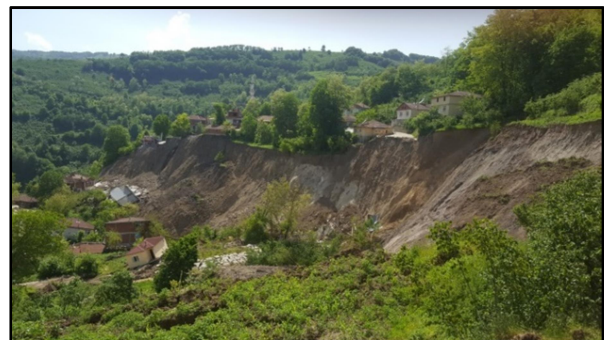
Figure 6: General view of the landslide main scarp from the west.

The Saęlık District landslide occurred on thick cover of debris formed by the decomposition of volcanic bedrock. This landslide initially occurred as a slow-moving deep slide. The cracks that started in the crown part of the landslide continued with the collapse and 34 meters high, 350 meters long crown area was formed (Figure 6, 8).

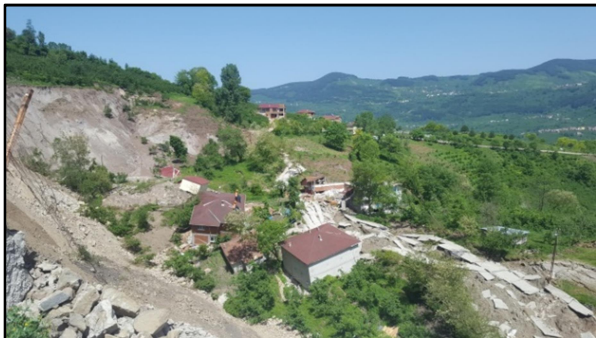
Figure 7: Some houses maintained their integrity even though their vertical status was impaired during the collapse. A view from the east.

During the collapse, the houses on the rupture site were destroyed. However, although vertical conditions of houses on the collapsed block have partially deteriorated, a significant number of them have maintained their integrity (Figure 7).

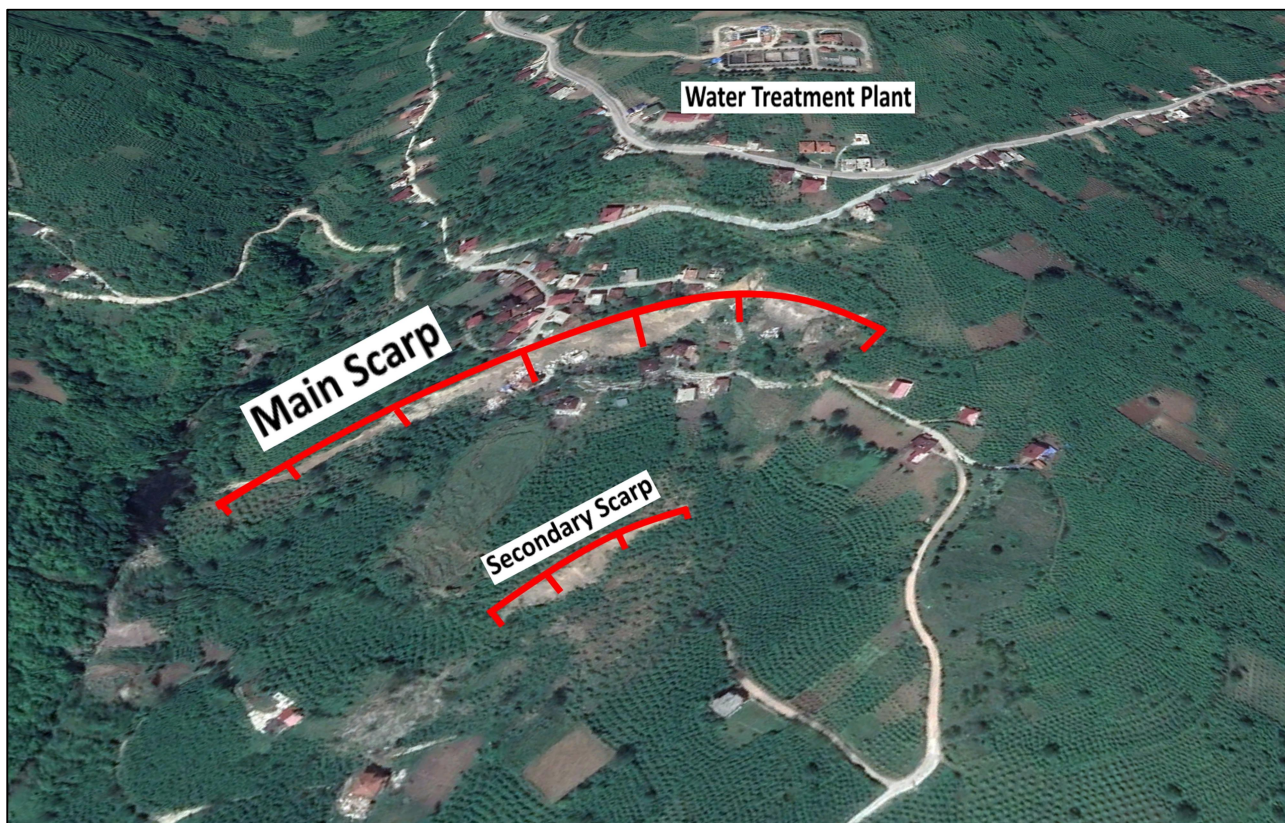
Figure 8: The landslide area and its surroundings.

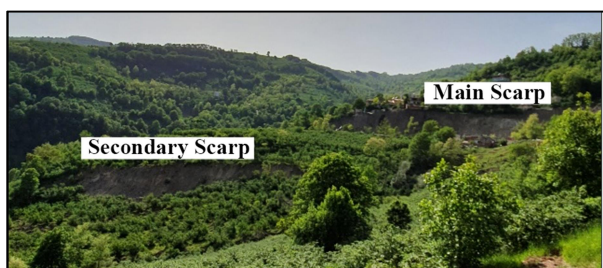
Figure 9: General view of Sağlık District landslide from the northwest, which has a two-part structure.

The mass of the landslide drifted towards the heel following the collapse and led to blistering and stretching there. The swells on the heel triggered a new landslide and a second collapse occurred about 120 meters south of the main scarp. Thus, Saęlık District landslide has acquired the feature of a two-

part compound landslide. After the landslide, the terrain profile gained a fresh look (Figure 9).

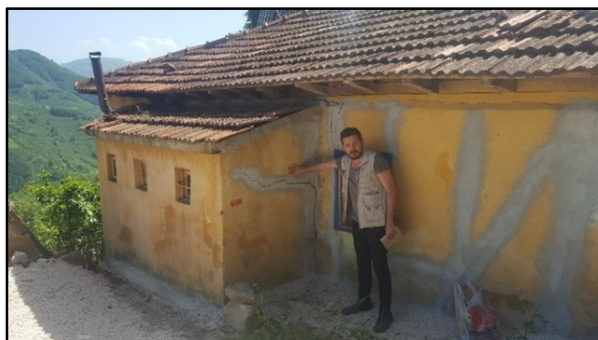
Figure 10: Some of cracked walls were repaired in 2015 but later these cracks were reopened.

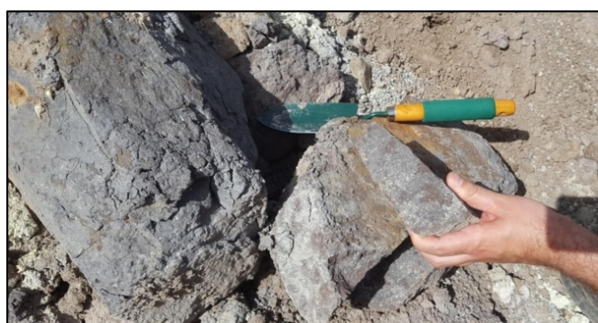
Figure 11: Andesitic bedrock pieces come out in the eastern part of the crown area of main scarp and partially altered.

During investigations in the crown area of main scarp, it was understood that the mass forming the ground was moved and mixed because of an ancient landslide (Figure 12). However, in eastern part of the crown area, volcanic bedrock was revealed and thick debris and soil cover was found on it (Figure 11).

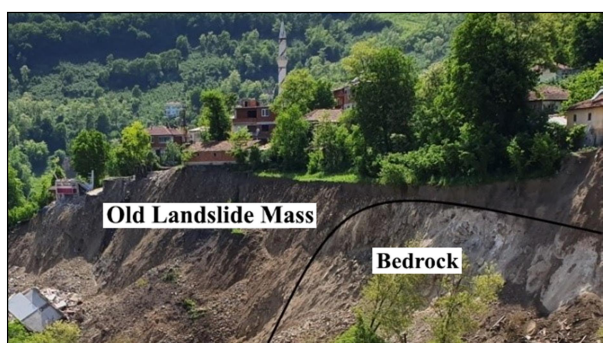
Figure 12: Crown area of main scarp cut partly an old landslide mass and partly the bedrock and debris cover on it.
