Archeological Traces of Sixth Century Earthquakes in İstanbul Küçükçekmece Lake Basin (Bathonea) Excavations

Şerif BARIŞ, Şengül AYDINGÜN, Hakan KAYA, Cem GAZİOĞLU

Research Article**Archeological Traces of Sixth Century Earthquakes in İstanbul Küçükçekmece Lake Basin (Bathonea) Excavations****Şerif Barış^{1,*}, Şengül Aydıngün², Hakan Kaya³, Cem Gazioğlu^{3,4}**¹ Department of Geophysics, Faculty of Engineering, Kocaeli University, TR² Department of Archaeology, Faculty of Art and Science, Kocaeli University, TR³ Istanbul University, Institute of Marine Sciences and Management, Department of Marine Environment, 34134 Vefa Istanbul TR⁴ Istanbul University, Faculty of Architecture, Department of Architecture, 34126 Beyazıt Istanbul TR* Corresponding Author: Ş. Barış
E-mail: srfbrs@gmail.comReceived: 21.04.2020
Accepted: 09.04.2021**How to cite:** Barış et al., (2021). Archeological Traces of Sixth Century Earthquakes in İstanbul Küçükçekmece Lake Basin (Bathonea) Excavations, *International Journal of Environment and Geoinformatics (IJEGEO)*, 8(3):386-396, doi. 10.30897/ijegeo.914055**Abstract**

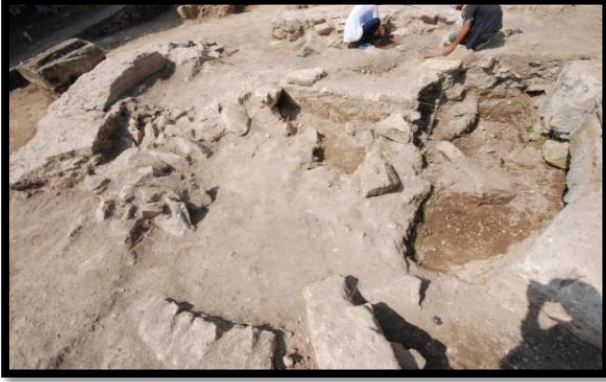
Fig. 3a. Excavation of collapsed semi-dome of church.

excavated in areas numbered 24-25 in the basin experienced a sudden collapse and was destroyed to the foundations based on architectural remnants (Figure 3a-b). Additionally, an important example proving this situation was the identification of the skeletons of two individuals, holding each other, under the dome stones and rubble in the structure. Probably praying in this church, these people could not escape from sudden and very intense shaking (due to seismic movements) and

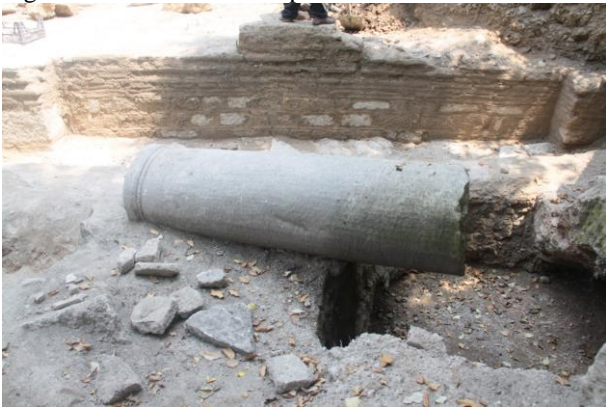
Fig. 3b. Sudden collapse and destroyed architectural remnants.

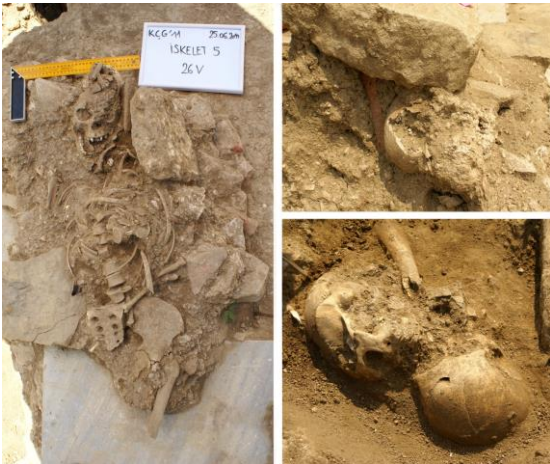
Fig. 4a-b-c. Excavations of skeletons obtained on the marble floor of the church, individuals holding each other crushed under the collapsed semi-dome.

These skeletons were found on a marble floor and among stones and soil remains forming different layers, with fractures not only identified in their skulls but in arm, leg and rib bones (Figure 4a-c). Other evidence that this destruction and death occurred after a disaster like an earthquake is that these individuals were not buried in the city's necropolis. The individuals were found on the marble floor of the church under stones and rubble. According to forensic medicine expert Dr. Ömer Turan on the excavation science team, the skulls of the individuals were broken by heavy architectural stone fragments and one of the most important pieces of evidence documenting that death occurred due to remaining under destruction due to shaking was that stone fragments were found within the fractures in the skull. This evidence is shown in Figure 4a, b, c. In addition to the bones of individuals under the rubble, coins obtained belong to Justinian I (527-565) who was emperor in the 6th century. The coins found under this collapsed structure were determined to date from 550 according to the excavation numismatic and ancient historian (Figure 5).

The surface the skeletons were found on was a marble floor. Heavy dome stones, soil and a rubble pile were found above them. The fracturing of the skeletons’ skulls by dome fragments and very scattered distribution of other bones shows that this was not a normal death. Bones like the ribs, arm and legs of the individuals were crushed and contained fractures. The forensic medicine experts in the excavation stated that the crush may have been under a very sudden and intense collapse based on investigations of the bones. The scattered and fractured bones belonging to the head and body show that these individuals were within the building when it collapsed

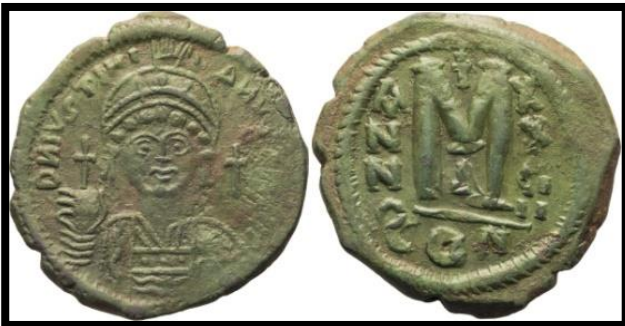
Fig. 5. Emperor Justinian coin found near individuals under the collapsed semi-dome and dated to 550.

date of these earthquakes causing this damage by investigating historical catalogues, and comparing the findings with historical earthquakes. It is significant that a coin with Justinian's stamp dated 550 was found by careful excavation beside the individuals trapped under the dome. Additionally, ceramic fragments were also found and a perfume bottle dated to the 6th century (Figure 11a-b). The clear date on the coin proves that these structures were destroyed by earthquakes occurring after 550. Similarly, the finding of skeletons under rubble, rather than in the city's necropolis, proves that death was sudden and that the structure was not used again as bodies were not removed from the rubble.

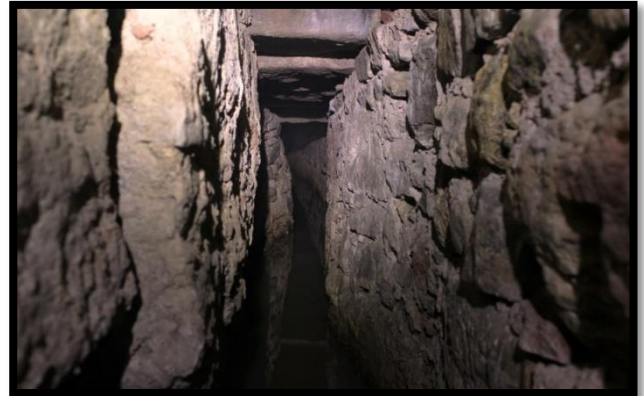
Fig. 6. Water tunnel with deformation after ground movements. The tunnel narrowed to 20 cm at some points.

A tunnel noticed in the water infrastructure of the building was researched by our gallery cave group and it was identified that the tunnel narrowed to 20 cm at some points (Figure 6). It is thought that this narrowing is connected to the events which collapsed and destroyed the apse structure Eğilmez et al., 2017.

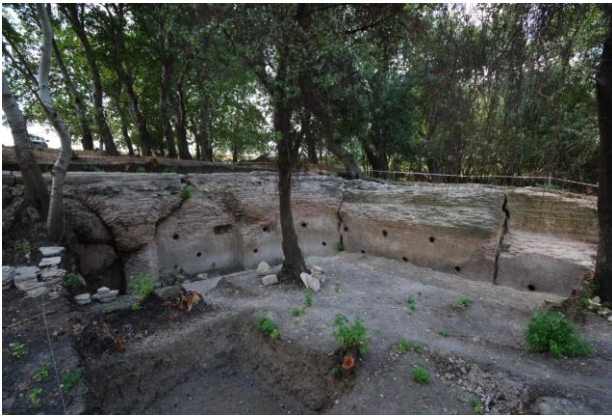
Fig.7. Body walls with oval corners in the cistern and offsets and damage identification relief studies of walls due to probable large earthquake.

have not been fully completed, but two sections of the body walls may be investigated. With the aim of identifying the dimensions of the cistern, excavations following the walls measured 70.2 x 18.2 m. Investigations of the cistern identified that after destruction occurring in the Late Antique Period the standing body walls in north and west directions were preserved, while additions to the west wall were extended and a new wall was completed in the west section, indicating that perhaps the building continued to be used for a different function. The original structure had internal dimensions of 40 x 13 m according to the plan scheme in its current form. The body walls with nearly 3 m thickness were made of brick and mortar on the interior, while the external surface displays stone and brick alternations. With brick thickness varying from 4-5 cm, the structure has nearly 4 cm-thick mortar. In terms of construction technique and material, the structure is dated to Late Roman-Early Byzantine period, and was organized with oval form at the corners of the walls to increase pressure resistance at the corner points, a specific design principle for body walls in contact with water. The internal surface of the body walls is covered with 5 cm-thick red-colored hydraulic plaster. The floor of the cistern is covered with hydraulic plaster with 10 cm thickness. The presence of terracotta pipes inserted at regular intervals in the body walls of the cistern is remarkable as an exceptional application that is not found in Istanbul cisterns. Each has 20 cm diameter and 38 cm length, and it appears the back sections of the pipe were consciously closed (Figure 7).

First observations led to consideration that the pipes were inserted in the body walls as a precaution against pressure on the walls when large amounts of water were stored in the cistern (Altuğ, 2017: 181).

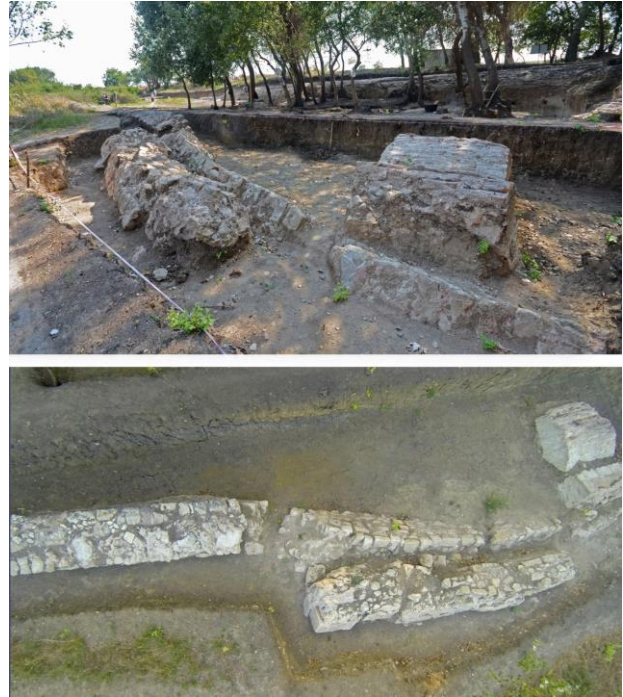
Fig. 8a-b. Laterally collapsed wall in the water structure due to probable earthquake effects.

Field observations observed that some walls in the cistern were laterally collapsed. It is probable that this form of destruction of these types of strong walls may have occurred with force occurring during seismic motions. Detailed observations of the cistern continue, but though some walls were very thick, we identified that walls had fractured and were offset with the causes of this type of damage investigated. This damage

strengthened our belief that it probably occurred due to destructive earthquakes affecting the region (Figure 8a-b-c).

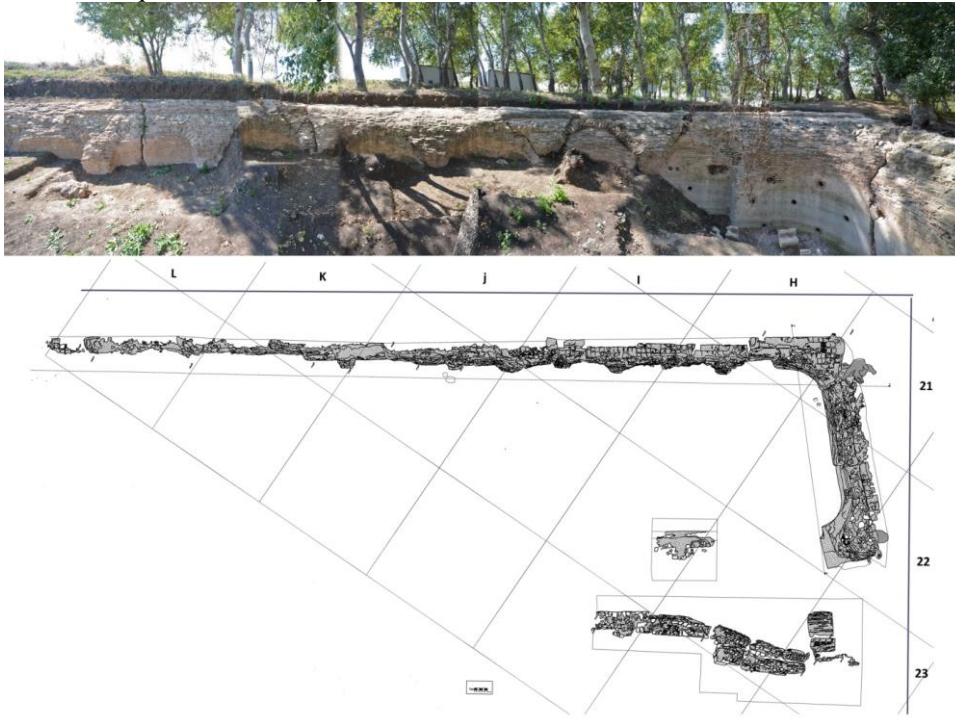
Fig. 8 c. General view of great cistern and plan.

According to results of technical investigation of the Great Cistern, nine arch traces were identified at three-meter intervals on the west side of the structure, and these are considered to indicate the joist points for arches carrying the roof system of the cistern. This result reveals that the structure may have been an enclosed cistern. With walls reaching 3 m thickness, this strong structure may represent the infrastructure of a significant building carried above it in the past. However, with incomplete excavation, the archeological fill remains within the cistern. From this aspect, drilling studies planned for the autumn of 2020 in fill within the cistern, along with georadar scanning; will provide more definite data in terms of explaining this problem. The results of studies of the Great Cistern identified in Küçükçekmece Lake Basin (Bathonea) excavations lead to consideration that the possible roof system of the cistern collapsed as a result of a probable earthquake in the Early Byzantine period and that construction material from the vaults were transported and used in other structures in the area (Altuğ 2017). In addition to indicators provided by the construction technique, stamped bricks obtained from the Great Cistern indicate that the construction of the structure began in the period of Emperor Constantine (324-337) and then continued later as understood from bricks carrying the stamps of Constantine and his consecutive sons Contans (337-350) and Constantius (337-361) (Aydingün, 2013: 46-47; Sayar, 2015: 187-189).

Apart from technical investigations of the structure, geophysical and seismic investigations identified probable wall offsets and some structural damage traces on observational measurements of the exposed cistern walls and in the cistern structures. Offsets in the cistern walls and fractures in the walls, especially, led to the view that they occurred as a result of large earthquakes occurring in the region. Some findings were obtained that are compatible with other observations in the region of the cistern. Similar damage and several skeletons give the impression that damage and loss of life occurred during a large earthquake within the settlement.

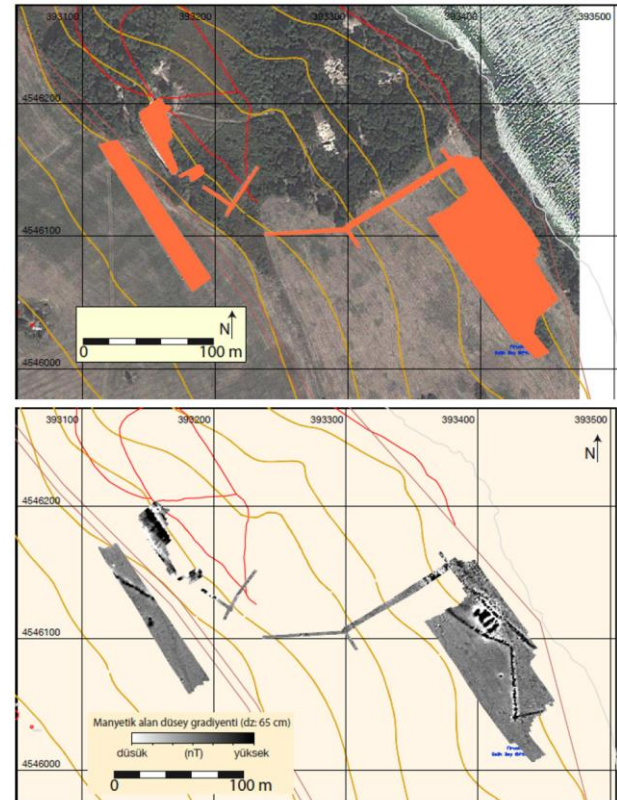
Fig. 10. Geophysical results from Great Cistern and surroundings. An example of the geomagnetic measurement results from the excavation area. Dark color regions show magnetic field variations. These probably show terracotta and rocks with magnetic characteristics.

Geomagnetic measurements could be taken over a total of 2 hectares in the region. The locations of the measurement sites are shown with red color in Figure 9 and Figure 10 show the geomagnetic measurements on a satellite map (Pekşen et. al., 2017).

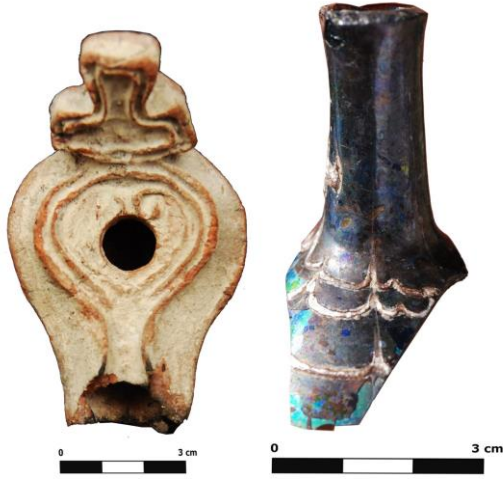
Fig. 11a-b. Oil lamp and a perfume bottle dated to the 6th century
