## Assessment of the Acoustic Performance of Historical Structures That Shed Light on Today's Technologies: Fatih Pasha (Kurşunlu) Mosque - Diyarbakır

*architectural acoustics, historical religious buildings, Fatih Pasha (Kurşunlu) Mosque, objective acoustic parameters*

### Fatih Pasha (Kurşunlu) Mosque

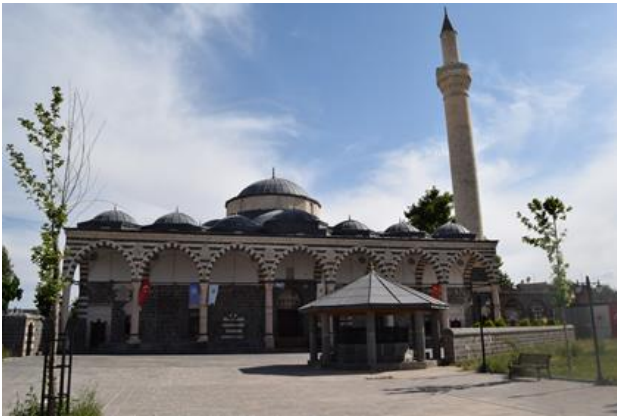
Figure 1. Fatih Pasha Mosque

Fatih Pasha Mosque, which was evaluated within the scope of the study, was built in 1516-1520 by Governor Bıyıklı Mehmet Pasha. It was the first Ottoman period artefact in Diyarbakir. The mosque, popularly known as the Kurşunlu Mosque because of its lead-covered domes, is located in the eastern part of the old city surrounded by walls [8], [9]. The mosque was built as a part of a complex. The complex consists of a mosque, two tombs and a Shafi'i section. In the northwest corner, there is a single honorable minaret adjacent to the structure, a tomb, and in the northeast, there is the Tomb of Özdemirolu Osman Pasha, which is independent of the structure. There is hazire<sup>1</sup> in the east and south [8–10] (Fig.1).

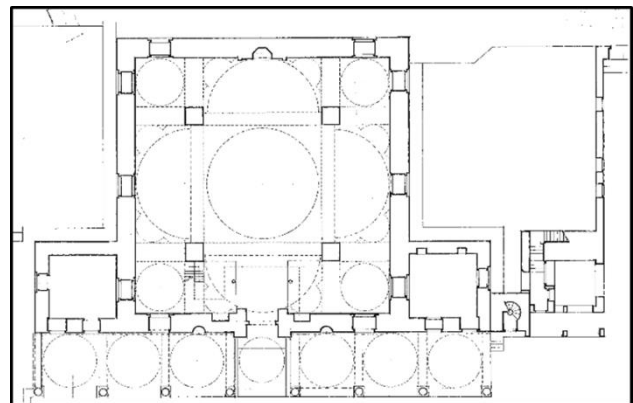
Figure 2. The plan of the Fatih Pasha Mosque [12]

Fatih Pasha Mosque shows the characteristics of classical Ottoman art with its plan, architectural features and materials [10]. The mosque consisted of a square-planned (20.24×20 m.) prayer hall and a seven-unit final congregation along the northern façade. It has an area of approximately 420 m<sup>2</sup> and a volume of approximately 4520 m<sup>3</sup>, including the women's mahfil. The prayer hall

part of the mosque has a central plan supported by four half domes. The first standout point when entering through the main door is the cover system built on four square feet. A dome in the middle and four half domes in four directions around it reflect the characteristics of a central structure with four small domes in the corners [8]. A hexagonal pulley carries the central dome. Eight pointed arched windows were opened in the pulley. Half domes sit on half octagonal pulleys. Pulleys end with a row of hedgehog fringes as an early feature [10]. In the northeast and northwest corners of the prayer hall and just behind the narthex, there is a square-planned, domed room (5.2×5 m) (Fig.2).

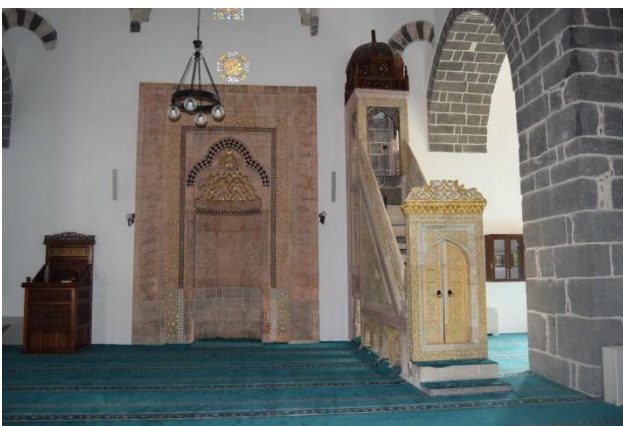
Figure 3. The minbar and the mihrab in the qibla wall

The mihrab of the mosque is made of finely cut limestone. In the past, it is known that the mihrab is covered with tiles. But today there is no sign of tiles. The minbar and door on the right of the mihrab are marble (Fig.3). A wooden dome with geometric decoration was later added to the throne section of the minbar with the cage carving technique. All the wall surfaces of the structure, which are still plastered today, are basalt rubble stones, while the feet and arch stones are made of smooth basalt cut stones. The main construction material of all domes is brick. It is covered with lime plaster. The original flooring material is basalt. It is then covered with carpet. It has been supported to reduce the interior reverberation time by using carpet covering over basalt stone as flooring. Accessed by a basalt staircase, the women's mahfil is made of wooden flooring and wooden railing carried by wooden posts. The flooring is covered with carpet. The main entrance door of the mosque and the profiles of the windows are also wooden.

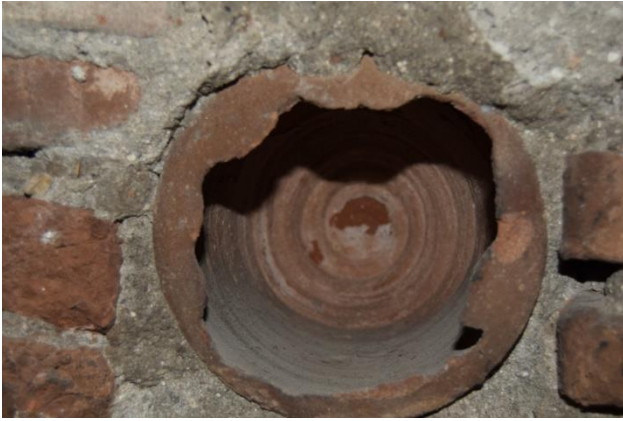
Figure 5. Acoustic pot in the dome

Pots used as acoustic resonators were uncovered in the mosque with plasters removed after the fire. Resonators have become a kind of practice over time, especially in mosques, which are a religious structure. In the 16th century, Sinan also widely used acoustic resonators in its mosques [13]. The simplest type of acoustic resonator is the Helmholtz resonator. This is a volume of air that is connected to the volume of the room with a small opening and neck as soon as it is located in a cavity of a full mass (Fig.4). The sound energy that strikes causes the air in the neck to vibrate. This air tends to hare as a mass, such as a spring, which also includes the air behind the cavity due to compressed volume. This spring-mass system has a resonance frequency and is the maximum energy transfer when they are at the same frequency as the multiplier sound wave. Energy is swallowed by rubbing against the neck and the air particles inside. Some of the energy is transmitted into the cavity inside and continues to spread again until the sound stops. Therefore, resonators can extend reverberant sound energy in-room volume. If the inner surface of the resonator used is not swallowing, it will come out very quickly at frequencies above and below its own resonance frequency. That is, if the resonator is in the swallower feature, it will be effective in a larger bandwidth. The sound energy emitted back into space will also decrease due to the ingestion of energy [14]. Equation (1) [13] displays the formula that can be used to calculate the resonance frequency of the resonators soon as it is selected. The acoustic pot in the dome of the mosque can be seen in Fig. 5.

During the restoration application carried out between 2016 and 2019, all the plasters of the mosque, which were damaged by fire and renewed in 2008, were removed and replaced with lime plaster compatible with the original. Only the surface where the original chasing in the dome were found was not removed but was reinforced by cleaning. In this process, almost all the plasters on the inner surface were removed, so the original wall and top covering materials and acoustic pots placed in the domes could be seen.

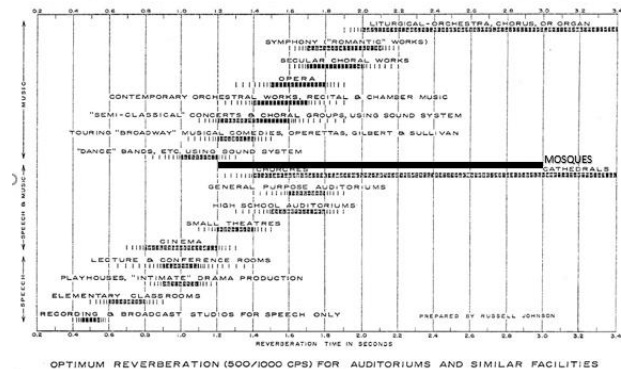
Figure 6. Optimum reverberation time (RT) for different functions [4]

According to Su Gul and Caliskan (2013), optimum reverberation time limits for 500 Hz-1000Hz are indicated in Table 1 [2]. According to Karabiber and Erdoğan (2002), the optimum levels for functions performed in mosques are between 1.7 and 2.8 seconds [3]. Bal Koçyiğit (2014) showed the optimum time for 500Hz - 1000Hz as 1.2sn-3.0sn (Fig. 6) [4].

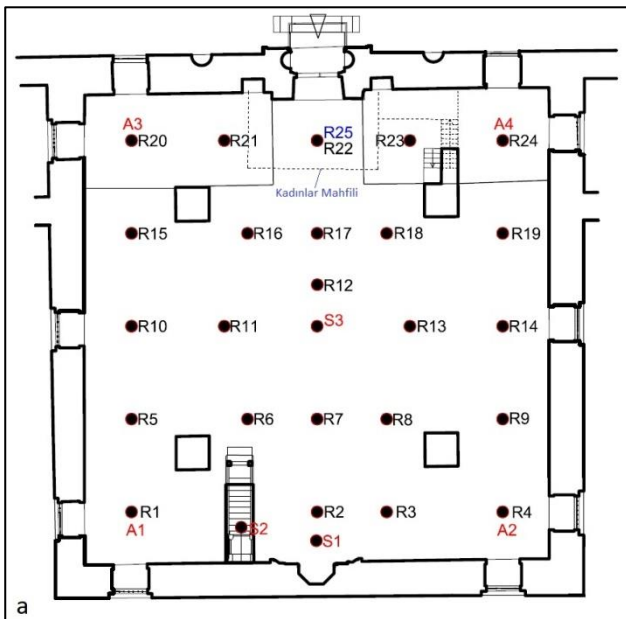
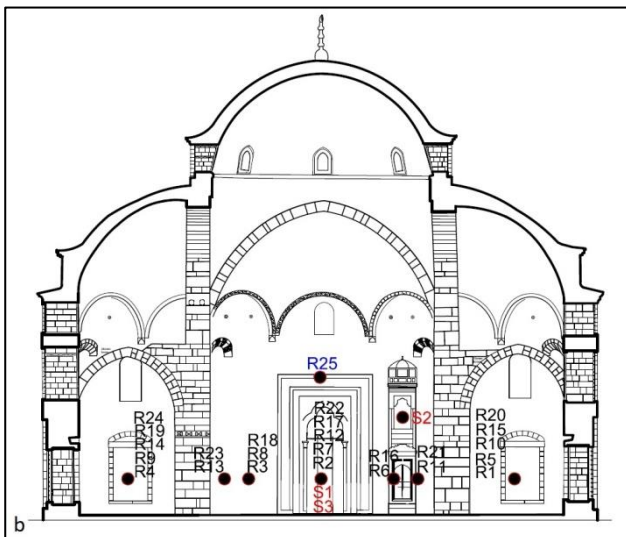
Figure 7. The positions of the Source-Receiver points in a) plan, b) section

At the beginning of the work, the background noise level was measured primarily at four points of the mosque (A1, A2, A3, A4). Acoustic parameters were measured at three sound sources and 25 receiver points in order to determine the acoustic performance of the mosque. Three source points (S1, S2, S3) were determined for the measurements. S1 is positioned in front of the mihrab, S2 is in the minbar, and S3 is located in the center of the prayer hall. 25 receiver points are designated to be at least 3 m between them. One of the receiver points is on the women's mahfil and the others on the ground floor (Fig. 7).

The distances between the sources and receivers and their distances from the nearest reflective surface are arranged to be at least 1.5 m. Sound sources are positioned at a height of 1.5 m from the floor. Since the source S1 is determined as the position of the imam to pray to the congregation in front of the mihrab, the receiver points are 1.5 m high from the floor; For the S2 source placed on the minbar, the congregation listened to the Friday sermons by sitting, so receiver points have a height of 0.8 m; For the S3 source placed in the center, the receivers were placed 0.8 m above the floor.

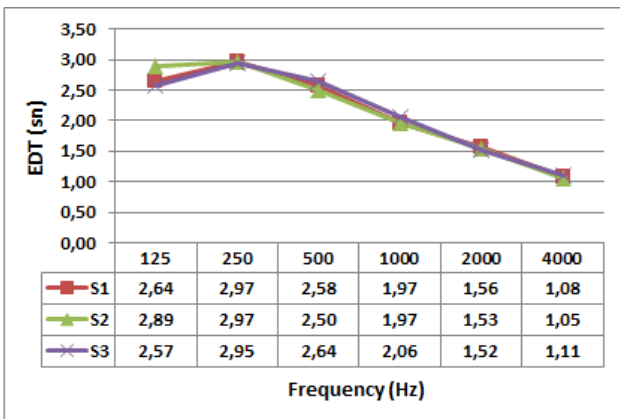
Figure 9. Average EDT for 25 receiver points for S1, S2, S3 sources

For S1-S2-S3 source points, Fig. 9 shows the average EDT data between 125-4000 Hz obtained from R1-R25 receiver points is given. The average EDT of 25 receivers for 500Hz-1000Hz at S1, S2, S3 source points ranges from 2.50sn-2.64sn for 500Hz to 1.97sn-2.06sn for 1000Hz. These data were found to be among the reference data because the EDT must be  $\pm 10\%$  of the T30 value.

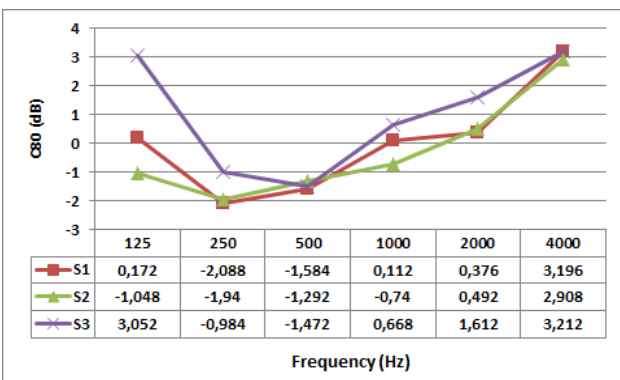
Figure 10. Average C80 for 25 receiver points for S1, S2, S3 sources

In Fig.10 shows the average C80 data between 125-4000 Hz from R1-R25 receiver points for S1-S2-S3 source points is also provided. At the S1, S2, S3 source points, it was determined that the average C80 of 25 receivers was at reference for 1000 Hz compared to the reference values -1 and +3 dB, and slightly below the reference for 500 Hz.

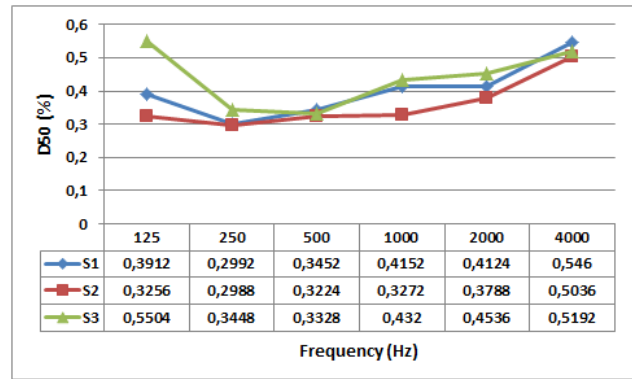
Figure 11. Average D50 for 25 receiver points for S1, S2, S3 sources

For S1-S2-S3 source points, Figure 11 shows the average D50 data between 125-4000 Hz obtained from R1-R25 receiving points is also given. According to TS EN ISO 3382-1, the D50 values of the mosque are below the optimum limit value in S1 and S2 sources for 250 Hz, all other data are among the reference data.

In the measurements made in the study, T30 values, which are high at low frequencies, were obtained at low levels at medium and high frequencies, due to the high differences in sound absorption coefficient values in octave band frequency ranges on carpeted surfaces. The reverberation time (RT) of the mosque is in the acceptable range, especially at 500Hz and 1000Hz. EDT values are among reference values, reference values for 1000 Hz in C80 data, and slightly below the reference value for 500 Hz. D50 is below the optimum limit value in S1 and S2 sources for 250 Hz, all other data are among the reference values.
