A STRATEGIC POINT ON THE EASTERN ROMAN BORDER: ADİLCEVAZ CASTLE

Emine TOK*

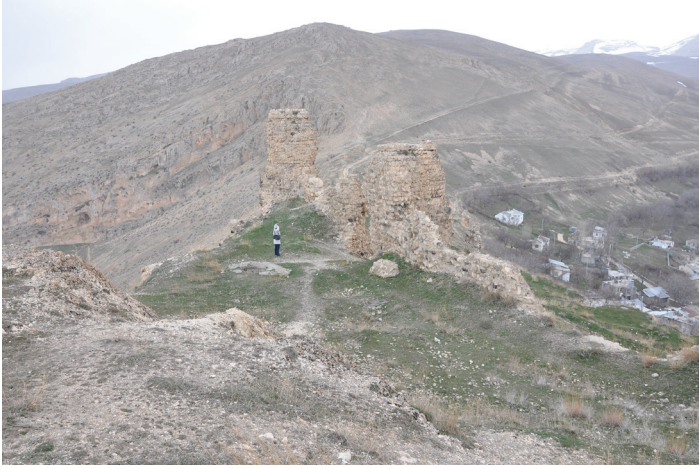
First, the area at the top of the hill should have been surrounded by a fortification. The fortification system of the citadel was adopted to the topography of the hill. Probably, the upper part of the cone-shaped hill was cut and a flat area was obtained; the walls were built on the edge of the steep slope. Thus, the steep slope, on the one hand, formed the foundation for the city walls, on the other hand, made the castle much safer in these sections. The general view of the acropolis walls is in the shape of an irregular triangle (see **PL.1**). Inside of the castle is filled with soil and rubble today. In places, illegal digging pits attract attention (**Fig. 4**).

Fig. 4: Citadel; view from interior. (Phase I)

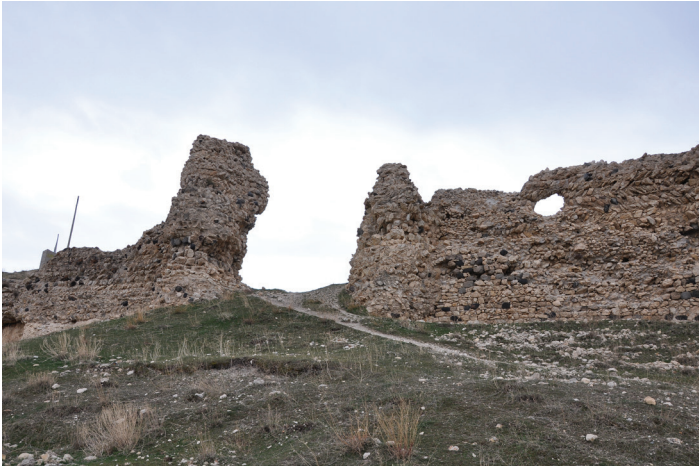
Fig. 5: The northern gate.

The northern gate is reinforced with two towers rising on either side of the entrance (**Fig.5**). They have survived to the present day but the upper sections have been demolished and the facade stones have been removed. The door has lost its original appearance. However, the remaining traces suggest that the entrance was in the form of an arched opening. Even so, no clear data on the shape of the arch survived. It is thought that this door was also probably in the form of a round-arched opening; because of the fact that the first fortified part of the hill is the inner castle and the entrance to the south is in the form of the round arch seen in the Roman and Byzantine periods.

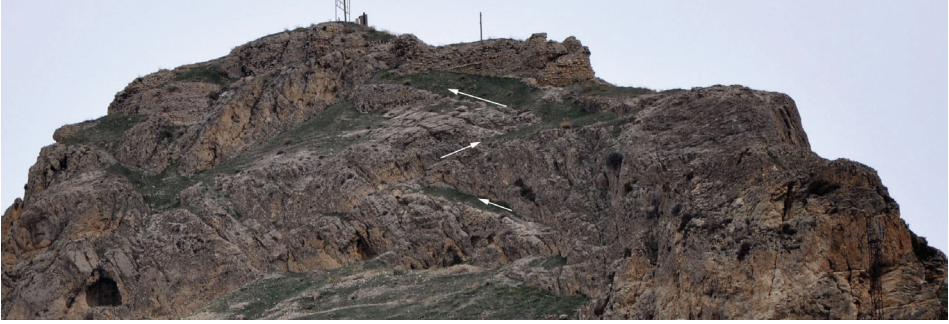
The first gate in the Southwest is destroyed today. In front of the gate, there is an earth road that runs westwards and then goes towards north. Probably, this road was an extension of the road network, which provided access to the castle in medieval times. Indeed the churches and monasteries, located about 5 km away to the Northwest, are located on this road network. The topography, sloping in an east-west direction in front of the gate, has been solved by building a ramp. Although the ramp system was partially destroyed over time, it still maintains data on its original appearance (**Fig. 8**). The width of the ramped road and the door are big enough to allow vehicles to enter or to exit. The door system is of overlay plan type. Gates of this type are planned by placing the walls on top of each other (**see PL.1**). This planning is known and applied in Anatolia since the Hittites.

Fig. 6: Ramp-shaped path along the steep slope.

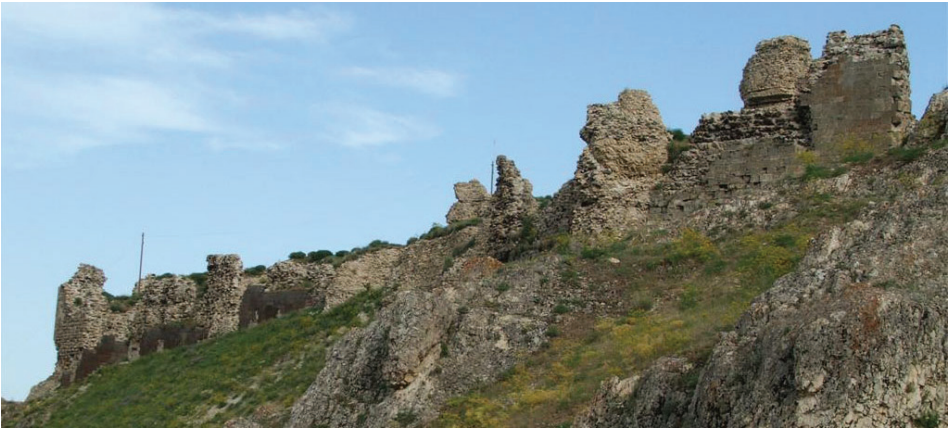
This system starts in front of the circular tower to the northeast of the citadel and continues to the north, then turn to west and go ahead till northwest. Here, there is a buttress built on bedrock. With a sharp turn to south from this section, the wall is attached on the inner castle. The system rises above natural rock in places, so the fortification line was determined by the topography. The second phase wall is supported by a total of six towers, five of which are circular in plan and two of which are rectangular (**Fig. 7**).

Fig. 7: The wall, adjacent to the north of the citadel (Phase II)

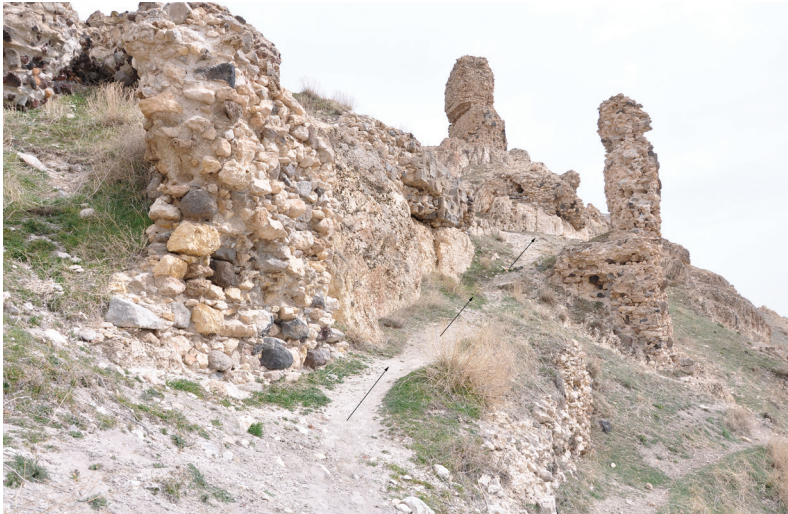
Fig. 8:
Gate in the
Southwest.

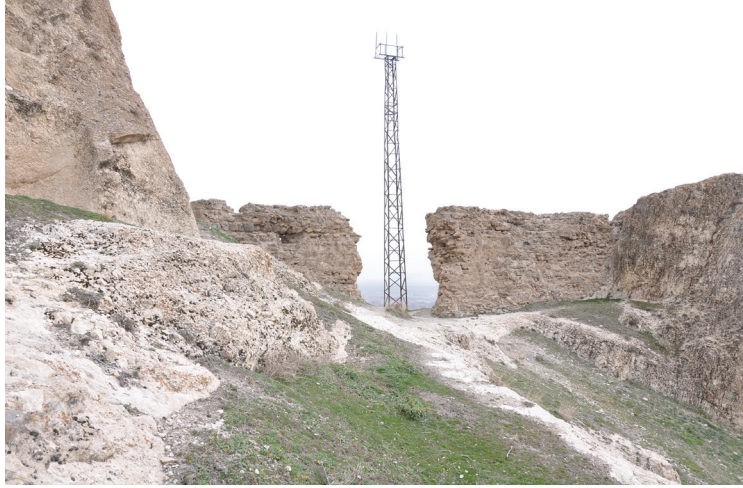
Fig. 13:

Traces of stairs inside the wall.

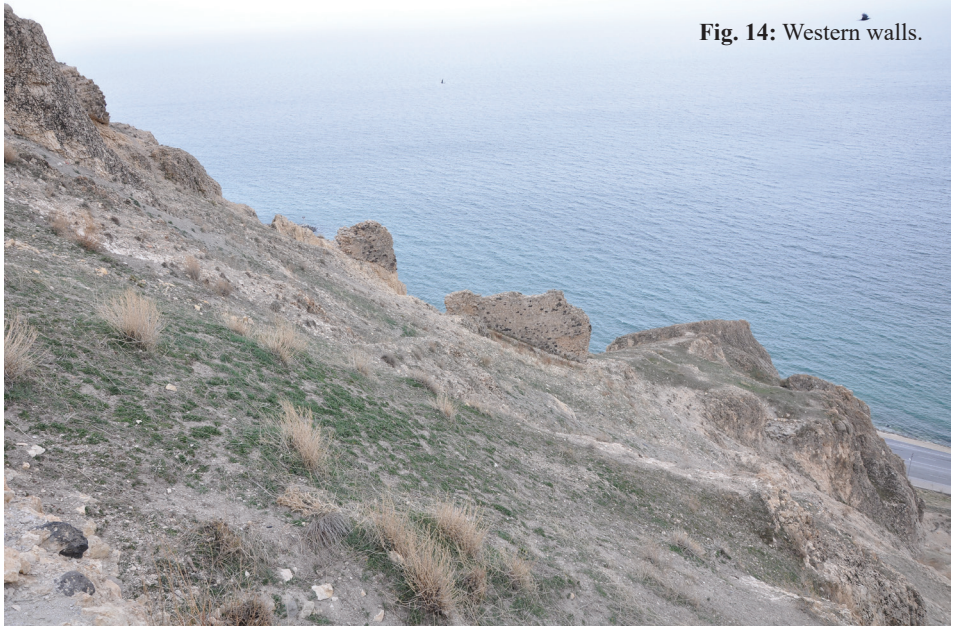
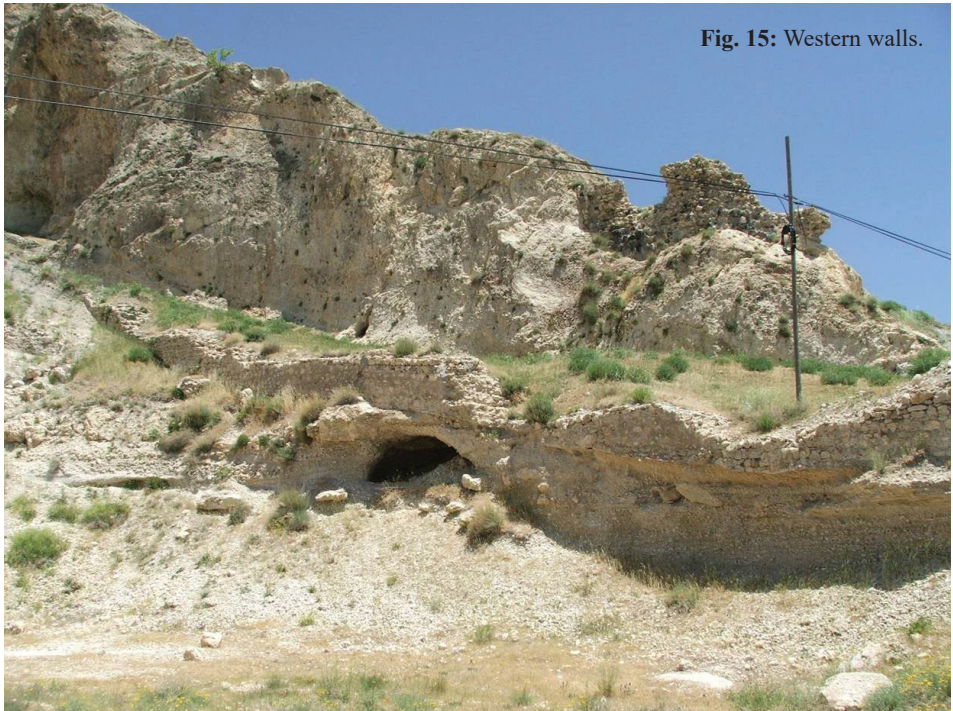
Just like the walls in the east, the wall extending from the west towards the lake was completely shaped by topography (**Fig. 14, 15**). In the higher elevation, walls in the west are preserved partially. Most parts are destroyed to the base level. It is thought that the original height of the walls was not much, because of the cliff. Indeed, it is almost impossible to attack rocky sections. Due to the advantages of topography, tower construction was not required. A rocky cliff disappears towards the lake. In this area, the wall was tried to be strengthened by building an embankment wall. Evliya Çelebi says that there was another entrance to the city from the west. However, due to the rise of the lake level and the subsequent constructions, no traces of the gate(s) (?) here has survived to present day.

Fig. 14: Western walls.

Fig. 15: Western walls.
