COĞRAFYA DERGİSİ
JOURNAL OF GEOGRAPHY
2022, (45)

Wetland Dynamics, Trends and Environmental Implications: Comparative Study in Bamenda II and III Municipalities, North West Region, Cameroon

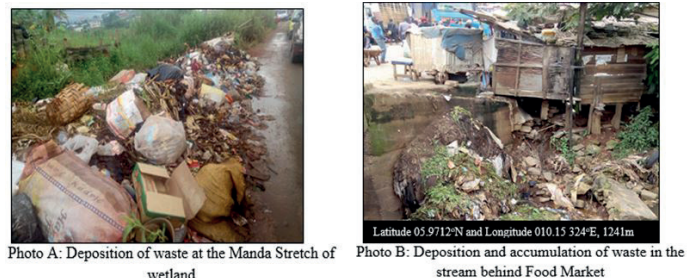
Photo A: Deposition of waste at the Manda Stretch of wetland
Photo B: Deposition and accumulation of waste in the stream behind Food Market

Figure 6: Pollution of wetlands in Bamenda II and III municipalities (Field Survey, 2020).

Photo A depicts household waste at the *Manda* wetland stretch directly opposite Fokou Supply, whereas B captures waste deposited into the stream behind Food Market in Bamenda II municipality. All these conspicuously depict this phenomenon in the study areas. Therefore, the deposition of waste on wetlands and into streams significantly pollutes the environment and streams in Bamenda II and III municipalities. This was witnessed within the localities of the study areas especially, with the case of individual household waste deposition into streams and wetlands in Mankon and Nkwen.

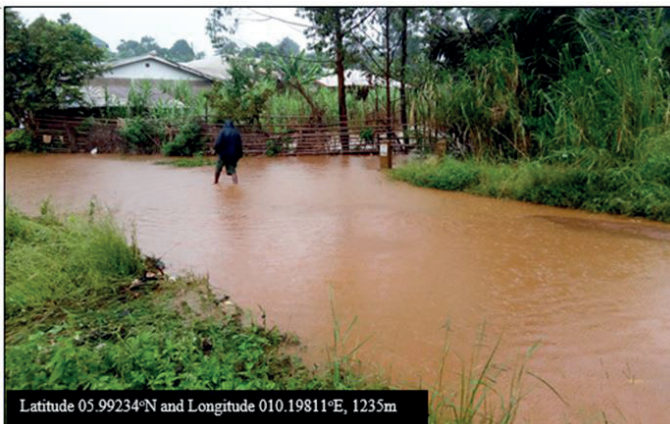
Photo 1: Flooding at Njengang, Bamenda III municipality (Field Survey, 2019).

The photo taken captures a flash flood event at the Futru-Njengang wetland stretch in the Bamenda III municipality in October 2019 with crops and road inundated. This wetland ecosystem has undergone severe transformation. Flooding has been a nomality in wetland areas, which is often experienced during the rainy season as an opportunity for wetlands to recharge and store more water to gradually release during the dry season. However, mutation has turned this into a recurrent disaster in these municipalities. Thus, the mutation of wetlands driven by housing construction and agricultural expansion exposed the population to floods in Bamenda II and III municipalities. This has been apparent with flash floods at Njengeng, Futru, Teken, Alahlie and Manda in Bamenda III municipality, and that of the Mulang in Bamenda II municipality, as well as prolonged floods at Lower Bayelle-Manda in Bamenda III municipality.

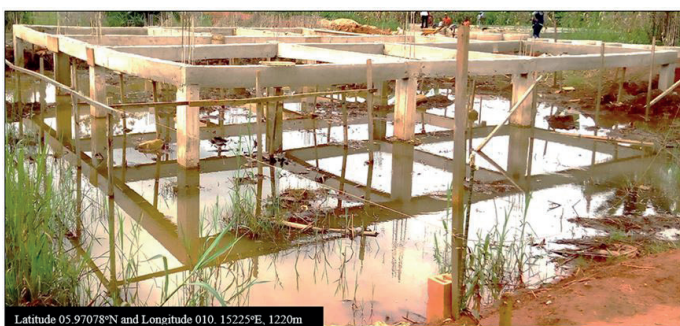
Photo 2: Raised foundation on wetlands at Mulang (Field Survey, 2020).

A greater portion of the population in and around the wetlands raise their foundations during construction as a means of adopting to the impacts of wetland encroachment, especially with regards to flooding (**Photo 2**).

This is a raised foundation within water on wetland at Mulang in Mankon Bamenda II municipality. This is a measure employed to adapt to the problems of wetland encroachment. This method was discovered to be rampant in wetland areas occupied by settlements and constructed business sites, which had their foundations raised to about 2 meters to guard against inundation. This is employed by wetland inhabitants in Bamenda II and III municipalities, and was observed more in the localities of Mankon and Nkwen where wetlands degradation is conspicuous. The population in the study areas also use rocks to construct foundations as a strategy to cope with the environmental implications of wetland degradation (**Photo 3**).

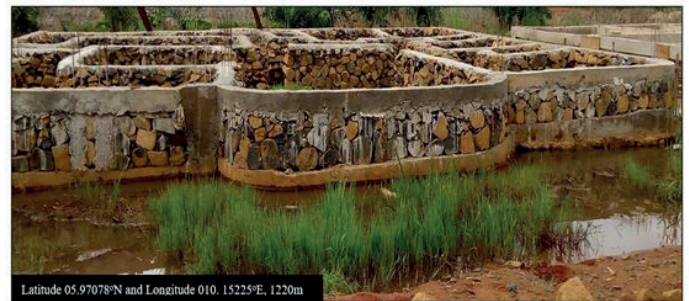
Photo 3: Rocks used for a foundation in the Mulang wetland (Field Survey, 2020).

Photo 3 shows a foundation made up of rocks at Mulang Street 7, behind house number 3 in the Bamenda II municipality. Construction in wetlands in Bamenda II and III municipalities often utilize these rocks due to their relative durability and resistance to weathering. This permits the foundations and other infrastructure on wetlands to have a degree of firmness, as acknowledged by the population in these municipalities. This mechanism is facilitated by the availability of these rocks in the study areas in Nteilah in Bamenda III and Mankon in Bamenda II municipalities. This is a central engineering method adopted on wetlands. Typically, lateritic soils were also brought into wetlands and allowed to be compacted naturally by rain before commencing construction activities. This completely changes the morphology and composition of wetlands in these areas. Most stream courses on wetlands in Bamenda II and III municipalities have also been mutated and straightened. The population in and around wetlands in Bamenda II and III municipalities also construct embankments as a coping mechanism to check water overflow and to prevent soil collapse as observed around infrastructure.

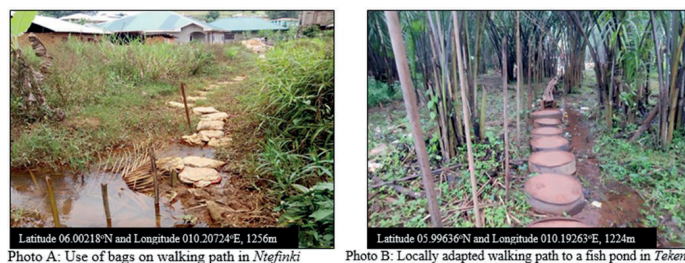
Figure 10: Adaptation strategies on wetlands in Bamenda II and III municipalities (Field Survey, 2020).

Photo A displays the use of bags as a foot path in Ntefinkiki in Bamenda III on wetland, and B is a locally adapted path to a fish pond in Teken, making use of tyres filled with soil, sticks and bamboo. Furthermore, non-native species of plants such as eucalyptus are used by the population of Bamenda II and III municipalities to absorb water and render the wetlands dry. This is especially as this plant has been noted for its high water demand and exotic nature in the environment. This is found from Mbelem to the east in Bamenda III, to Ntumbong to the west in Bamenda II municipality. These exotic species significantly absorb and release water to the atmosphere through transpiration. Thus, there exists varied local adaptation strategies to the environmental implications of wetland encroachment.

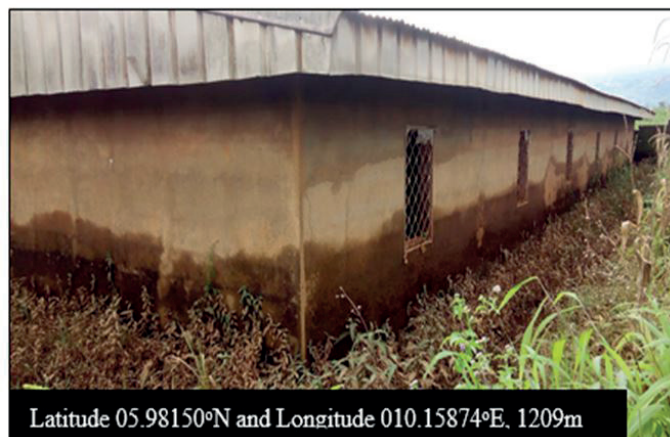
Photo 4: Abandoned structure on wetland at Mulang (Field Survey, 2020).

Thus, when the environmental impacts of wetland encroachment become overwhelming, the population resorts to abandonment. This happens when all adaptive measures have been exhausted, but the environmental impacts, especially flooding, keep aggravating. Local and regional authorities also resorted to prohibition of reclamation activities and non-provision of town planning acts to wetland inhabitants in the Bamenda II and III municipalities. Here, authorities displayed information prohibiting the reclamation of wetlands, carrying various ordinances and decrees and stating them out of bound for any encroachment as they are state public property. Added to this has been the non-provisions of town planning acts to the population on wetlands.
