The Investigation of University Buildings Environments with Regard to Turkish Standards on Accessibility: Gazi University Faculty of Education Buildings

This article was prepared from my ongoing M.S. Thesis “The Investigation of University Buildings and Their Environments in The Context Of Turkish Standards On Accessibility: Gazi University Faculty Of Education Buildings” (Gazi University Graduate School of Natural and Applied Sciences, Program of Architecture, M.S. Thesis) [15] and also same methods were used in the study.

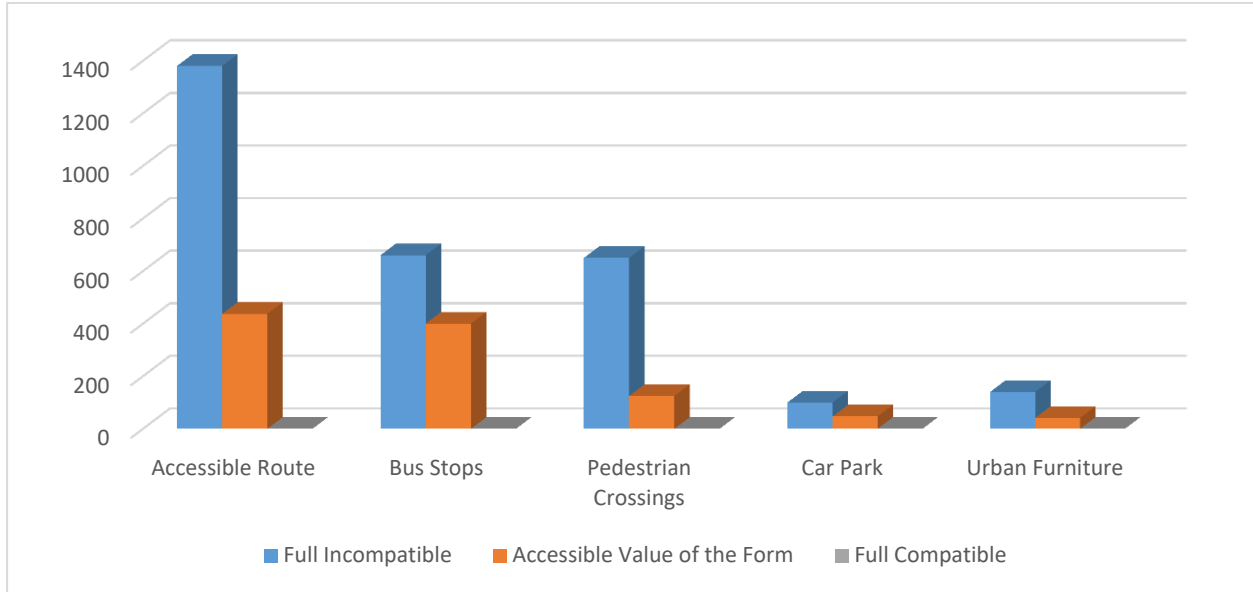
Graph 3. Evaluation of Accessible Value of the Forms

In Graph 3, the maximum incompatibility value to be obtained in case of incompatible answers to the questions in all the query forms (number of questions * 5) was determined, the maximum compatibility value was determined if it was completely compatible (number of questions * 0) and the current accessibility values in the query forms were shown comparatively. As can be seen in the graph, Bus Stops and Car Park are the most problematic areas regarding accessibility.

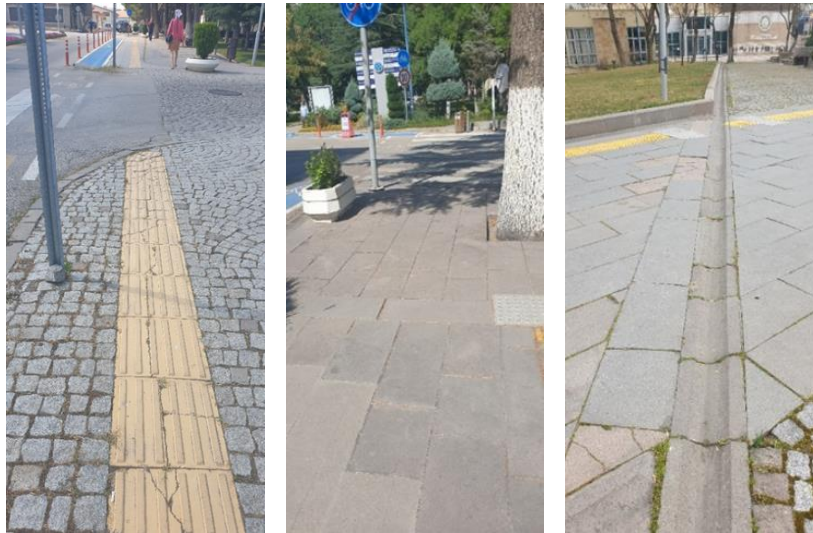
Figure 3. Accessible Routes (Photograph: Gamze MIZRAK, July 2021)

It is seen that accessibility is highly provided on the accessible route from Gate A to the main entrance of the building. However, it has been determined that the pavement materials of some garden paths are not one-piece, smooth and evenly inclined. When evaluated from the bus stops to the main entrance of the building, it is seen that there is no 150*150 cm area at the beginning and end of some of the ramps, sidewalk paving stones are not smooth and evenly inclined, and some obstacles on the route such as plants, trees and poles are not taken into the safety lane correctly.

- About the problems observed about Accessible Routes; Floor and pavement surfaces along accessible routes must be hard, stable, durable and non-slip (wet & dry). (TS 9111 Article 4.3.5) External stairs must be covered from atmospherically conditions. If the width of the stairs is more than 300 cm, a railing should be made in the middle. (TS 9111 Article 4.7.1.3.3) There should be a warning surface at the beginning and end of the ladder. A protective non-slip strip with a width of 2.5 cm should be placed at the end of the step. There shouldn't be protrusions at the ends of the steps. The diameter of the handrail must be 32-40 mm. It should contain information in Braille alphabet. (TS 12576 Article 5.3) Two levels of 70 cm and 90 cm high handrails must be built on the railing on the ramps. (TS 9111 Article 4.4.3.2) At the beginning and end of the ramps, there should be an area of at least 150 x 150 cm. (TS 12576 Article 5.2.1) There should not be advertising and information signs that would restrict freedom in the corners of the pedestrian sidewalks. (TS 12576 Article 5.1.7.3) Pedestrian sidewalks and curbstones should be different color and texture. (TS 12576 Article 5.1.7.2)

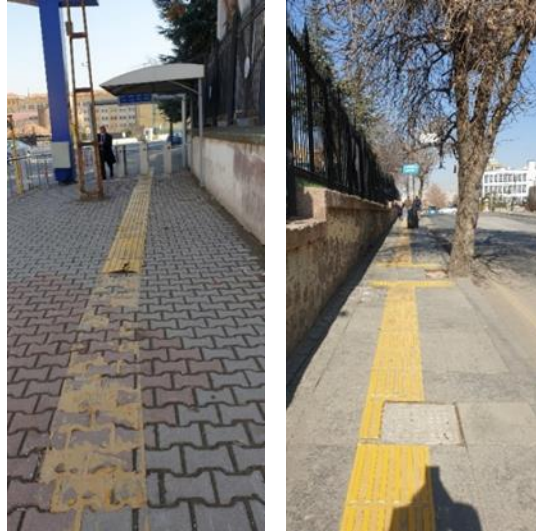
Figure 4. Accessible Routes (Photograph: Gamze MIZRAK, February 2021)

The guide track route is interrupted by moving and fixed obstacles and manholes. Pedestrian sidewalks and curbstones are not easily distinguished because it is the same color and texture.

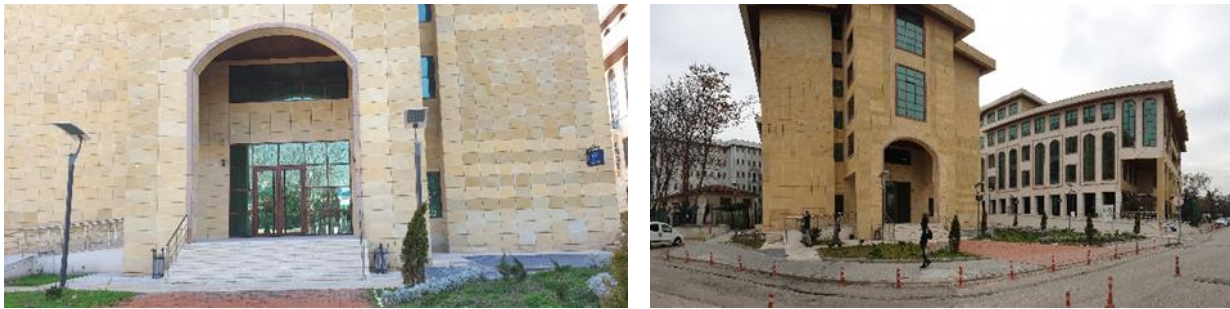
Figure 5. Accessible Routes (Photograph: Gamze MIZRAK, July 2021)

When the accessible route from bus stops in the direction of gate E to the building rear entrance doors was examined, it was determined that the building rear entrance staircase wasn't covered from atmospheric conditions and there were protrusions at the ends of the steps. There were no non-slip tape strips, and there was no surface for the visually impaired at the beginning and end of the stairs. It is seen that the diameter and height of the handrail are not suitable, and although the width of the stairs is more than 300 cm wide, no railing is made in the middle.

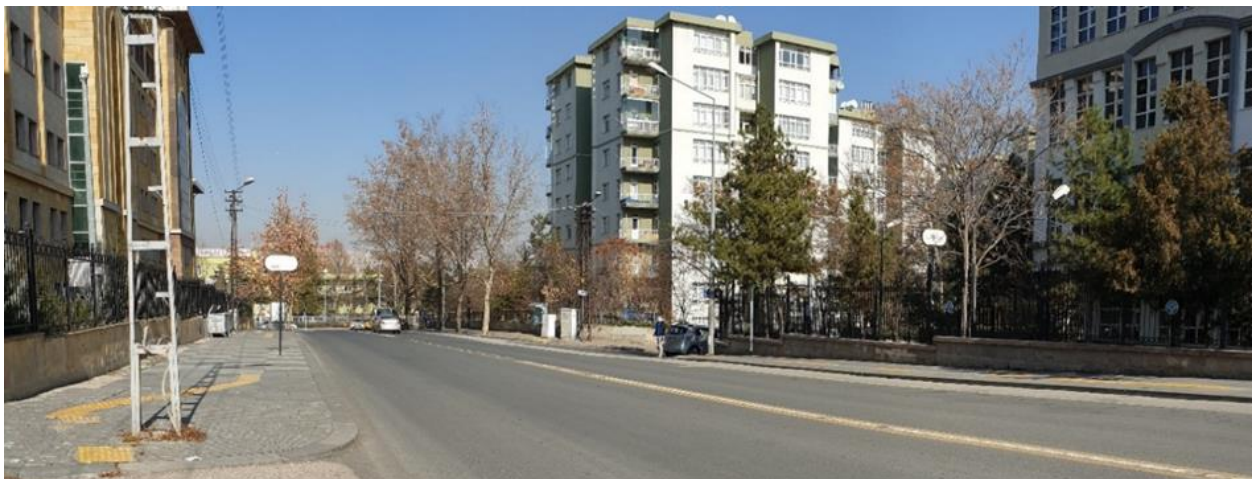
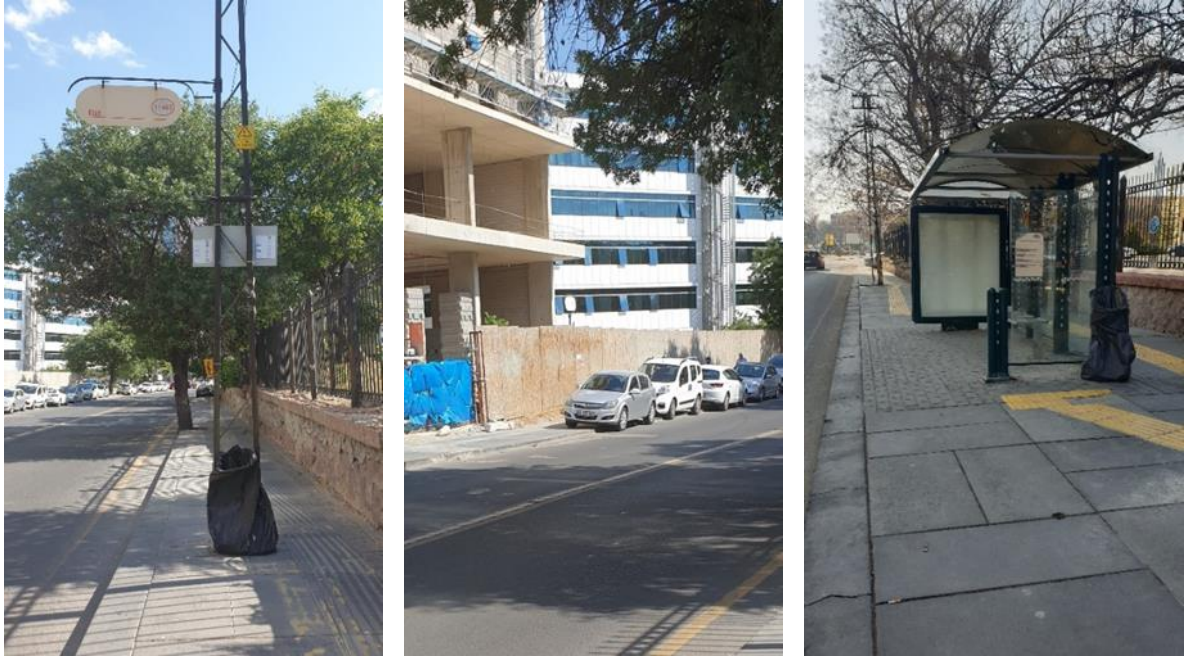
Figure 6. Bus Stops (Photograph: Gamze MIZRAK, July 2021)

Most of the bus stops which close to the campus entrance gates are not adequately arranged. Except the bus stop in front of Gate A, there are not adequate markings and information signs at the other stops. There are no arrangements with covered and sitting benches to protect people from the weather conditions at bus stops except the bus stops in front of Gate A. Except for the bus stop in front of Gate A, the widths of the pavements are inadequacy according to the Standards. In addition, at the bus stops there aren't any warning signs about no parking.

- About the problems observed about Bus Stops; there should be an organized bus stop which protected against the atmospherically conditions. There must be a bench at 41-46 cm. height and there should be a back resting above 45 cm. behind the bench. The width of pavements near the bus stops must be at least 300 cm. There should be information signage and adequate markings at the bus stops. At 100 cm. and 140 cm. level there should be a 15 cm. thickness retro reflective warning tape. At all bus stops there must be no parking warning signs.

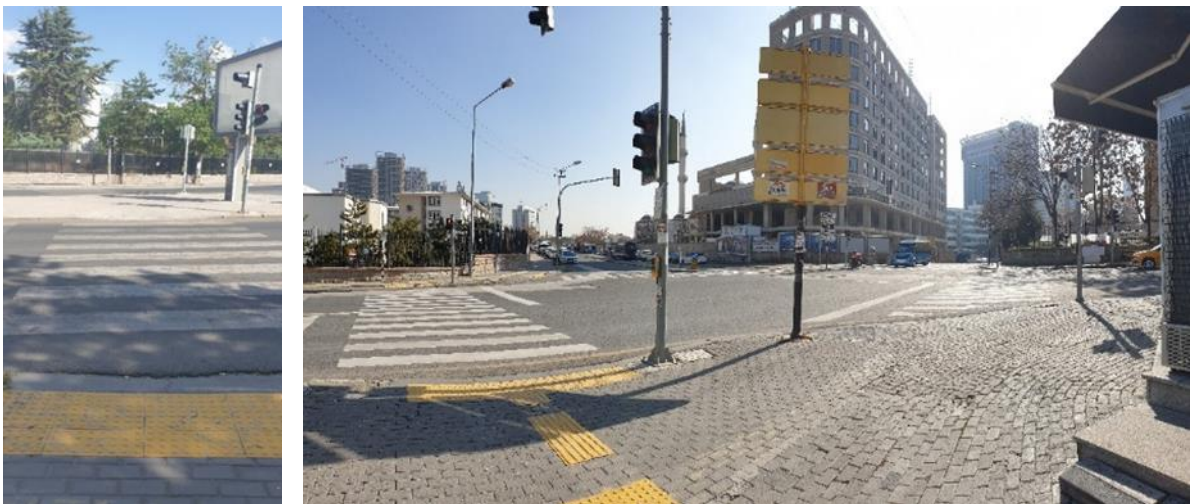
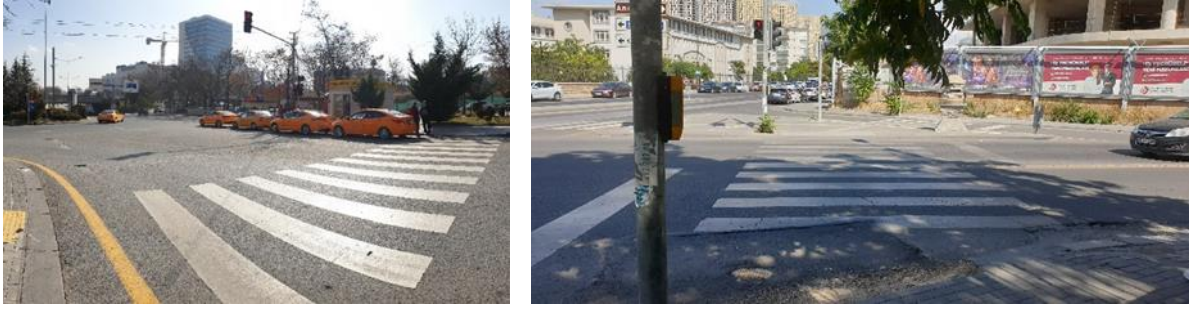
Figure 7. Pedestrian Crossings (Photograph: Gamze MIZRAK, July 2021)

Pedestrian crossings provide highly accessibility with their widths, markings and materials. It has been determined that some pavements and tactile ground surface indicators are damaged on the sidewalks reaching some pedestrian crossings. And also, tactile ground surface indicators which indicate the transition to the pedestrian crossing are missing. There are also no special lightings to make it easier to spot pedestrian crossings.

- About the problems observed about Pedestrian Crossings; there should be distinctly brighter from road lighting and lit from above. (TS 12576 Article 5.4.1.4) There must be three-sided curb ramps between the pavements and pedestrian crossings. (TS 9111 Article 4.11.1.3) At the start of the ramp, there must be a tactile ground surface indicator at least 60 cm. wide. (TS 9111 Article 4.4.3)

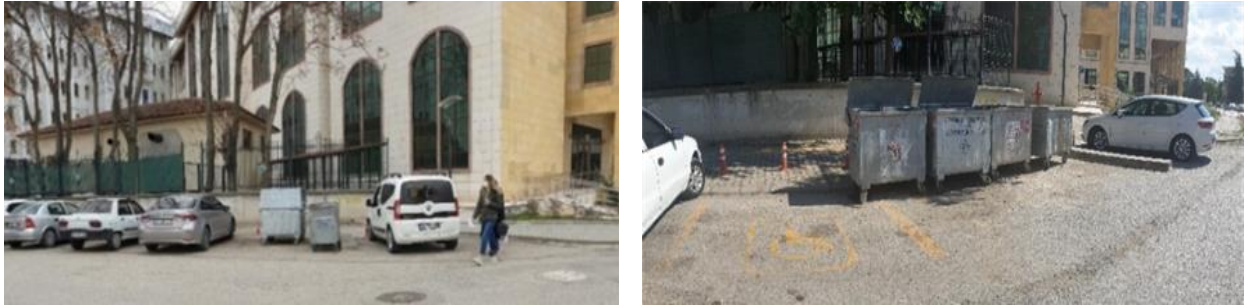
Figure 8. Car Parks (Photograph: Gamze MIZRAK, March 2021)

In the outdoor car park area which close to the building entrance, 5 disabled parking spaces are arranged by marking on the ground. However, there aren't any maneuvering areas at 150*600 cm. dimensions between the parking spaces. In addition, the night lighting of the car park is not adequate and there are no curbs on the sidewalk. There isn't any accessible route for the disabled from car park to the selected buildings entrances covered from weather conditions. There is also no directing sign for disabled parking. It is seen that the garbage containers are placed on the disabled parking area and there is no marked disabled car park in the parking garage.

- About the problems observed about Car Park; night lighting of the Car Park should be sufficient. (TS 9111 Article 4.4.1) Between the car parks there must be at least 150*600 cm. maneuvering areas. (TS 12576 Article 5.7.4) There must be curb ramps between loading zone and pavement. (TS 9111 Article 4.4) There should be directing sign for disabled parking. (TS 9111 Article 4.4.1)
