Research Article

Assessing the efficiency of drinking water treatment plant and the impact of broken distribution systems on water quality of Wukari-Ibi plant

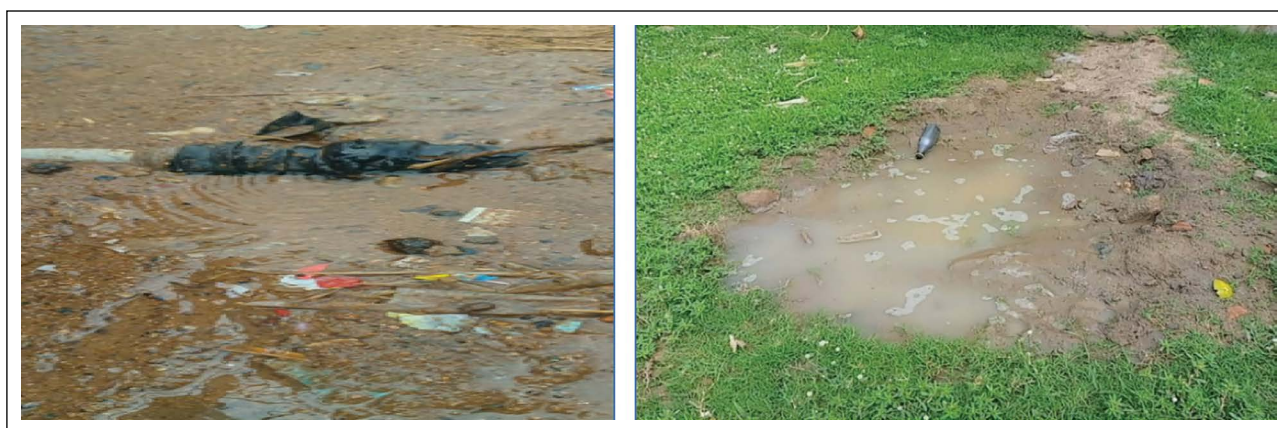
**Figure 2.** Broken pipes indicating potential contamination pathways within the city.

ly impact vulnerable children, elderly people and visitors who have not been exposed to such level of contaminants. The difference may likely be due to broken pipes (Fig. 2) at various point in the distribution system. The findings of the study corroborate with findings from [19] which indicates that leakages from pipes can severely impact water quality.

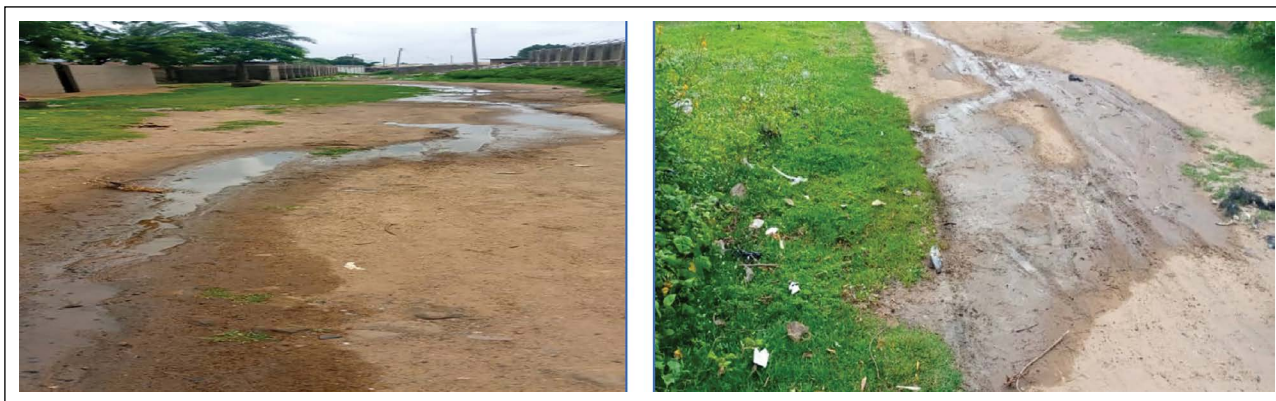
Figure 5. Water loss during pumping due to broken pipes within the city.

Historically, the provision of piped water within homes have been associated with improve sanitation and hygiene and a significant decrease in water related diseases [19, 20]. However, with continuous stress, poor maintenance and ageing of water infrastructure, water distribution systems are likely to become vulnerable to contamination. The loss of water along the distribution system accounts for a substantial volume of water and energy annually, and although the water pipe system in the study area is not metered, and therefore water loss cannot be accounted for (Fig. 5), but however, the risk to water contami-

nation through these leaking pipes has been identified. Materials used in water distribution systems (including pipes) have different life span and therefore require monitoring to ensure that they do not deteriorate to the point that they pose severe risk to the quality of water that is being distributed [19].

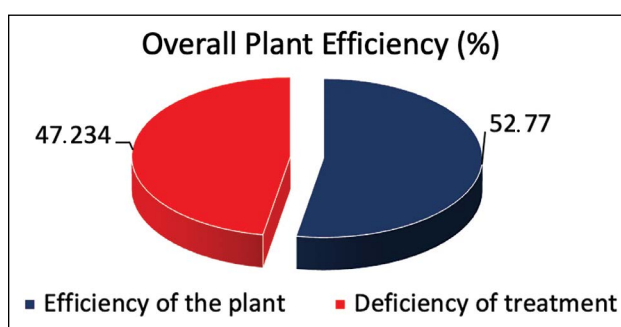
Figure 6. Overall treatment plant efficiency and deficiency (%).

The RE was computed and tabulated in Table 5. The computation indicates that colour had a removal efficiency of 74.69%, turbidity (66.57%), TDS (32.58%), total hardness (30.11%), and coliform form count (59.88%). The study result is in conformity to findings from [10, 11, 13]. This suggests that the treatment plant is indeed removing the

contaminants but however not to the desired level. For instance, in a study by [27], the removal of colour should be at least around 86% to ensure water is aesthetically acceptable by most consumers. This however indicates that all though colour in our study was removed to conform to drinking water standards, the RE was not adequate.

This can be seen in our study results indicating colour with mean value of 13.7 TCU at a RE of 74.7%. A further increase in RE to the minimum 80% suggested by [27] will likely decrease colour to under 12TCU. Similarly, the removal of turbidity at 66.6% was not sufficient to reduce turbidity to conform to drinking water standard. More so, findings from [28] suggests a RE of over 90% to adequately reduce turbidity which will increase the removal of bacterial contaminants. Total hardness and TDS having a low RE indicating failure of the plant in effectively removing contaminants. Ineffective removal efficiency of dissolved solids can suggest poor removal of metals and other chemical contaminants in water. Consequently, there was a low RE of biological contaminants which also suggest risk to public health particularly because coliform count was significantly greater than the stipulated drinking water standards. The treatment plant showed an overall efficiency of 52.77% (Fig. 6) which is not sufficient especially to service two local government areas with large scale agricultural activities. The study outcome therefore suggests the need to assess each stage of the treatment plant process to understand how each stage performs.
