Urban Renewal: Examination of a building in Beykoz, Istanbul

Muhammed Fatih YENTİMUR¹, Emin Burak KÖSE²

^{1,2} Recep Tayyip Erdogan University, Department of Civil Engineering, Rize, Turkey.
Responsible Author email: muhammedfatih.yentimur@erdogan.edu.tr

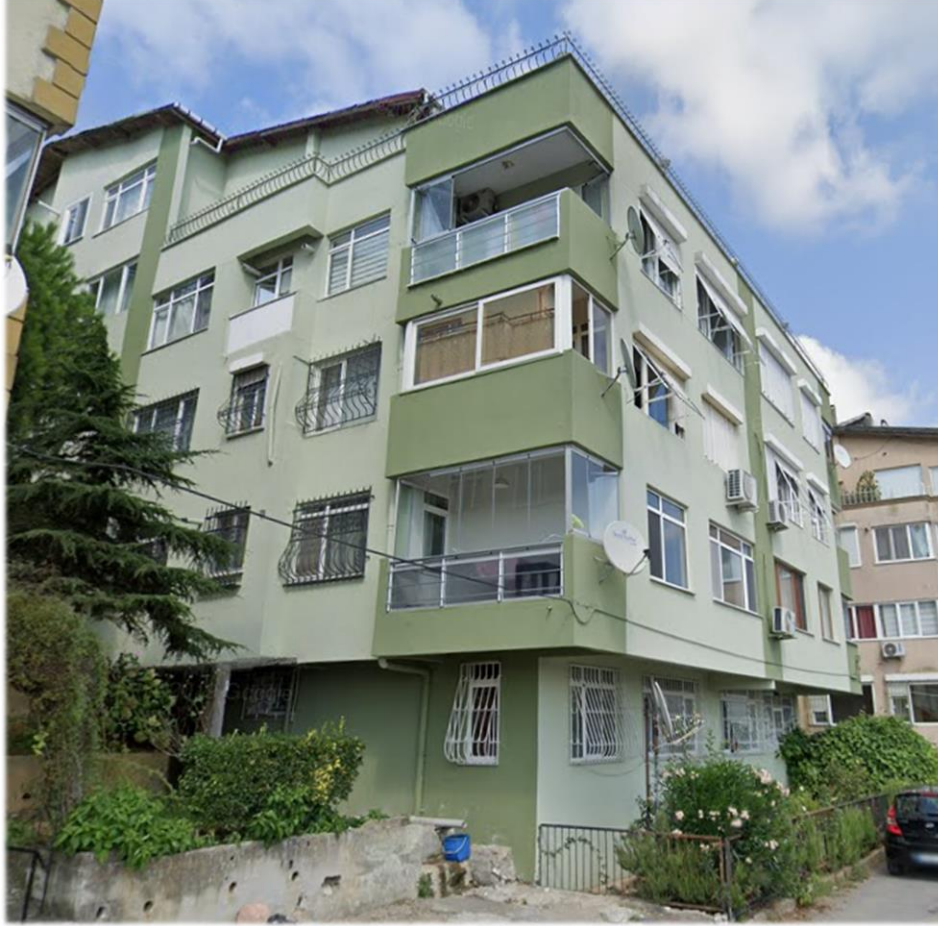
Fig 1.1

that have completed their lifetime, and protecting people from the negative effects of natural disasters are among the main goals of urban transformation. The urban transformation processes of the building located in Yaşar Alboran Çıkmaızı No:4 Kanlıca / Beykoz / Istanbul will be discussed and examined.

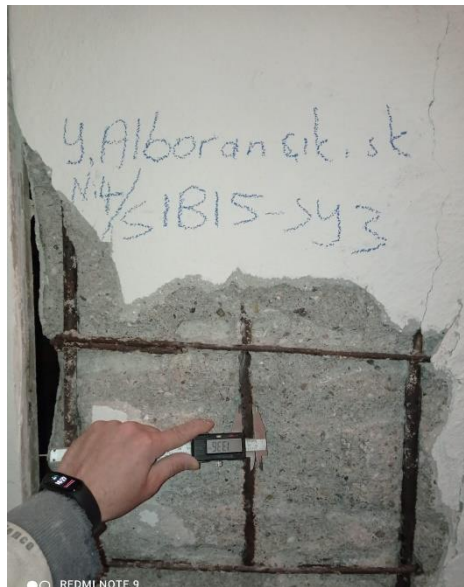
Fig 2.1

Column stripping was performed in the study floors, and the reinforcement diameters were determined.

The yield strength of the existing reinforcement will be determined depending on the type of reinforcement. As a result of the stripping process, the carriers with corrosion in the reinforcement and the decrease in the diameter of the reinforcement due to corrosion will be determined. The average diameter reduction amount of the reinforcement found by stripping is calculated separately for the floors whose survey is taken.

Tables were created with the data obtained from the laboratory results of the building located in Beykoz, Yaşar Alboran Çıkmazı street. For example, 8ø14 longitudinal reinforcements and 24ø8 stirrup reinforcements of our column named S1B15 are written in the tables. The amount of corrosion was calculated as 5%. As a result of corrosion, the diameter of our longitudinal reinforcement was 13.36, and the diameter of our stirrup reinforcement was 7.67. The stripping table of the 1st basement floor is given in Table 2.2.

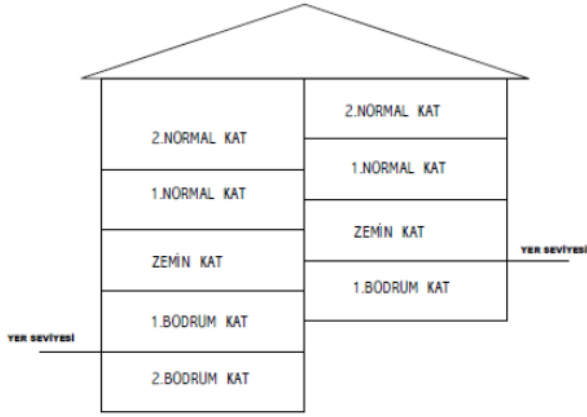
Fig 2.8

Figure 2.8 is the schematic view of the structure in the X-Y plane.
