Forgiving Road Design and Improvement of Accident Black Spots: A Case Study for Düzce City

Case Study: Düzce Example

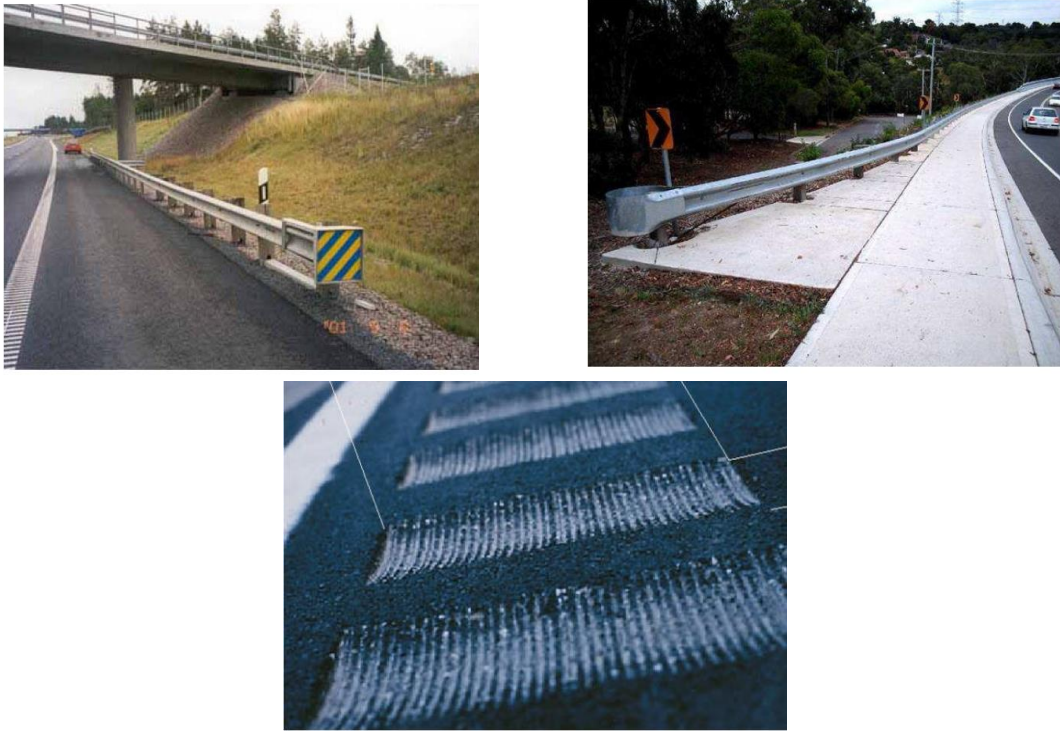
Some road safety elements and their contribution to road safety can be briefly examined as follows. Shoulder rumble strips are road safety structures that warn drivers against straying off the road or drifting into other driving lanes and have both a perceivable vibration and an audible warning feature. These are designed against the possibility of careless drivers causing an accident (Thomson et al., 2006b). Energy-absorbing mechanisms are needed in the areas where the guardrails end to prevent fatal accidents and dangers caused by highway guardrails. For example, absorber mechanisms (Atahan, 2003) and the outer shoulder width allow faulty drivers to correct their trajectory without going off the road. On the other hand, it has been observed that the coated shoulder is safer than the uncoated one. In addition, the improved shoulder design effectively reduces reverse crashes (Figure 2) (Armour and McLean, 1983; Zegeer et al., 1992; Zegeer et al., 1994; Karaşahin and Bağırğan, 2007).

Figure 2. a) Tangent terminal (Thomson et al., 2006b), b) flared terminal of guardrail (La Torre, 2012), c) typical shoulder rumble strip (Thomson et al., 2006b).

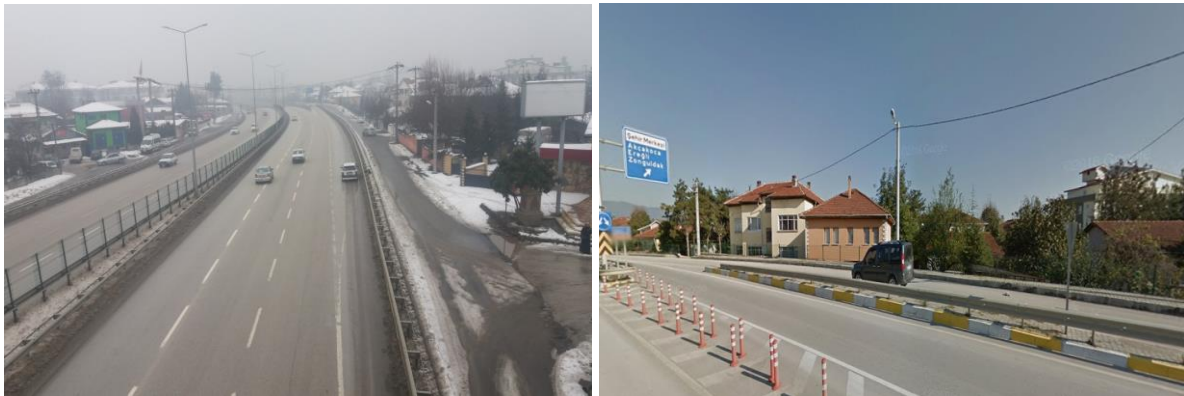
On the D100 Highway, the lane width is 3.5 m, and the outer shoulder width is 2.5 m. In the direction of Istanbul, there is a transition zone towards Zonguldak at point 3, as seen in Figure 3, while the vehicle is in motion. While the outer shoulder serves as 2.5 m before reaching zone 3 (zone 1), it reaches the width of the lane (3.5 m) in the transition zone (in zone 3); however, there is not enough

width in this area to fully ensure navigational safety. The shoulder width should be increased in the previous section, and the lane width should be regulated to 3.5 m before reaching the transition zone. In addition, at this point, the fact that the region close to the transition zone (zone 2) is the beginning of the horizontal curve causes some problems. In this part of the road, the lane direction and guardrail directions were constructed in accordance with the horizontal curve direction. However, the construction of the guardrail in the transition zone in accordance with the horizontal curve causes the vehicle to be disturbed by the guardrail during the passage (zone 3). In this section, the driver may experience discomfort with the psychology of entering a narrow area directly from a wide area. Figure 4 and Figure 5 show the view of the road.

Figure 4. a) The course of the highway in the direction of Hendek, b) Transition zone.

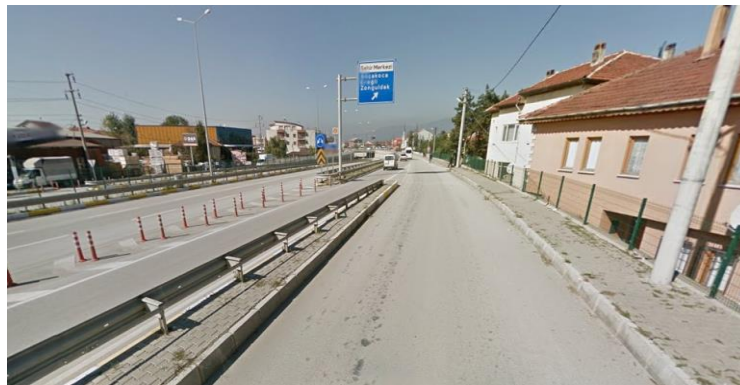
On the other hand, centrifugal force acts on the vehicles in the horizontal curve. Sudden maneuvers of vehicles under the influence of centrifugal force towards the transition zone cause loss of control, thus reducing driving safety (Figure 5).

Figure 5. Side road connection.

The lane width in the transition zone should be reconsidered in accordance with the conditions to transform the specified accident black spot into forgiving road status. The fact that the highway section, which serves as an outer shoulder width of 2.5 m, has been transformed into a normal lane in the transition zone and serves vehicle traffic, causes the drivers to be extra careful and make an effort,

and the risk of accident. Continuing the application of additional shoulders to the lane at the transition point where the connection to the side road is made, even if it is minimal, will eliminate the risk of an accident.

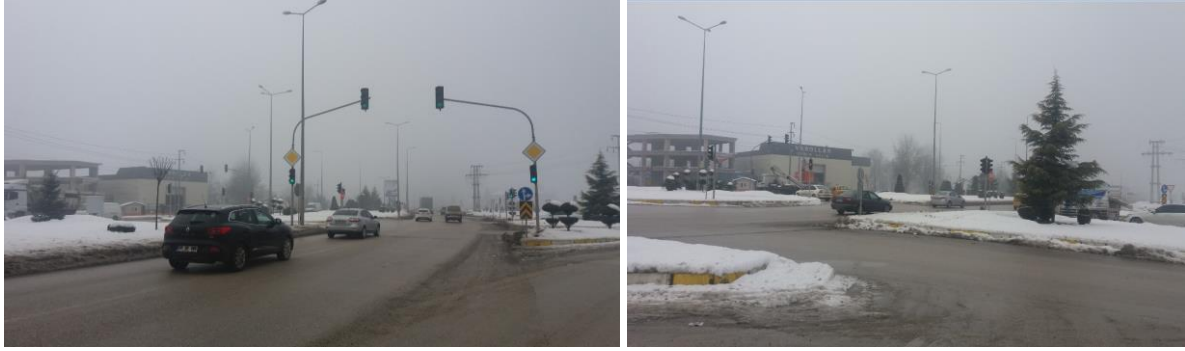
In the examination, it is seen that the intersection is four-legged. It has been determined that the necessary traffic signs for the vehicles that want to change their directions to the İstanbul-Bolu Road from other directions are not made at a sufficient level, and the vehicles are given the right of slow and controlled passing. In addition, there are obstacles originating from the landscape at the median that restricts the view of the vehicle drivers on the main road (Figure 6 (zone 1) and Figure 7).

Figure 7. a) View of the intersection, b) the tree that does not allow safe passage and obstructs the view.

Considering the plan view, both the traffic warning light and the tree that obstruct the driver's view should be removed from their location to ensure that the vehicles connecting to the main road from the north can pass slowly and carefully.

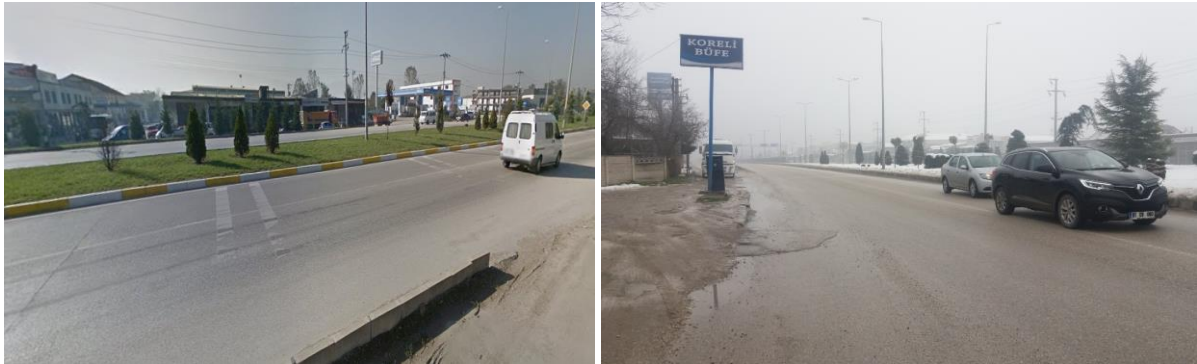
In addition, as a result of the examinations, it was determined that the road expanded and then narrowed just before the traffic warning lamps at the intersection while driving from Düzce to the direction of İstanbul (Figure 6 (zone 3)). The reason for this sudden expansion is due to the fact that there is a side road connection to the highway before the traffic warning lamps, and the road widens at that connection section (Figure 8). The road widening in the connection section narrows in the area where the traffic warning lamps are located. This causes the vehicles on the road to be disturbed by the vehicles connected to the road by the side road in certain areas.

Figure 8. a) Section with side road connection, b) the section where the highway narrows after the side road connection.

The section where the road suddenly widens needs to be improved. This improvement can be made, albeit partially, by shifting the area that connects to the main road from the side road further back. A warning sign should be placed to warn the vehicle drivers traveling on the main road for vehicles that can be connected from the side road in case this improvement does not be made (Figure 6 (zone 3)).

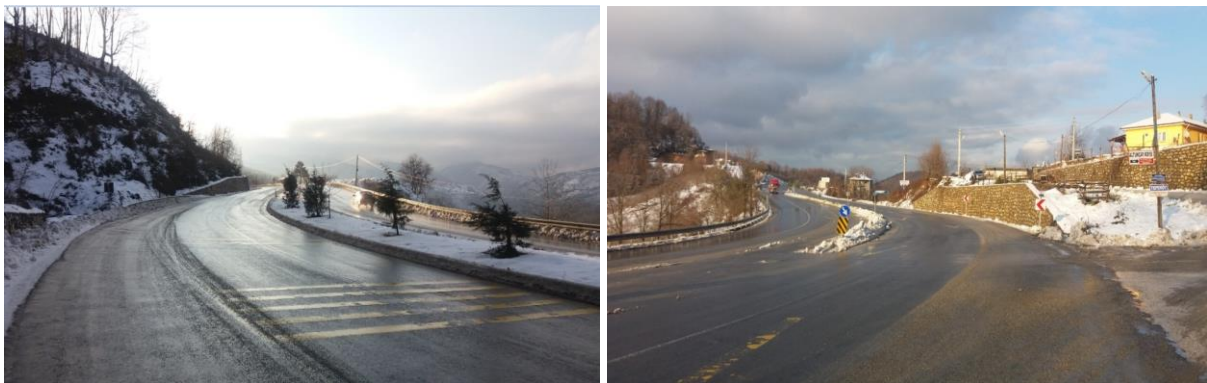
Figure 10. Direction of arrival to Tepeköy intersection (Düzce-Akçakoca direction), b) road section with vehicle passage.

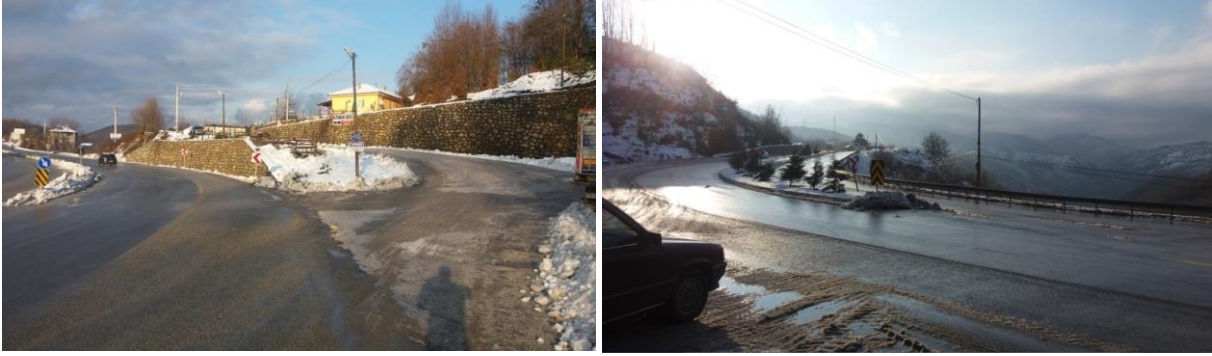
Figure 11. Rural road connecting to main road, b) the direction and form of connecting vehicles to the main road.
