Investigation of Static and Dynamic Analysis of Asynchronous Motors in the Cement Industry

Within the scope of this study, the dynamic analysis of the asynchronous motor with a stator voltage of 6300V operating under heavy load and drive in the Crusher-1 unit and the static analysis of the asynchronous motor of the Cement Mill-3 unit were examined and the areas for improvement were identified and the points where maintenance is required were determined.

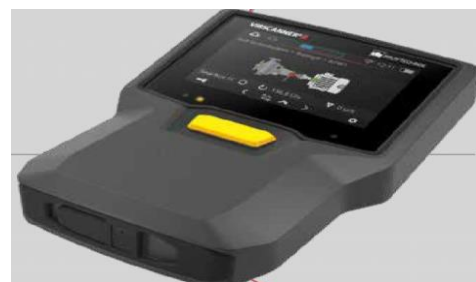
Figure 1. Vibration FFT Analyzer [16]

In the field study of vibration measurements in dynamic plants, a device with universal software that facilitates easier, more powerful condition monitoring by analyzing vibration signals and process variables by simultaneously measuring overall values, spectra, and time signals in 3 axes, depending on filter settings, with 3-channel route-free measurements with a sampling rate of up to 131 kHz per channel, was used as a data collector. The label data of the asynchronous motors to be measured will be defined for the device to be used and the work will be started after the measurement points are determined. Once collected, the data will be computerized for signal processing [16].

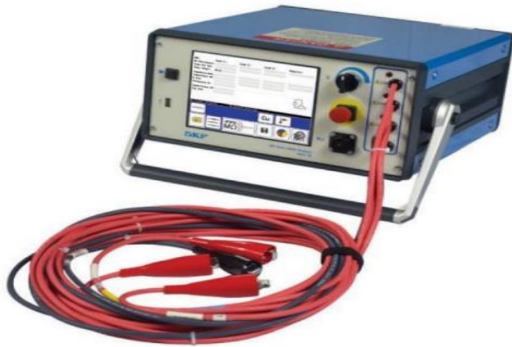
Figure 2. Static Motor Analyzer SKF Baker DX Series [17]

In static tests, insulation resistance, insulation conditions, and short circuit analysis of the windings of a motor are required to maximize the efficiency of asynchronous motors. In our field applications, a special device with easy portability, maximum test voltage between 4–40 kV, record storage capacity of approximately 400 coils, source current maximum of 600 mA, overcurrent error 1.2 mA, ease of data transfer by USB and universal software were used. After the asynchronous motors to be measured are de-energized and safety applications are completed, the operation will be run following that the

connections are made on the motor supply terminals. Once the data is collected, it will be transferred to a computer for signal processing [17].

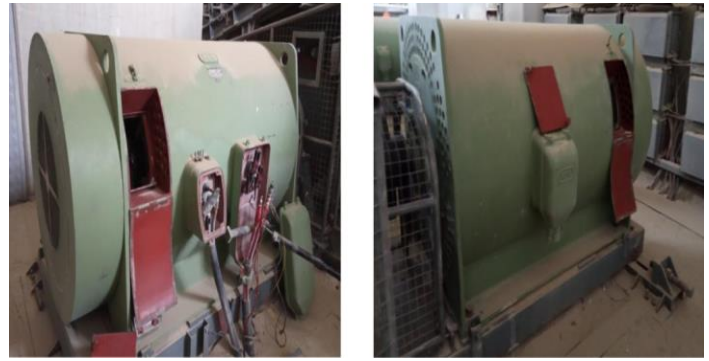
Figure 3. Crusher-1 Main Drive Motor General Field View

The crusher-1 main drive motor is an important piece of equipment belonging to the unit that crushes the raw materials coming to the factory. In order to operate the motor efficiently, electrical and mechanical maintenance work must be carried out in certain periods. The shape of the motor, from which the vibration data is collected, is horizontal and connected to the steel frame with foot bolts. The front and rear bearings of the induction motor consist of grease-lubricated ball bearings. It is connected to the system it drives by a belt-pulley system. Shim plates are evenly distributed on the motor legs for vibration control. The tag values of the motor are given in Table I.

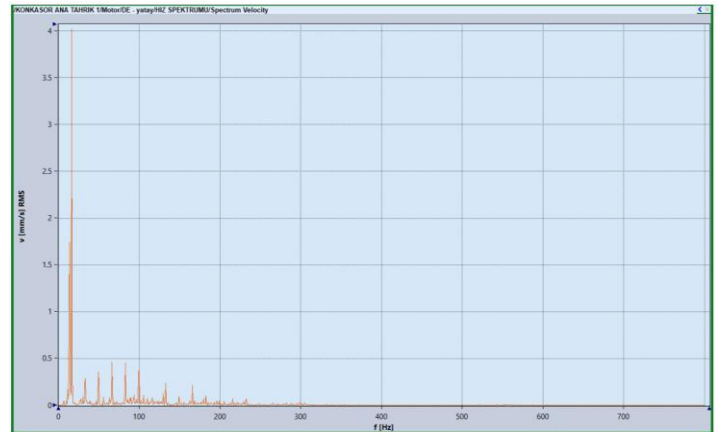
Figure 4. Crusher-1 Motor DE Horizontal Vibration Analysis

DE Horizontal measurement shows a dominant signal corresponding to 1X layer of the RPM. This signal can be characterized as unbalanced. Since the motor is integrated into the load with a belt-pulley system, the belt-pulley settings should be checked and recalibrated. Although it is observed as unbalanced in the 1X layer, other factors should also be examined. In the literature, the change in vibration values of 1X times over time is referred to as “light rotor rubbing”. For this reason, it would be useful to measure and check the bearing cover clearances. Other reasons to suspect friction failure are due to DE vertical and DE axial measurements. Light rubbing can be triggered by geometric misalignment problems (shaft misalignment due to thermal expansion), and specific load and temperature values.

During the vibration test performed on the Crusher-1 main drive motor, the vibration values of the motor are above the standards. It is observed that the dominant signals seen at the 1X layer are due to unbalance, with angular misalignment and slight rotor friction as side factors. When the vibration graphs are examined, it is seen that these signals are caused from the motor. The motor is connected to the load by a belt-pulley system. It is necessary to check the adjustment of the belt-pulley system to which it is connected with the load and to make a new adjustment. In addition, the graphs of the measured vibration values show harmonics in the bearing carrier covers, which means a gap.

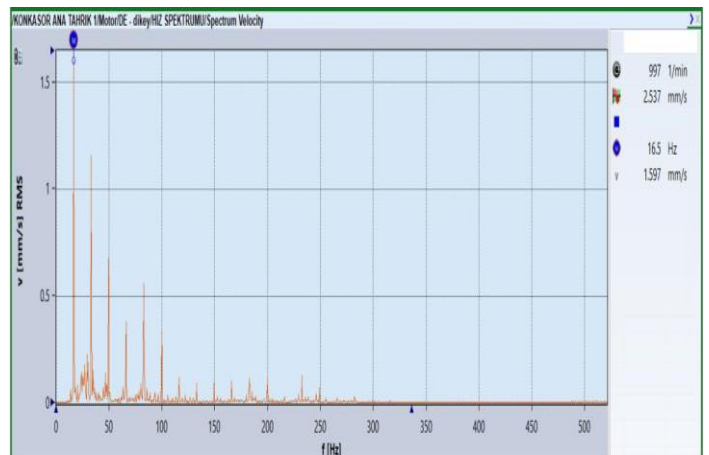
Figure 5. Crusher-1 Motor DE Vertical Vibration Analysis

DE vertical measurement shows high signals predominantly at the 1X layer and as a side factor at the 2X, and 3X layers. Bearing cover clearance needs to be checked and also balancing adjustments need to be made.

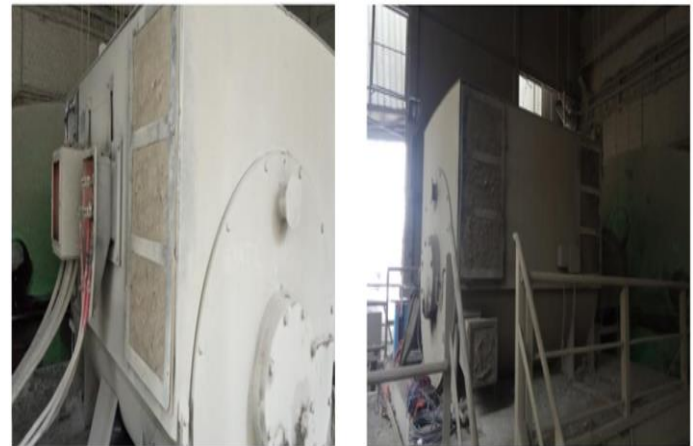
Figure 7. Cement Mill-3 Main Drive Motor General Field View

The main drive motor of the Cement Mill-3 is one of the most important main pieces of equipment of the unit where the grinding of cement is carried out. The shape of the motor is horizontal and connected to the steel frame with foot bolts. The front and rear bearings of the asynchronous motor consist of grease-lubricated ball bearings. The gearbox it drives is geared and connected by coupling. Shim plates are evenly distributed on the motor feet. The air filters are clean. The tag values of the motor are given in Table III.

After static tests and visual inspections of the main drive motor of Cement Mill-3, negative conditions were not found. There are no abrasion, ovality, and arc marks on the ring surface. The engine coals were pressed against the bracelet in a normal condition and there was no tooth loss. The distances between the pressures of the portables are measured at the correct level. The insulation resistance (IR value) and vibration values of the motor are in accordance with ISO standards.

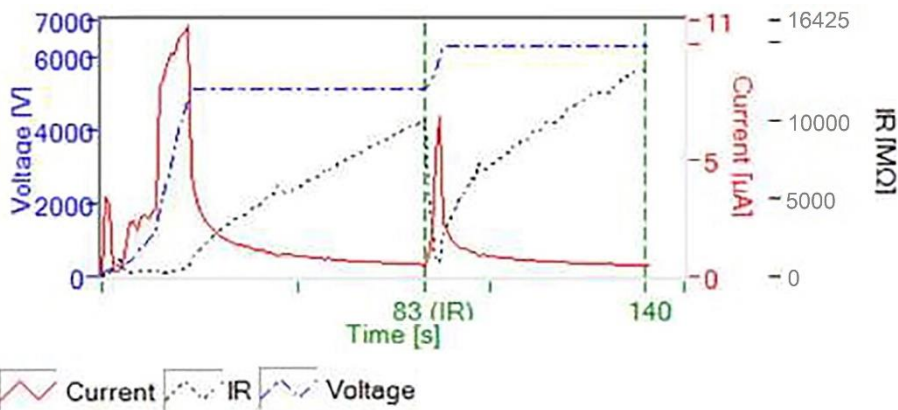
Figure 9. Stator DC Test Results

In Table VI, the stator HiPot measurement values are given. In Table VI, the insulation resistance (IR) on the stator was measured as 10119 MΩ and 13340 MΩ at 5120 V and 6310 V. Insulation is measured at a good level. Fig. 9 shows the DC test results of the stator. Where; IR is insulation resistance.

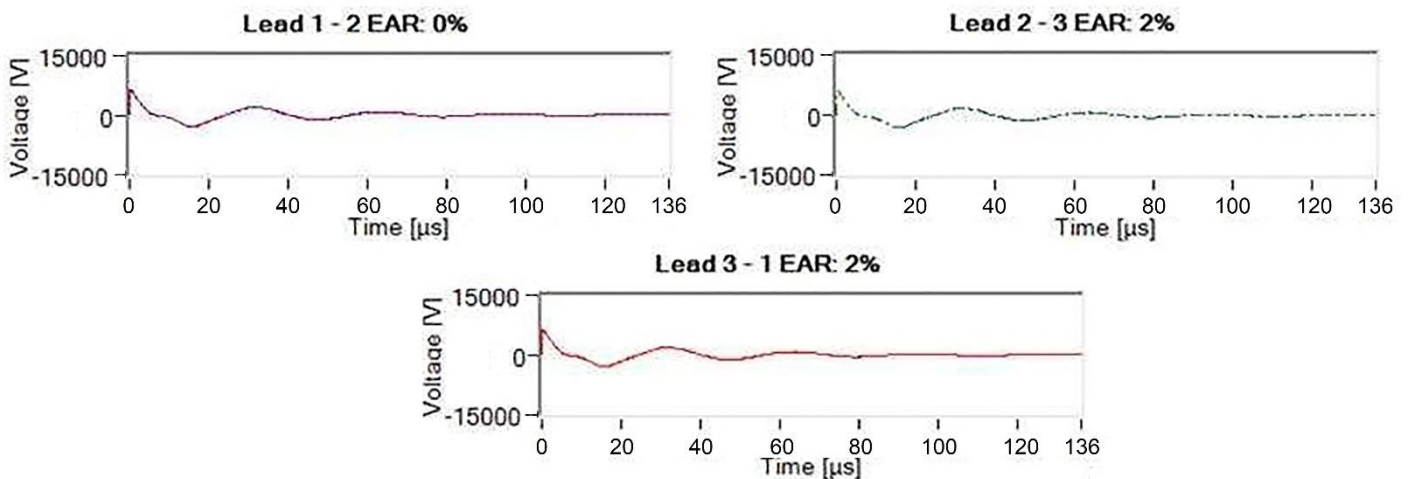
Figure 11. Stator Surge Test Graphics

In Table VIII, the stator surge test measurement values are given. Fig. 11 shows the surge test graphs of the stator. In Fig. 11, at a peak voltage of 6260 V between phases applied to the stator, the ripple waveform between phases is observed normally.
