The Effect of Different Heavy Overhang on Structural Performance in Reinforced Concrete Structures

There are many structural factors that affect the earthquake performance of buildings. Heavy overhang is one of these factors which are made to increase the storey area on the storeys above the ground storey. Within the scope of this study, the effect of different heavy overhangs on the earthquake performance of the building was investigated, which are commonly used in reinforced-concrete (RC) structures. A sample RC building with no heavy overhangs was chosen as the reference building model for numerical analysis. The numerical analyses were carried out for a total of 16 structural models designed by adding heavy overhangs of different lengths to different facades of the reference building model. The obtained results were compared with the results of the reference structure model without heavy overhang to reveal the heavy overhang effect. The period, base shear force, displacement, and performance levels were obtained for each structural model. It has been determined that the base shear force, period, and total mass increase with the increase of heavy overhangs, while the earthquake

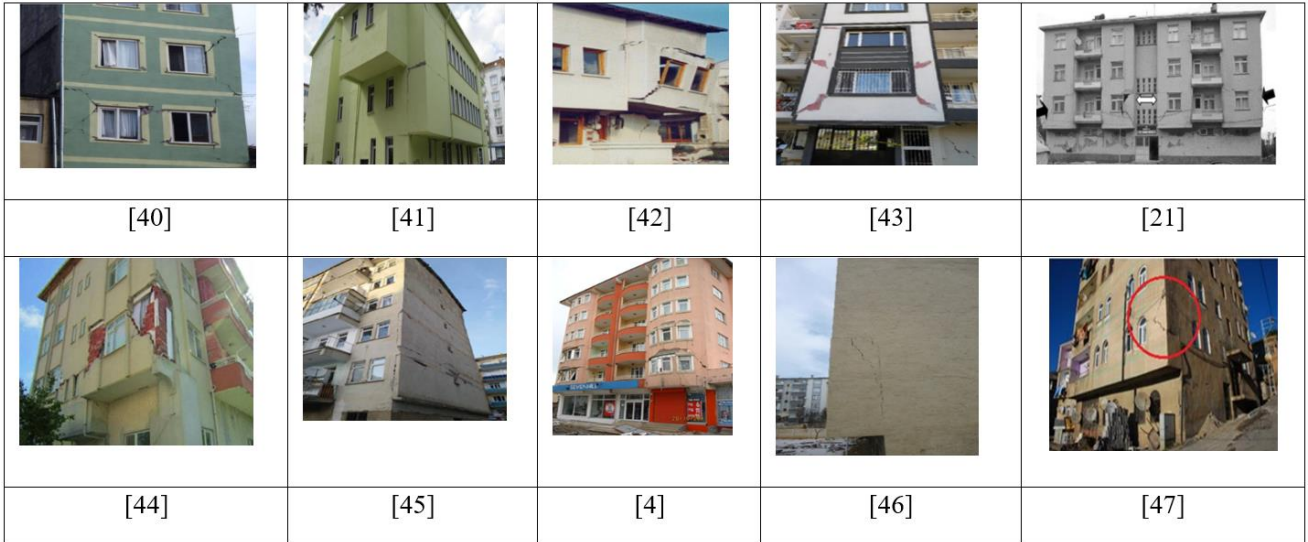
In heavy overhangs, the presence of beams negatively affects the aesthetic appearance, and due to architectural needs, beams are often not built in areas with closed overhangs, resulting in a lack of connection between column and beam. Since beam deficiencies cause frame discontinuity, the load transfer mechanism between column and beam is adversely affected [26], [37]. It has been stated by the researchers that especially the closed overhangs made on one side increase the distance between the centre of gravity and stiffness of the structure, and that the increase in weight affects the earthquake behaviour of the structure [21]. It has been understood that buildings with heavy closed overhangs are more damaged during earthquakes than buildings that are regular along the height [38], [39]. In buildings with heavy overhangs, these parts are damaged after earthquakes. Some of the damages caused by heavy overhangs in different earthquakes are shown in Figure 5.

Figure 5. Damages observed in heavy overhangs after different earthquakes in Türkiye

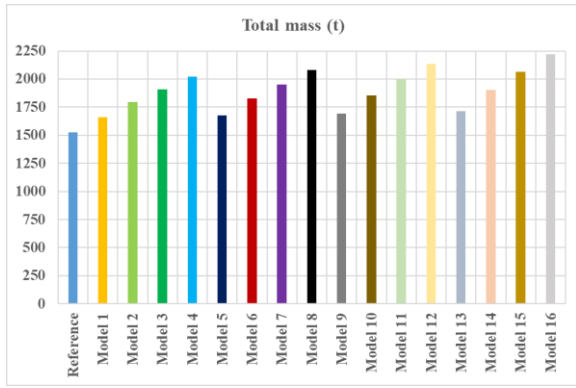
Figure 8 shows a comparison of the total mass values that were found for all of the structural models that were looked at as part of the study.

Figure 8. Total mass values obtained for structural models

- As more heavy overhangs were added to the facades of the sample RC building, the building's weight naturally went up.
- It has been found that the value of the base shear force goes up as more heavy overhangs are added to the facades.

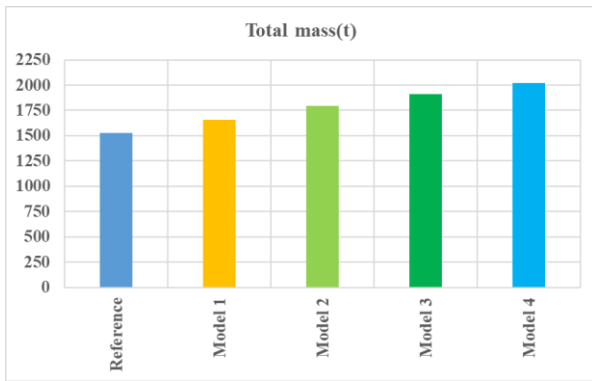
The comparison of the total masses obtained for Group I (heavy overhang on one side) is shown in Figure 9 as an example.

Figure 9. Comparison of total masses for Group I

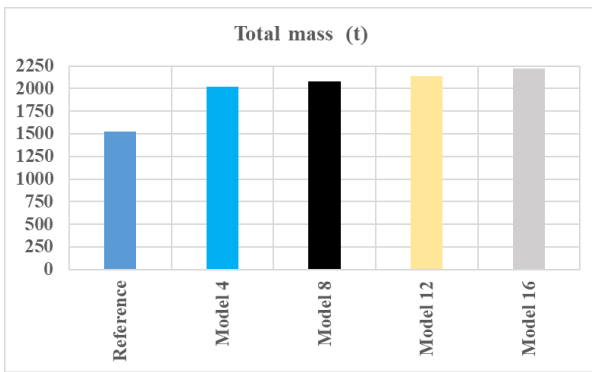
In order to have the heavy overhang length of 1.50 m, one structural model was selected from each structural group in order to compare the heavy overhangs on different numbers of facades. The total mass values obtained for reference for a single facade (Model 4), two facades (Model 8), three facades (Model 12), and four facades (Model 16) when the heavy overhang is 1.50 m are shown in Figure 10.

Figure 10. The effect of heavy overhangs on the total mass on different number of facades

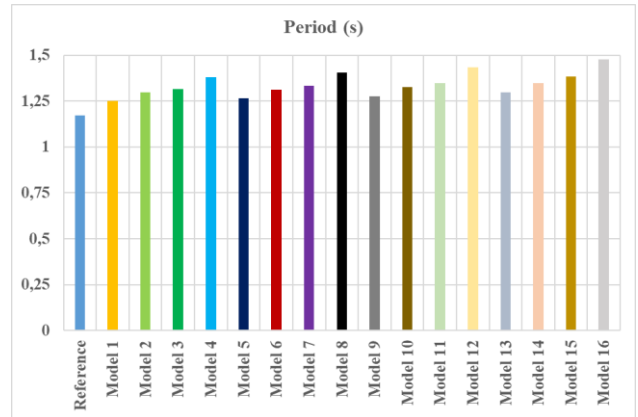
The comparison of the period values for selected structural models are shown in Figure 11.

Figure 11. Comparison of the period values for all structural models

- The period value increased as the length of the heavy overhang and the number of facades with heavy overhangs increased. The high period value is related to the rigidity of the structure. Therefore, the rigidity of structures with heavy overhangs will be lower than that of structures without heavy overhangs.

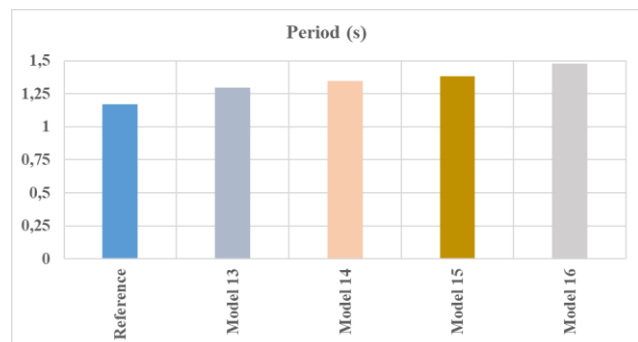
The comparison of the period values obtained for Group IV (heavy overhang on all four facades) is shown in Figure 13, as an example.

Figure 13. Comparison of periods for group IV
