The Effect of Soil Properties on Landslides along Forest Road

Abstract

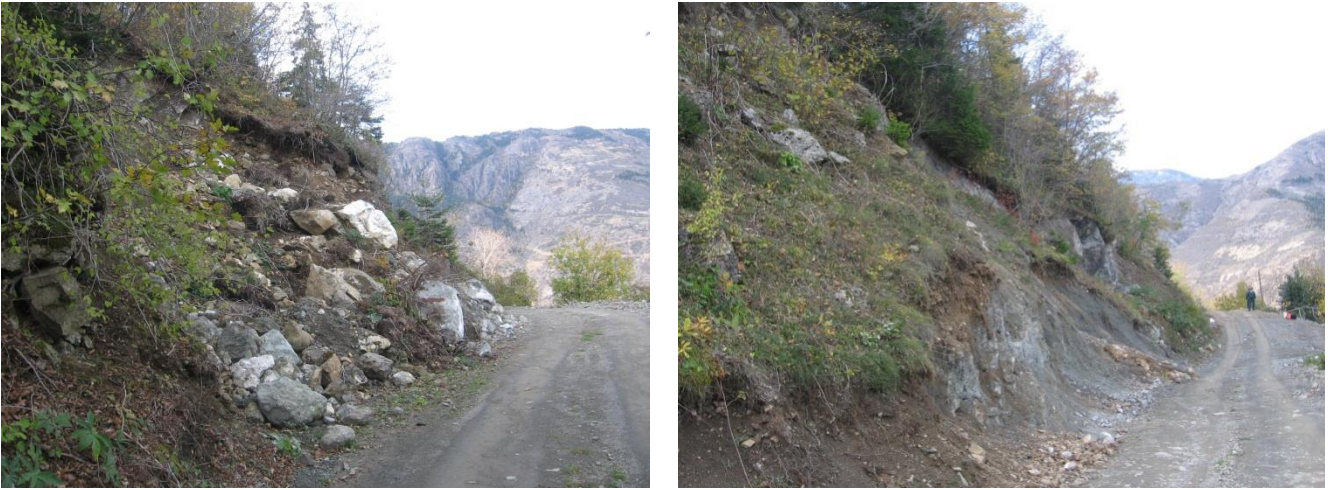
Figure 3. Sample SF (left) and CP (right) points in the study area

In the first stage, field observations have been performed in the forest roads within the study area as preliminary research. Then, total of 15 SFs were determined at the cut and fill slopes with landslides occurrence. For control, CPs were located at the cut and fill slopes which are 20 m away from each of SF with no landslide occurrence. SF and CP points were selected from the areas exposing similar terrain characteristics (i.e. slope, aspect), road geometry (i.e. the depth and gradient of the cut slopes), and flora (Figure 3). In addition, UTM coordinates of SF and CP points were recorded by a GPS. In order to determine some physical and chemical properties of soil in SF and CP, soil samples were collected from the cut and fill slopes where active landslide was observed. Soil

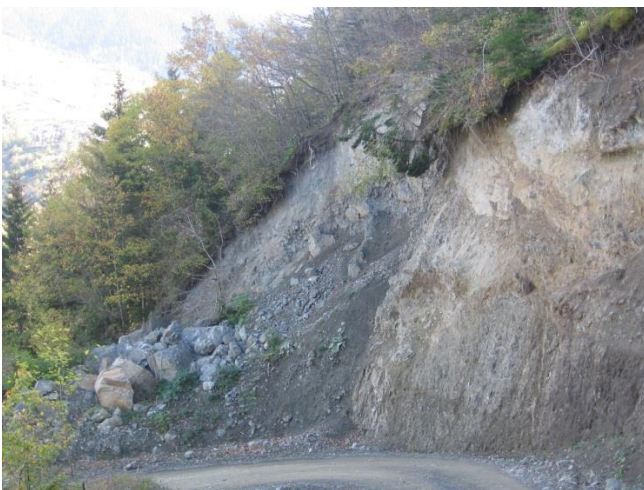
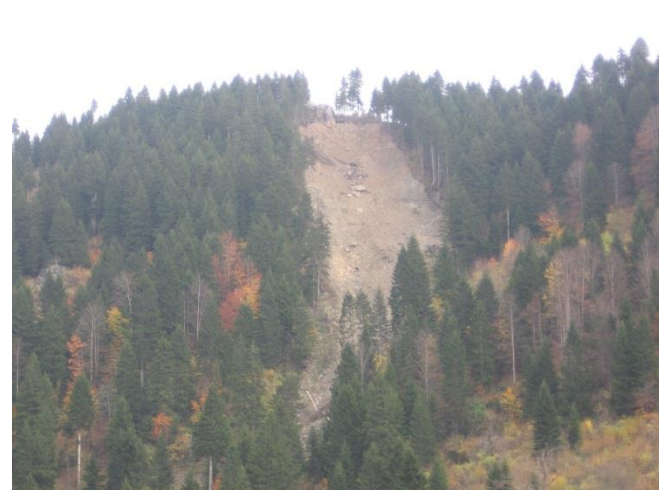
Figure 4. Slope landslide (left) and slipping (right)

The results indicated that most of the 15 landslides occurred at the cut slopes in the form of the slope landslide, while others occurred at the cut and fill slopes in the form of slipping (Figure 4). Table 1 indicates site information about SF points. It was found that the study area consists of bedrocks such as sandstone, ragstone, argillaceous limestone, silt stone, marn, basalt, quartzite, andesite, and dacite.
