Investigation of Sustainable Disaster Management with Fishbone Method; Hatay Province Example

Yeliz DEMİRHAN ARDA ^{1*}

Citation: Demirhan Arda, Y. & Soyuk, A. (2023). Investigation of sustainable disaster management with fishbone method; Hatay Province example. *Journal of Architectural Sciences and Applications*, 8 (Special Issue), 84-102.

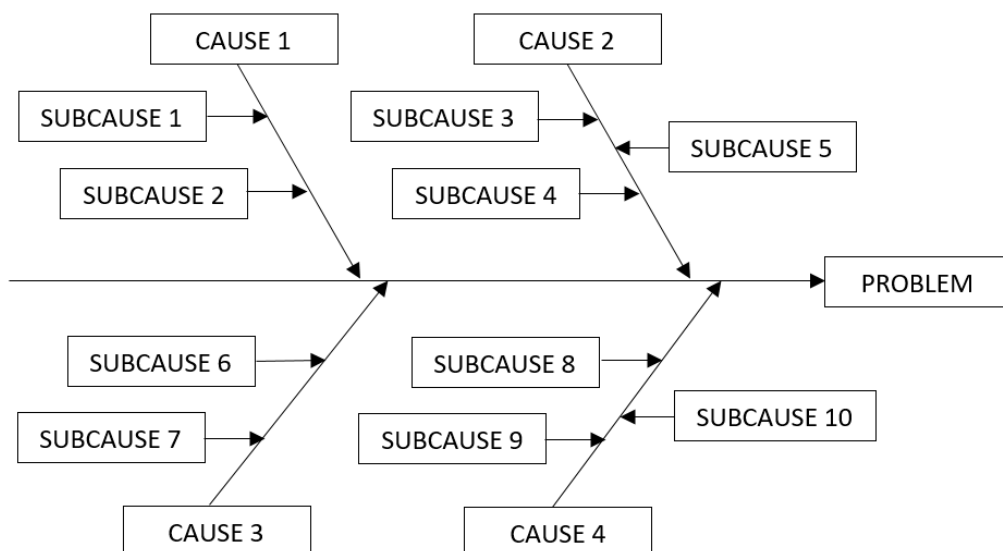
Figure 6. Cause - effect diagram phase 3 (Atalay & Kılıç, 2015)

All members within the scope of the project determine the sub-reasons of these main reasons found by brainstorming method. The important point at this stage is that the people participating in the brainstorming have information about the project and the problem. In this way, real reasons can be reached (Atalay & Kılıç, 2015). In Figure 6, the state of the graph after this phase is given.

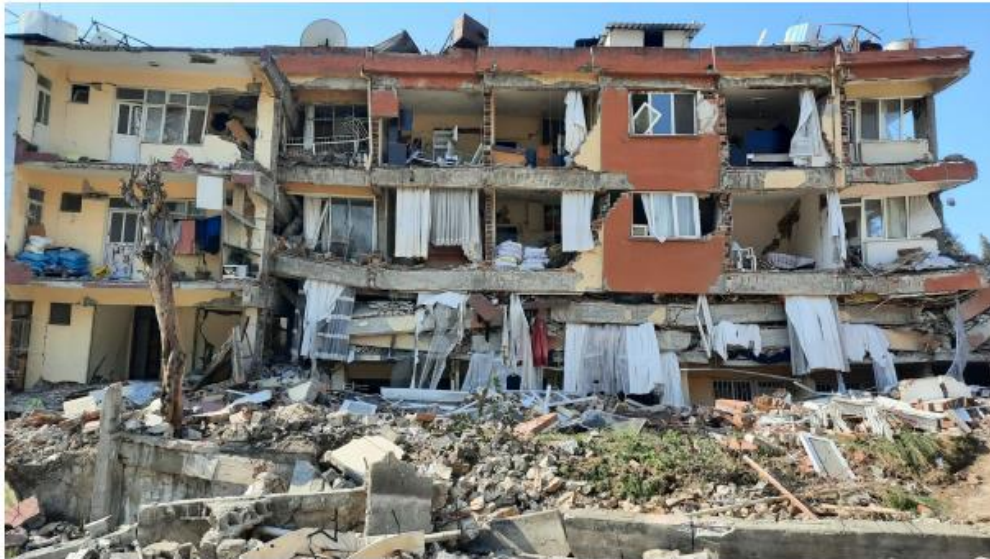
Figure 8. Hatay – city center heavily damaged and destroyed buildings (TMOBB, 2023)

Although the number of destroyed buildings in Belen and Defne districts of Hatay is low, it has been observed that all structures are at least moderately or heavily damaged. It has been observed that low-rise buildings and small industrial sites that have not received qualified architectural and engineering services in Defne district and Antakya have been severely damaged or destroyed. However, in the recent past, after the 2007 and 2018 updates of the Turkish Building Earthquake Code, intense damage has also been observed in the structures built. It has been observed that the soft floor effect is intense on the floors where residential and commercial functions are used together and commercial activities are carried out in most buildings (TMOBB, 2023). Figure 8 shows Hatay – city center heavily damaged and destroyed buildings.

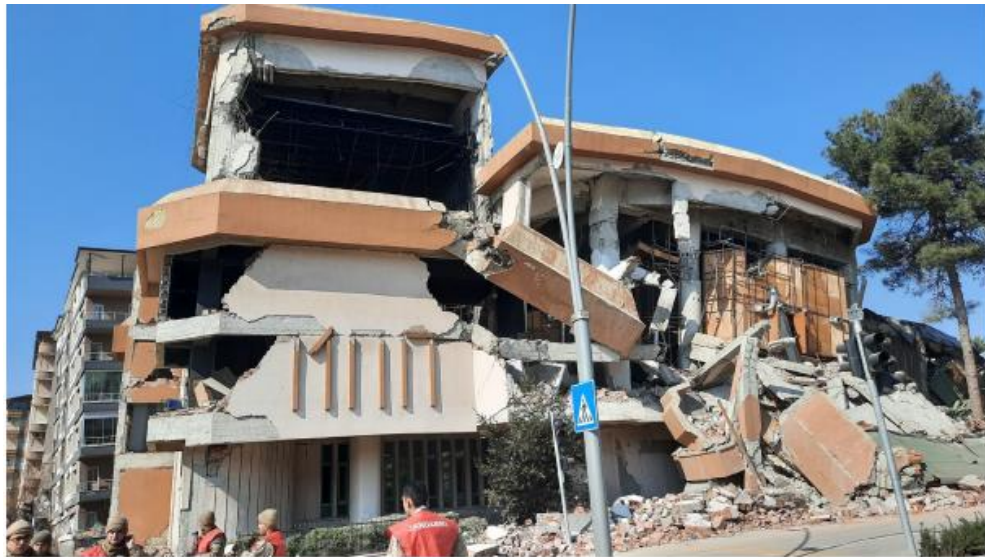
Figure 9. Hatay Cultural Center damaged after 6 February 2023 Earthquakes (TMOBB, 2023)

In the city center of Antakya, public buildings, religious buildings, civil buildings and residences have been destroyed or damaged. Figure 9 shows Hatay Cultural Center damaged after 6 February 2023 earthquakes.

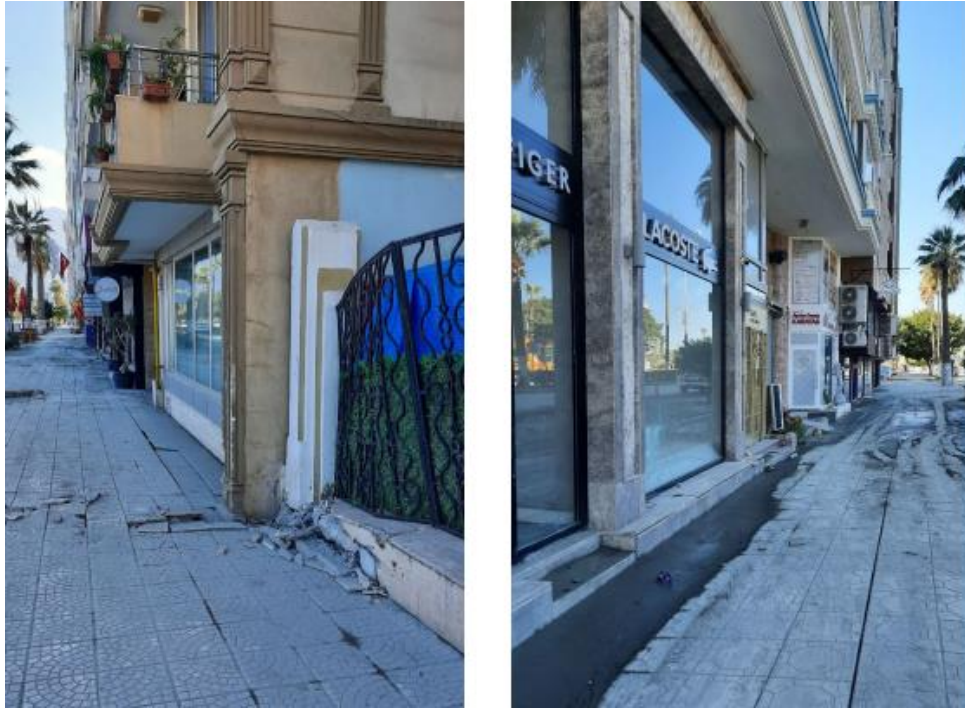
Figure 10. İskenderun Cengiz Topel Street (TMOBB, 2023)

Many buildings on the beach and in the center of the city were destroyed and severely damaged, and many lives were lost. In the city center of Iskenderun, liquefaction, subsidence and swellings were observed in the ground on Cengiz Topel Street and Atatürk Boulevard on the coastline. It was observed that the structures on the boulevard collapsed to the ground by 1 meter. On the second day of the earthquake, the sea level rose and the structures and roads on the beach were submerged (TMOBB, 2023). Figure 10 shows Iskenderun Cengiz Topel Street.

The construction on Cengiz Topel Street, which was limited to 2 floors in the past, was then allowed up to 4 floors. While the buildings built in accordance with these regulations on the coastline were not destroyed in the earthquake, the buildings with illegal floors in violation of the zoning rules were demolished. The 8-storey Eda Apartment, located on the beach, was demolished as a result of the construction of 4 more floors on top of the 4 floors allowed in the zoning rules. It has been learned that the other two buildings on the beach, which were demolished, had illegal floors over 4 floors (TMOBB, 2023). Figure 11 shows Iskenderun – Eda apartment.

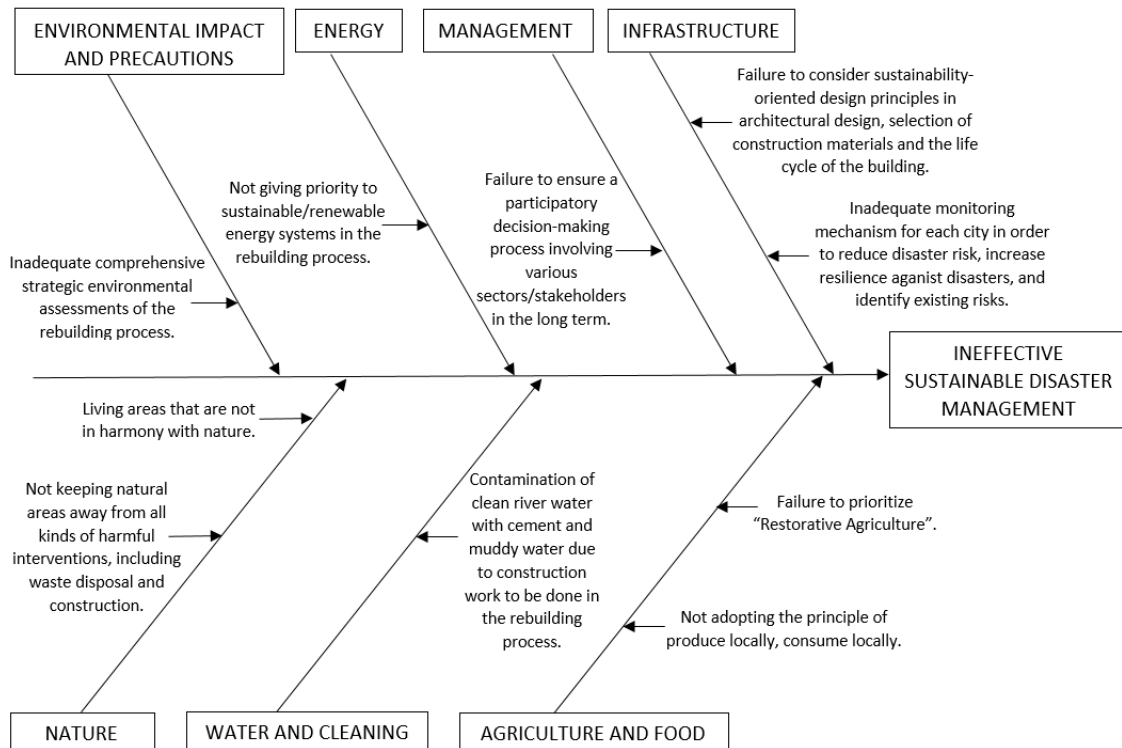
Figure 12. Analysis of the factors that adversely affect sustainable disaster management using Fishbone Method (Edited by the Author)

Analysis will be made by fishbone method, taking into account the latest situations in Hatay. First, ineffective sustainable disaster management is chosen as the main problem. Then, the main causes that may cause this situation to occur are determined. Principles set by WWF (2023), formed the main causes for the fishbone diagram. The main causes can be listed as follows:

- Environmental impact and precautions
- Energy
- Management
- Infrastructure
- Nature
- Water and cleaning
- Agriculture and Food.

Finally, a fishbone diagram is created by adding sub-causes to these causes (Figure 12). Then, the main causes will be discussed under headings and what can be done for effective sustainable disaster management will be discussed.
