Typological Analysis of Wooden Minaret Mosques in Tokat

Elif YAPRAK BAŞARAN^{1,*}, Özlem SAĞIROĞLU DEMİRCİ²

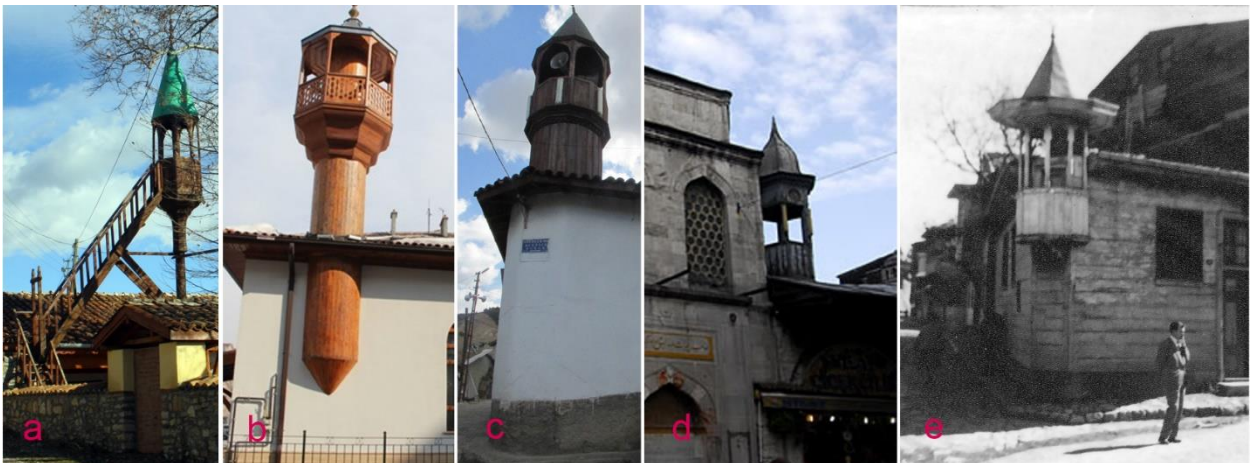
Figure 1. The different types of minarets are according to their location. (a) Belenalan village minaret, (b) Ferhuniye Hacıkaymak Mosque minaret, (c) Acepşir mosque minaret, (d) Köprülü mosque minaret, (e) Arpacı Hayreddin mascid minaret.

minaret is not closed around the main pole (seren), and the ladder is designed to reach directly from the ground, with or without relation to the main pole (seren) (Fig1a).

The other type of wooden minaret has cylindrical geometry and a closed outer wall. This type is common in Anatolia in general and in regions where wood is available throughout Anatolia. The main carrier of this minaret type is designed as a pillar formed by a solid wooden tree trunk. The wooden steps, which were positioned to surround the pillar all around, were surrounded by wooden covering boards and continued to the balcony. The finish of the minaret, which is completed with the şerefe and cone part, is usually covered with wood or metal material (Fig1 b,c,d,e).

Wooden minarets are designed in 4 different ways, depending on their location. Minarets can be located independently of the building or adjacent to the building. The examples designed adjacent to the building can be seen in 3 different ways. In the first two of these, the minaret is positioned on the main wall of the building and rises from the main wall (Fig1b) or, in a different way, from the upper cover (Fig1c). Another type of minaret, designed adjacent to the building, is the balcony-shaped "kiosk minaret." Examples of this type of minaret can be found in Köprülü Mosque (Fig1d) and Arpacı Hayrettin Masjid (Fig1e) in Istanbul [30].

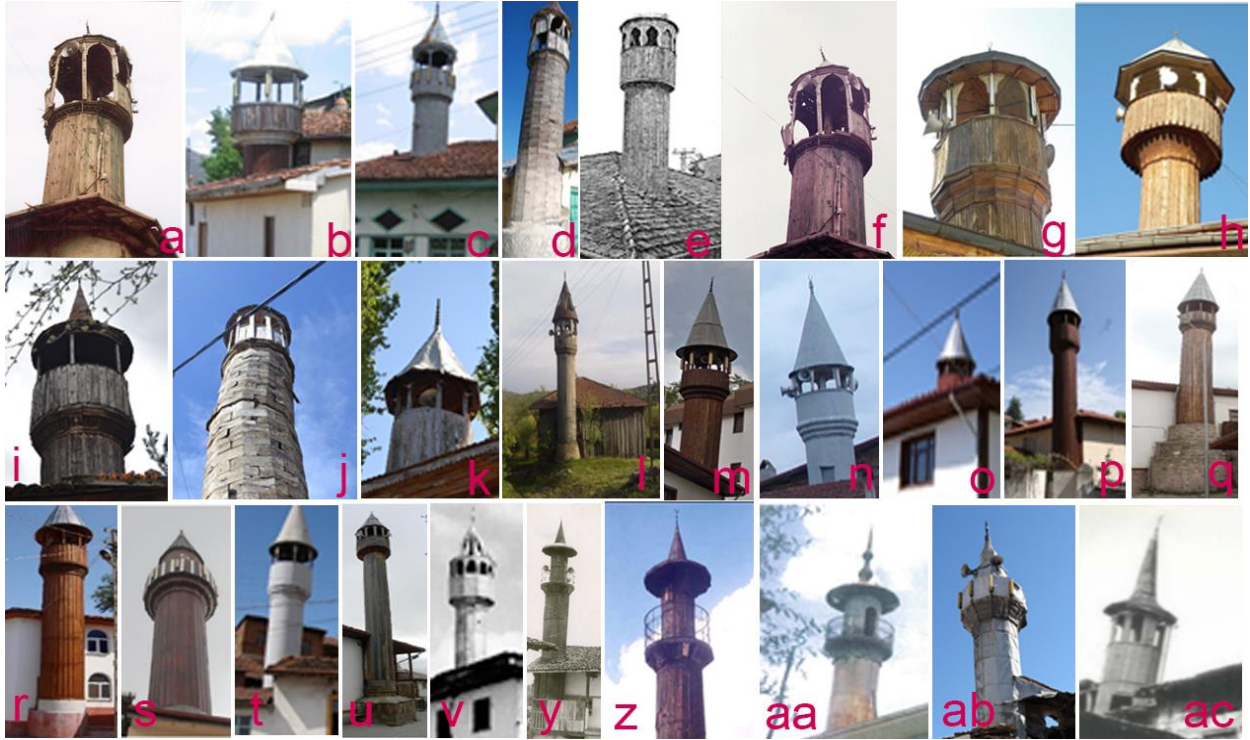
Figure 2. The wooden minarets of the mosques in the center of Tokat (Acepşir Mosque (a), Ahi Paşa Mosque (b), Akdeğirmen Mosque (c), Bozatalan Village Mosque (d), Gözova Village Mosque (e), Hoca Ahmet Mosque (f), Seyid Necmettin Mosque (g), Yolbaşı Mosque (h)); wooden minarets in Almus Province (Almus Gümeleönü Mosque (i)); wooden minarets in Artova Province; Yukarı Güçlü village Mosque (j)); wooden minarets in Niksar province (Akıncı Village Mosque (k), Alçakbel mosque (l), Çilhane Mosque (m), Derebağ Mosque (n)[35], Gazi Ahmet Mosque (o), Halil Efendi Mosque (p), Hanegah Mosque (q), Hüsam Mosque (r), Nalbantlar Mosque (s), Siragöz Mosque (t)); wooden minarets in Reşadiye province (Kızılcaören Mosque (u)), wooden minarets in Sulusaray province (Malum Seyyid Mosque (v)[35]); wooden minarets in Turhal province (Necip Village Mosque(y)), wooden minarets in Zile province (Behram Ağa (z), Beyazid Mosque (aa), Cedit Mosque (ab), Molla Yahya Mosque (ac)[35])

According to the results of the research, it has been seen that the oldest one of the documented mosques is the Beyazid Mosque in the Zile district. The building has two separate inscriptions showing the years 1206 and 1305. The construction year of the Şeyh Ethem tomb, located northeast of the mosque, is unknown. However, it is known that Şeyh Ethem Çelebi, who was buried in the tomb, died in 1356. The research determined that the Acepşir and Known Seyit mosques were built in the 14th century and the Bozatalan mosque in the 16th century. There are Ahi Paşa, Akdeğirmen, Seyid Necmeddin, Gümeleönü, and Molla Yahya mosques that have survived from the 18th century; Gözova Village Mosque, Artova Yukarı Güçlü Village Mosque, Niksar Gültepe Village Akçabel Mosque, Niksar Derebağ, Niksar Gazi Ahmet, Niksar Hanegah, Niksar Hüsam Necip Village Mosque and Niksar Nalbantlar mosques from the 19th century. Cedit Mosque, Zile Behram Ağa Mosque, Reşadiye Kızılcaören Village Mosque, Siragöz Mosque, Halil Efendi Mosque, Çilhane Mosque, Akıncı Village Mosque, Yolbaşı, and Hoca Ahmet Mosques are mosques with wooden minarets that have survived from the 20th century.

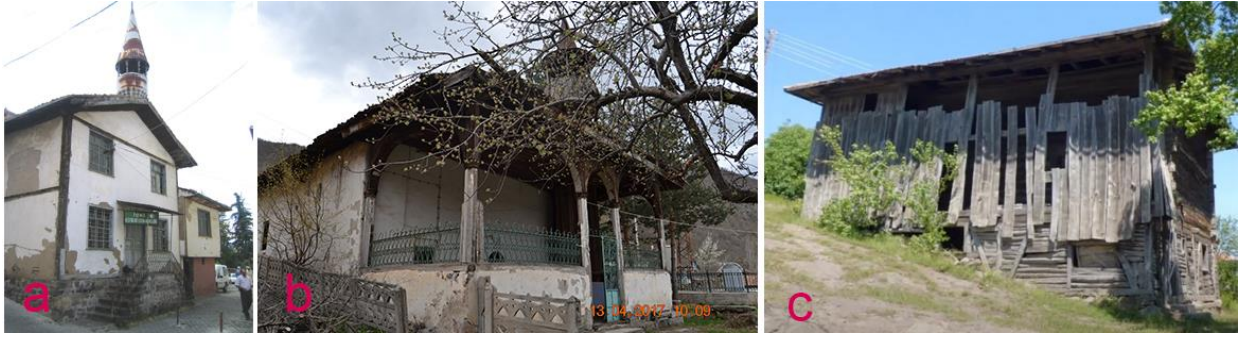
Figure 3. Mosques with different construction systems are available in the study area. Niksar hanegah mosque (timber frame - a), Almus Gümeleönü Mosque (stone masonry-b), Niksar Gültepe Village Alçakbel Mosque -c)

When the mosques are examined in terms of the construction system, it is seen that 25 mosques have the same construction system as a "timber frame system filled by local materials (wood, mudbrick, brick or stone). The construction system of the Almus Gümeleönü Mosque was determined as stone masonry. Niksar Gültepe Village Alçakbel Mosque, on the other hand, was built with the wooden masonry (Çantı) technique and differed from the others. This mosque is out of use today, and its minaret was destroyed.

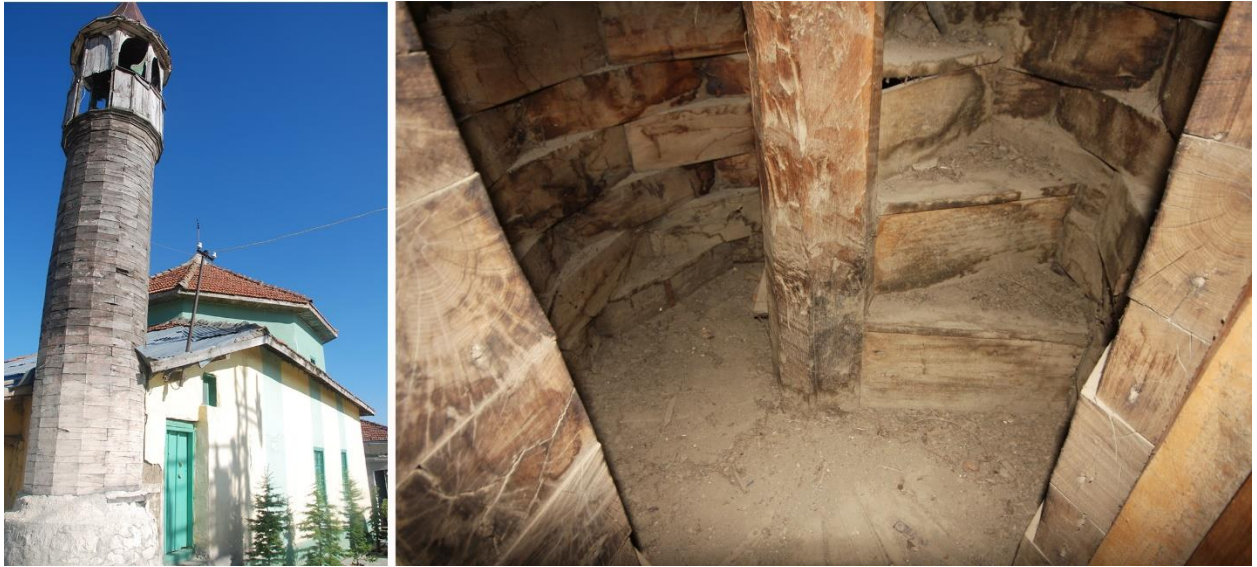
Figure 4. The photographs of the Bozatalan village mosque

When the construction system of the minarets is examined, it is seen that they were mostly built in the wooden frame system. However, the minarets of the Bozatalan Village Mosque, Artova Yukarı Güçlü Village Mosque, and Turhal Necip Village Mosques were built in the wooden masonry (çantı) technique.

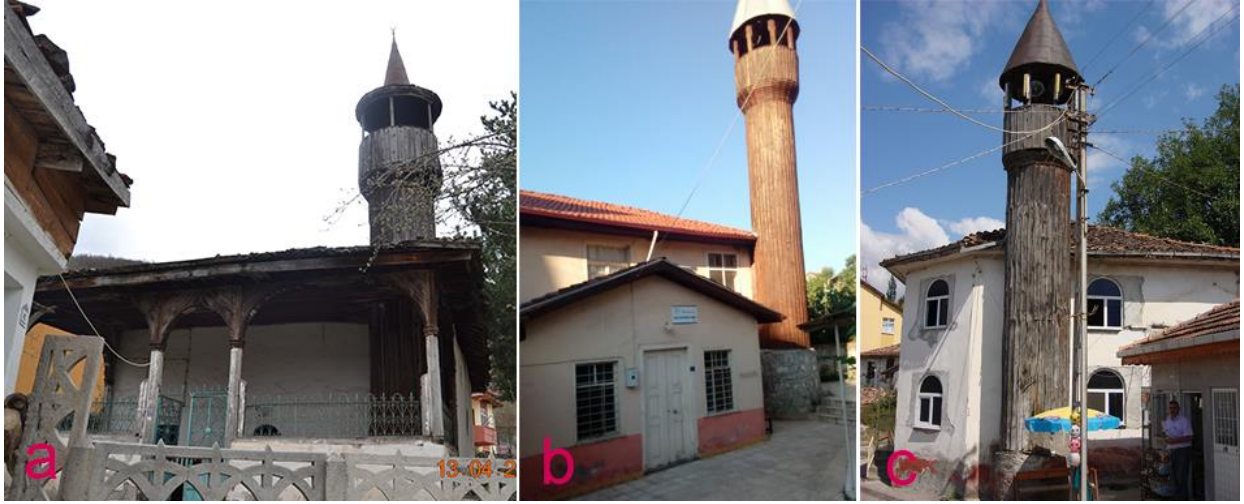
Figure 5. *Almus Gümeleönü Mosque, located in the latecomers' area (a), Niksar Halil Efendi (b) and Niksar Hüsam Mosque (c) Minarets located adjacent to the mosque.*

When the position of the minarets relative to the mosque is examined, it is seen that 10 of the 27 minarets were built separately from the mosque. In contrast, the others had a physical relationship with the mosque. Among the other minarets adjacent (attached) to the mosque, Niksar Halil Efendi and Niksar Hüsam Mosque minarets were built adjacent to the main mosque wall and the others to the roof.
