Ancient Repairs on the Alexander Mosaic from Pompeii

Demet BEŞİKÇİ*

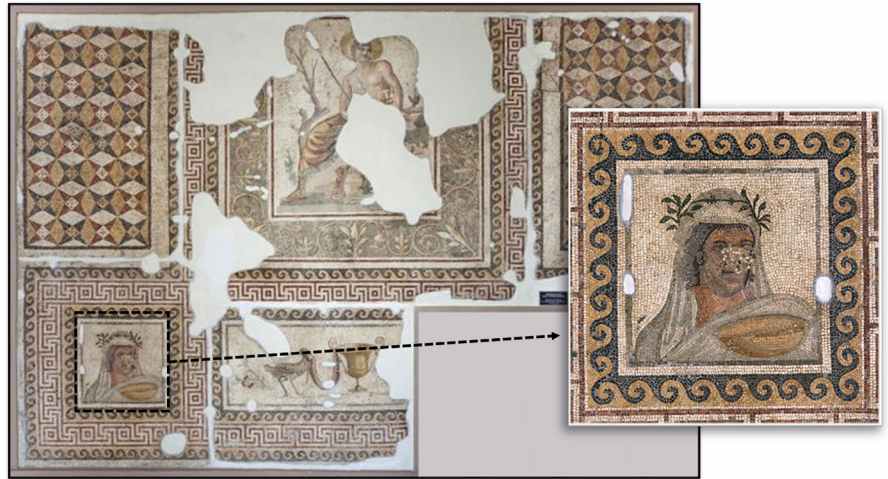
Figure 2
Ancient repairs on the Narcissus Mosaic
from Antioch (Cimok 2000: 178).

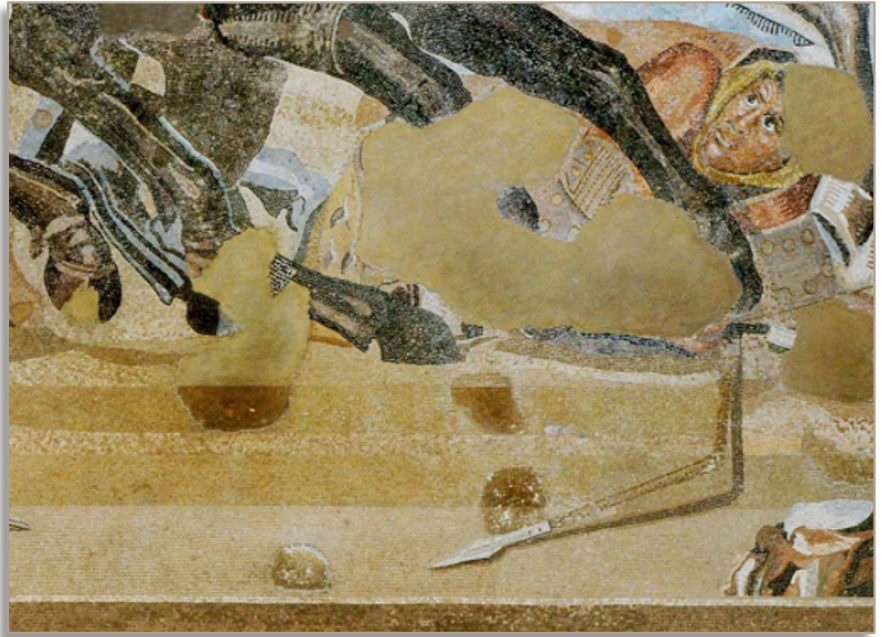
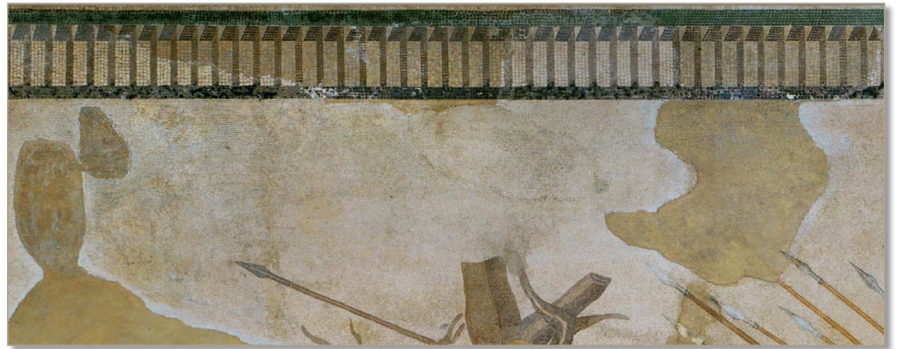
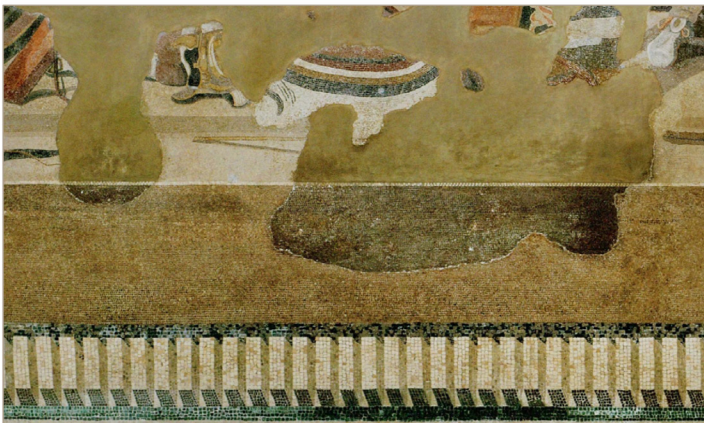
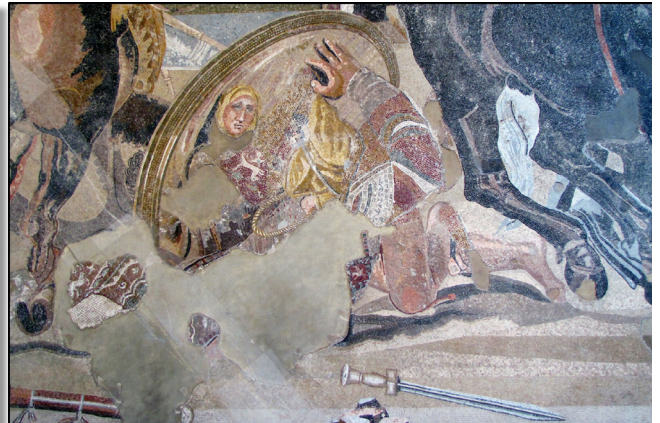
Figures 6-9
 Details of the ancient tesserae repairs on the Alexander Mosaic, Pompeii (Dunbabin 1999: 41).

When the ancient repairs on the Alexander Mosaic are examined in detail, small interventions stand out in front of the hooves of the four black horses pulling Darius' chariot in the lower right corner of the panel (Fig. 6). Here, the tesserae used for the repairs are darker than the originals (Beşikçi 2021: 35). Traces of repairs made with darker tesserae can also be seen on the dentate pattern border of the mosaic (Fuhrmann 1931: 94) (Fig. 7). Likewise, in the lower left edge of the panel on the thick band of dark green tesserae, some areas were repaired with darker tesserae than the original (Fig. 8). On the other hand, on the large central panel where the battle scene is depicted, the colour-tone difference of the tesserae indicates that in this section repairs were also made to the right arm of the Persian soldier, whose face is reflected in the shield (Fig. 9). This repair with tesserae is connected to the part repaired with mortar to the left of the soldier. Similarly, the dark green tessera-repair area below the panel neatly merges with the mortar-repaired section in the vicinity of Alexander the Great.

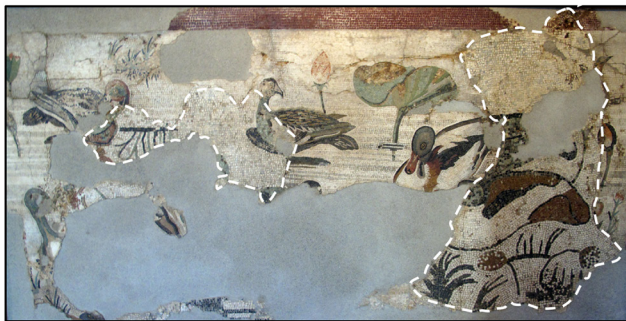
Figure 10
Details of the ancient repairs on the Nilotic Mosaic, Pompeii (<https://www.wikidata.org/wiki/Q47468132>)

Other artworks damaged by the devastating earthquake of 62 AD are the mosaic floor panels at the entrance of the exedra where the Alexander Mosaic was located, dating to 90-80 BC and representing Nilotic scenes (MANN, inventory number 9990) (Meyboom 1995: 81, 365) (Fig. 10). These three panels, in which various animals such as ducks, ibises, a hippopotamus, a crocodile, snakes and an Egyptian mongoose are depicted, are the continuation of each other in content. As in the Alexander Mosaic, ancient restoration efforts seem to have also been made on these mosaics immediately after the 62 AD earthquake (Wohlgemuth 2008: 60, 137).

The animal and plant depictions on the rightmost panel appear different from the animal and plants on the other two panels. Despite the repairman's obvious efforts to stay true to the original theme, the differences in style between the originals and the repaired parts is clearly discernible. The relatively clumsy craftsmanship is especially noticeable in the repaired duck figures of the right panel (Wohlgemuth 2008: 137). Although the colour of tesserae used for repairs are the same tone as the originals, they differ in size and arrangement. Comparably, on the left side of the panel, the arrangement of the tesserae above the water in which the ducks are swimming is also not faithful to the original. In addition, while the plants above the water should be growing in an upward manner, on the contrary, they are depicted pointing downwards. Some scholars suggest that like the Alexander Mosaic, the Nilotic scene mosaic may have been brought here from the Eastern Mediterranean and placed in the exedra of the House of the Faun (Meyboom 1995: 358). However, this idea is not widely accepted as plausible as the tesserae of the Nilotic Mosaic were made from local materials, just as the Alexander Mosaic and other mosaics inside the House of the Faun (Meyboom 1995: 358). Since the entrance to the exedra where the Alexander Mosaic was located was from the column space on the right, it is

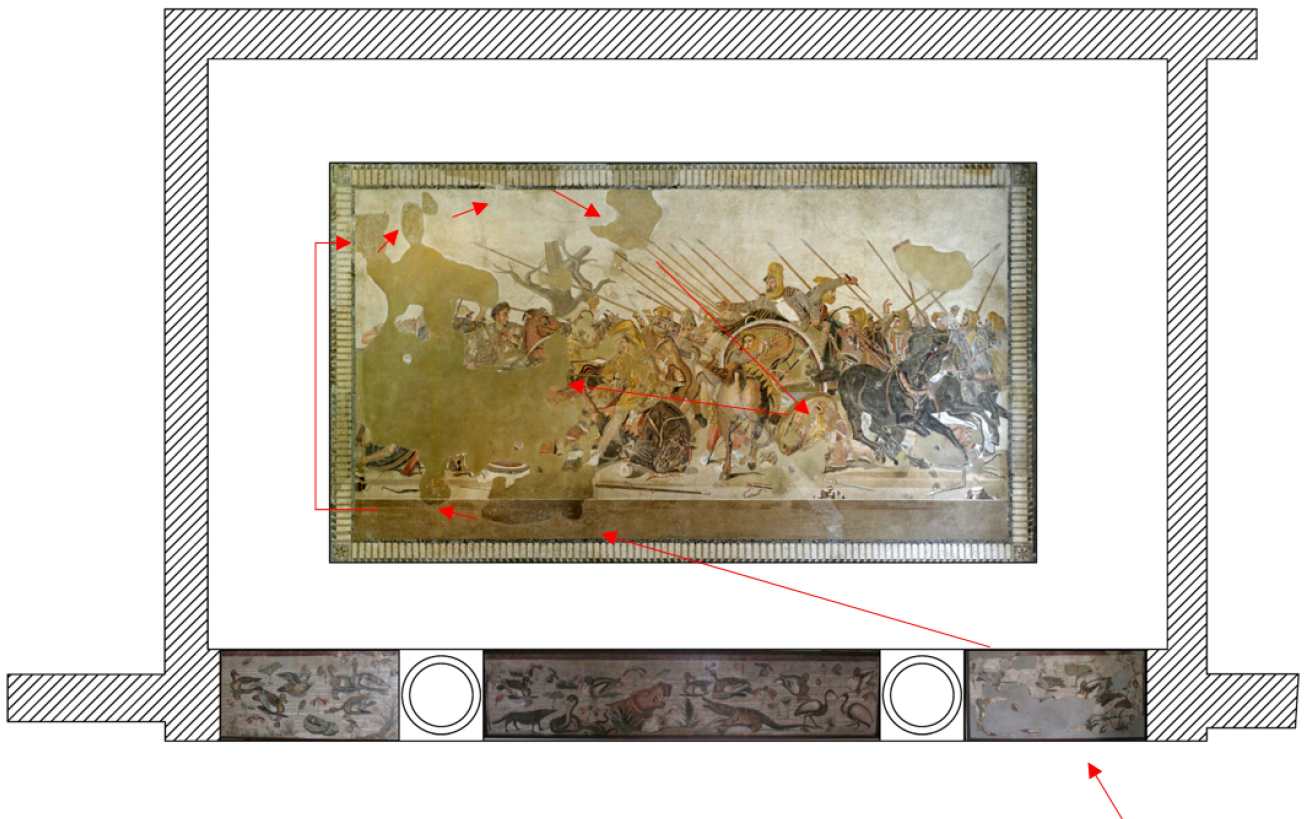
Figure 11
The likely sequence of repairs of the mosaics in the exedra of the House of the Faun (Illustration: Demet Beşikçi).

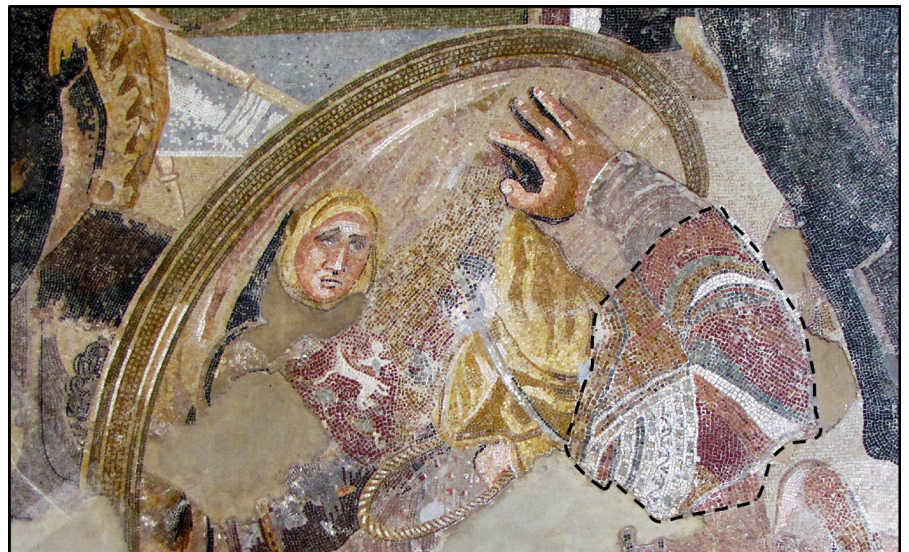
Figure 14

Detail of the repairs made to the right arm of the Persian soldier, whose face is reflected in the shield (Dunbabin 1999: 41).

Underneath Darius' chariot, the tesserae on the right arm of the Persian soldier whose face is reflected in the shield in his hand, were repaired using different colors (Fig. 14). The inability to recreate the light-shadow contrast and the fact that this area of repairs made with tesserae is situated in the direction of the mortar repair area on the left side of the soldier suggests that the mosaic master
