# Examination of the Impact of Contemporary Additions on the Historical Building's Energy Performance

Busra OZTURK<sup>1,\*</sup>

In this study, examinations were made on the historical Süleyman Pasha Bath located in Kocaeli in the Marmara Region of Turkey. As a result of the restoration works initiated in 2010, the effect of the contemporary addition on the energy performance of the building was examined. The reason why this historical building was chosen as a case study is that the building, which has undergone a significant restoration process, has historical and cultural value. In addition, it has undergone a functional and user profile change with the addition of a space built from contemporary materials after the restoration. The contemporary addition to the building has been selected as a case study because it is enough to form a space and it is thought that it will affect the energy performance of the building. In the analyzes made on the historical bath, the energy simulation method was used with the Design Builder program.

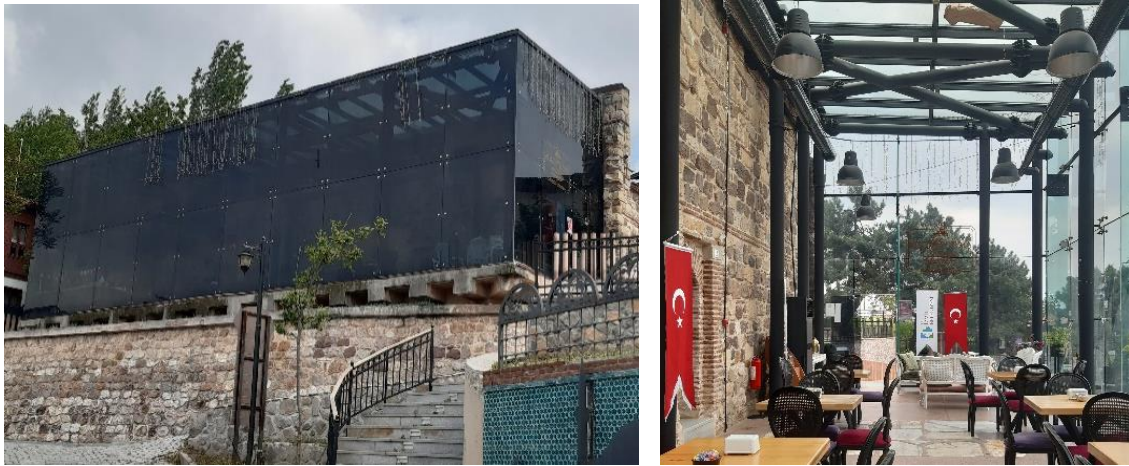
*Figure 1. Süleyman Pasha Bath and Cafeteria Space After Restoration (Personal Archive)*

The restoration works of the bath, which was seriously damaged in the 17 August 1999 Earthquake, started in 2010 [35]. Instead of the coldness space that has not survived until today, a glass addition built with contemporary materials. This contemporary construction was added to the front façade of the existing bath building for the need of cafeteria space required by the new function. At the base of the cafeteria, a reinforced concrete foundation was used, unlike the warm and hot areas. With the contemporary additional intervention, the total area of the cafeteria space has shrunk compared to its original condition (dressing hall). The historical bath continued as a museum until before restoration. However, after the restoration, it gained the functions of both a museum and a cafeteria [36] (Figure 1).

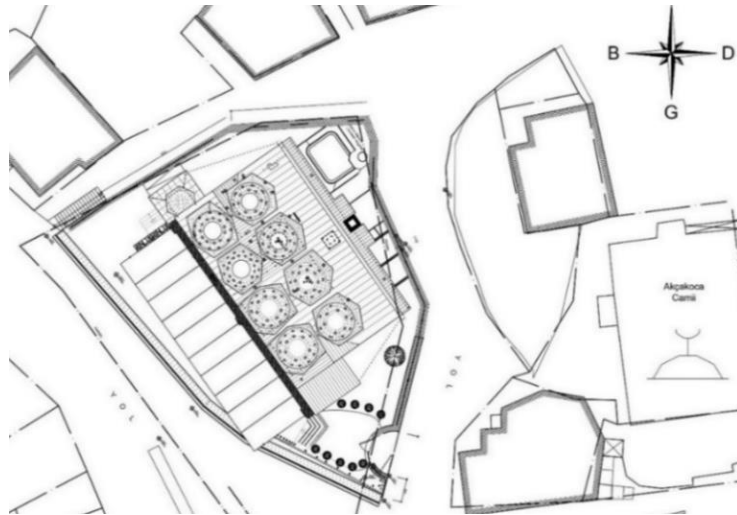
*Figure 2. Süleyman Pasha Bath Layout Plan (Güner Design - Architect Gülhan Dilaver)*

Süleyman Pasha Bath is located in Akçakoca Neighborhood in Kocaeli on section 85, block 368 and parcel no. 4 (Figure 2). It was built by Süleyman Pasha in the 14th century in the Early Ottoman Period as a double bath separately for men and women. As a bath plan feature, it consists of dressing hall, warm area and hot area, respectively (Figure 3). Since the dressing hall could not reach the present day and was destroyed, it was rebuilt with the restorations and started to serve as a cafe. There are man's and woman's toilets in the east and west directions. The woman's toilet in the western direction is covered with a dome. It is possible to pass from the warm areas to the toilets on the side. The hot area and the warm area are covered with double domes. However, the height of the dome of the warm room is higher than that of the hot area. The domes are plastered on their inner surfaces and naturally illuminate the space with elephant eyes. There is a furnace and water tank throughout the north of the hot areas [35]. In Klinghard's research and his surveys in 1925; The dressing room, measuring 9.50 m x 9.50 m, warm room is 3.85 m. x 3.60 m and hot room is 3.85 x 3.85 m. It is stated that the spaces are covered with a double dome [37]. For these reasons, these comments can be reached about the plan features of the dressing hall that have not survived to the present day. Klinghard's surveys were also helpful in the pre-restoration model of the building created in the simulation program.

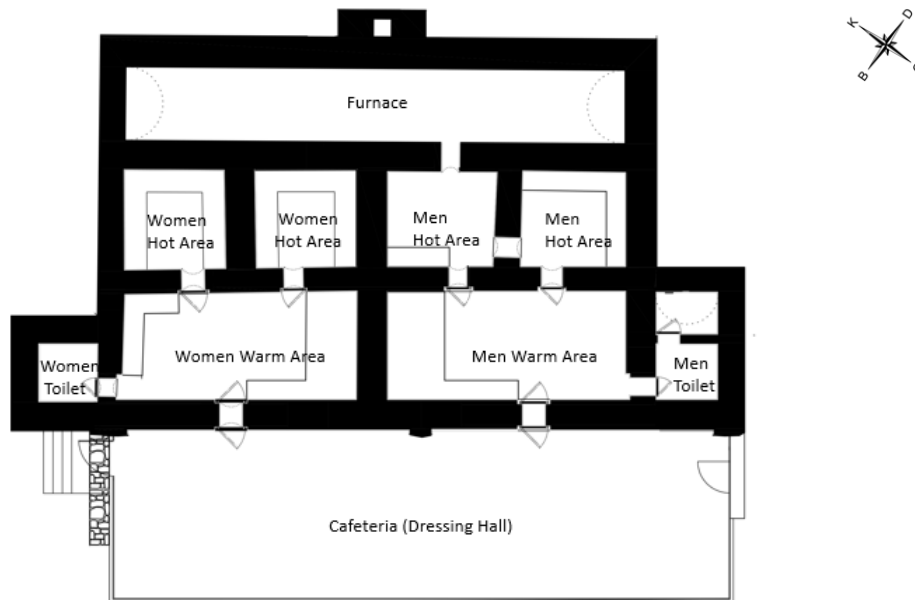
*Figure 3. Süleyman Pasha Bath Ground Floor Plan (Güner Design - Architect Gülhan Dilaver)*

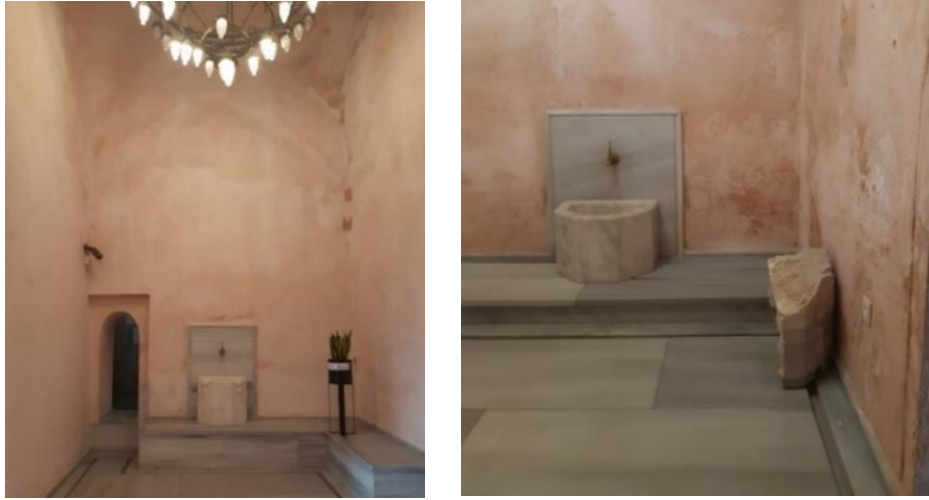
**Figure 4.** Suleyman Pasha Bath Warm Area and Hot area material details (Personal Archive)

Süleyman Pasha Bath consists of dressing hall, warm and hot areas in accordance with the traditional Turkish Bath culture. Warm and hot areas are covered with a dome by using pendentives, one of the transition elements to the dome. The dome covers are built with brick materials, but the inner surfaces of the dome are covered with plaster. The diameter and height of the dome covering the hot area is larger than the dimensions of the warm area. The facades of the bath were built in an alternating pattern from a mixture of stone and brick. However, the restaurant, which was built instead of the dressing hall of the building, which has not survived, is made of glass and steel materials, unlike the original material of the building. The façades of the building are generally built without windows or with small windows for privacy reasons in the traditional bath culture. Marble was used in the interior floors and basins of the bath. There is a glass floor measuring 1.51x1.28 m in the male and female warm areas of the bath (Figures 4-5).

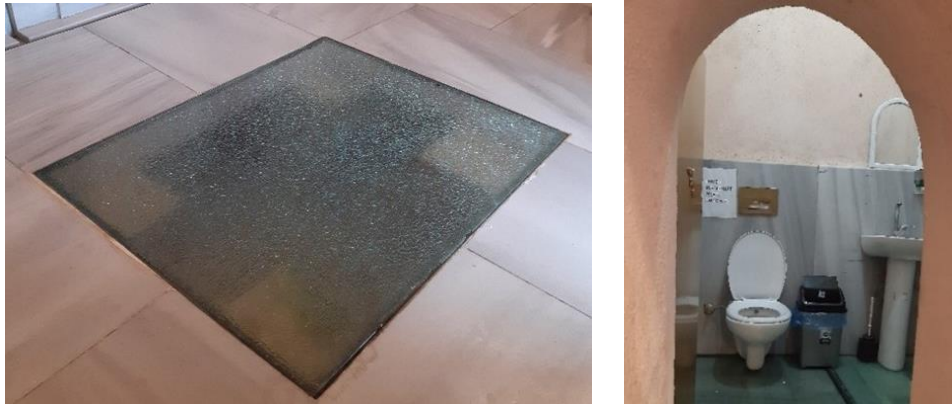
**Figure 5.** Glass Flooring Detail of Warm Area and Süleyman Pasha Bath Toilet (Personal Archive)

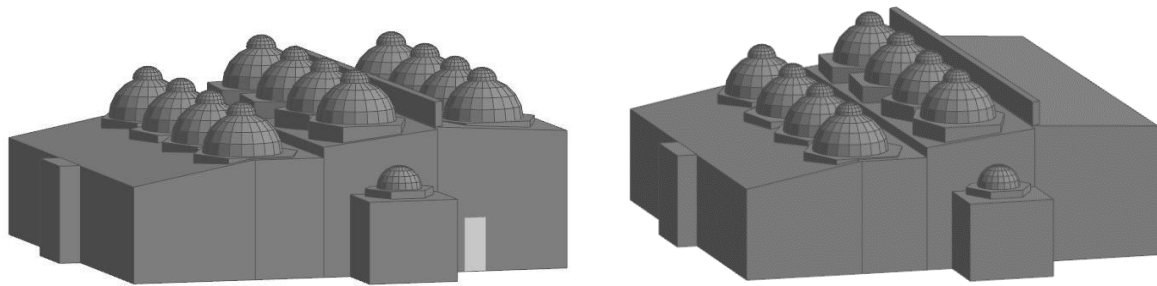
**Figure 6.** The model of Süleyman Pasha Bath before and after restoration created in the Design Builder

feature of evaluating the energy performance of the building according to various conditions, calculating heating and cooling loads, making lighting calculations, daylight analysis, determining user density and analyzing many evaluations such as CO<sub>2</sub> emission. While making these evaluations, it provides the user with the opportunity to benefit from the features of the materials and construction elements in own extensive library in the designer's model and to evaluate the effects of various materials and methods [38]. Solmaz [39] compares 9 building performance tools and it is revealed that the Design Builder tool provides many opportunities and is recommended according to today's requirements. Also Tayari and Nikpour [40] validated the Design Builder program on a traditional courtyard house. According to the comparative analysis of the simulation results and the experimentally measured results, the performance analysis of the program was verified since the difference was less than 10%. Similarly, according to the calibration study conducted by Abba et al. [41] the Design Builder program is recommended to be able to predict indoor thermal comfort and roof thermal performance. After the selected simulation program, in order to reach the desired analyzes in the study, two types of models were created as before and after the restoration. The first model was made according to the original plan and material of the dressing room, which was destroyed (Figure 7). In the second model, the cafeteria space addition after the restoration is modeled (Figure 6).

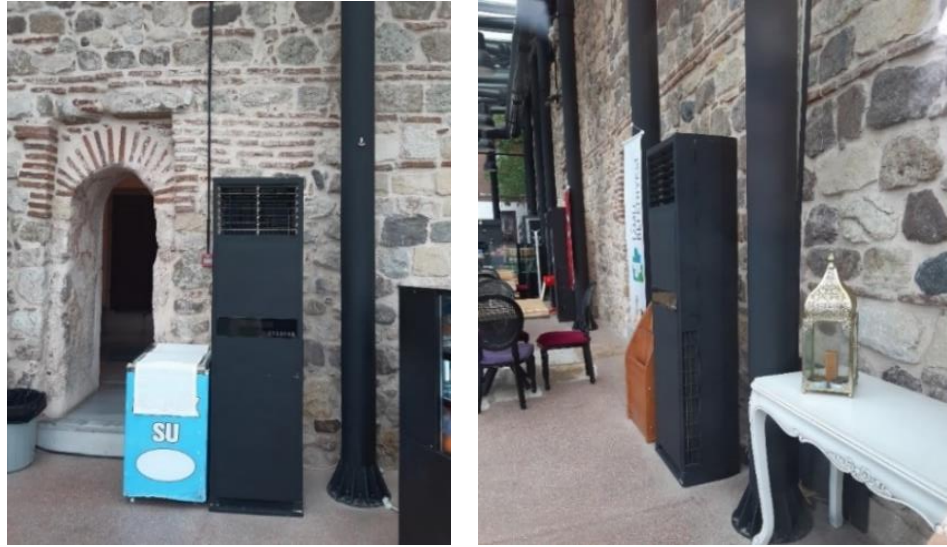
**Figure 7.** HVAC systems used in the restaurant of Süleyman Pasha Hamam (Personal Archive)

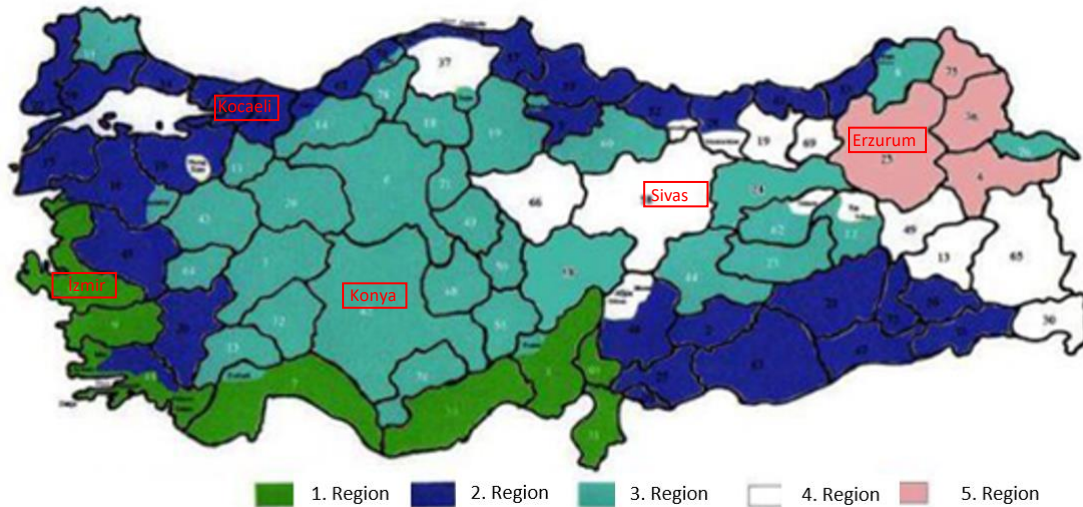
**Figure 8.** Türkiye degree day regions map [43]

It was aimed to determine the effect of contemporary additions on energy performance not only for the Kocaeli province, but also for Ottoman baths of similar plan types in Anatolia, and to create ideas and awareness in their design. For this purpose, provinces from five different climate regions in Turkey were selected (Figure 8).

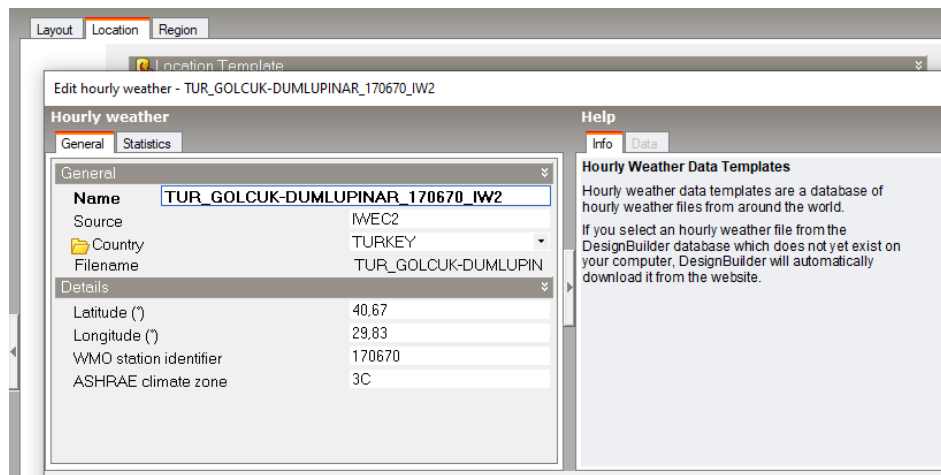
**Figure 9.** Processing of Kocaeli Province Climate data into Design Builder program

Konya, Kocaeli, Sivas, Izmir and Erzurum provinces were determined as the study area for energy analysis and scenarios were created based on these provinces (Figure 9). The data climate of the provinces determined for analysis evaluation was purchased from the White Box Technologies. Five provinces were selected from the five regions of Turkey, which are divided according to degree day regions. While the average air temperature measured in summer in Izmir from the 1st region is 43°C, the lowest air temperature is 22.4°C on average. In the province of Kocaeli, which is the original location of the building from the 2nd region, the average highest air temperature in summer is 44.1°C, while the lowest air temperature is -8.3°C. The highest air temperature measured in Konya province from the 3rd region is 22.8°C on average in summer, while the average temperature in winter is 0.6°C. In the province of Sivas, from the 4th region, the average temperature measured in summer is 38.3°C, while the average temperature in winter is -34.6. In the province of Erzurum, from the 5th region, the average temperature value in summer is 36.5°C, while the average temperature value in winter is -37.2°C [44].

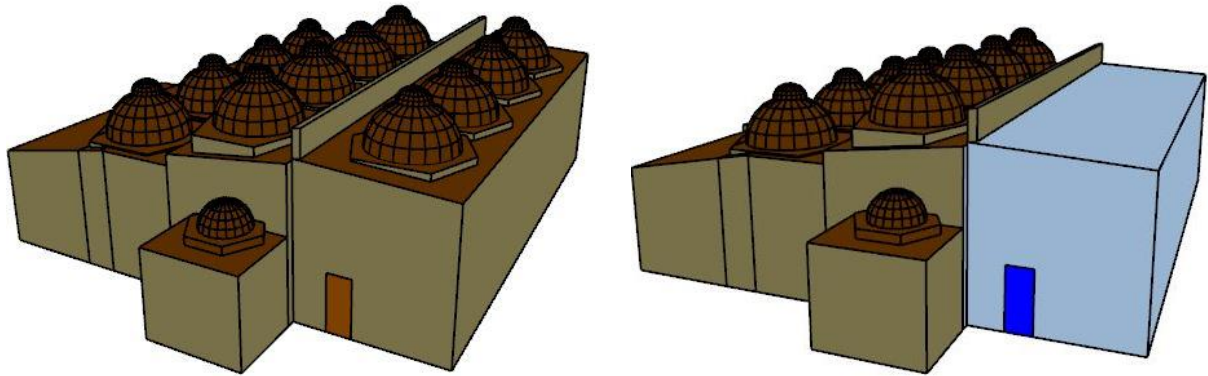
**Figure 10.** The model of the Bath's before and after the restoration the material was identified

After modeling the building and entering the climate data the thermal conductivity calculation value  $\lambda$  (W/mK), density value ( $\text{kg/m}^3$ ) and specific heat values (J/kgK) of the building components and material values of the bath were entered into the program (Figure 10). Material properties are taken from TS 825 Standard. The material library of the Design Builder program was used for the values that could not be reached in the TS 825 Standard (Tables 2-3).
