**Depolama tanklarının imalatında farklı amperlerde tozaltı kaynağının uygulanması ve kaynak bölgesinin incelenmesi**

*Application of submerged arc welding at different amperages in the manufacture of storage tanks and examination of the weld zone*

# Application of Submerged Arc Welding at Different Amperages in The Manufacture of Storage Tanks and Examination of the Weld Zone

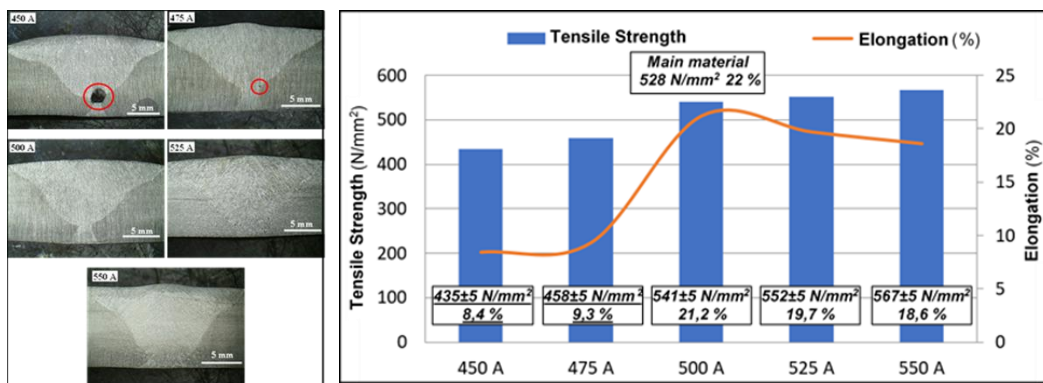
ASTM A36 steel plates are joined by submerged arc welding method using different amperage values.

Figure. Macrostructure images and tensile/elongation graph

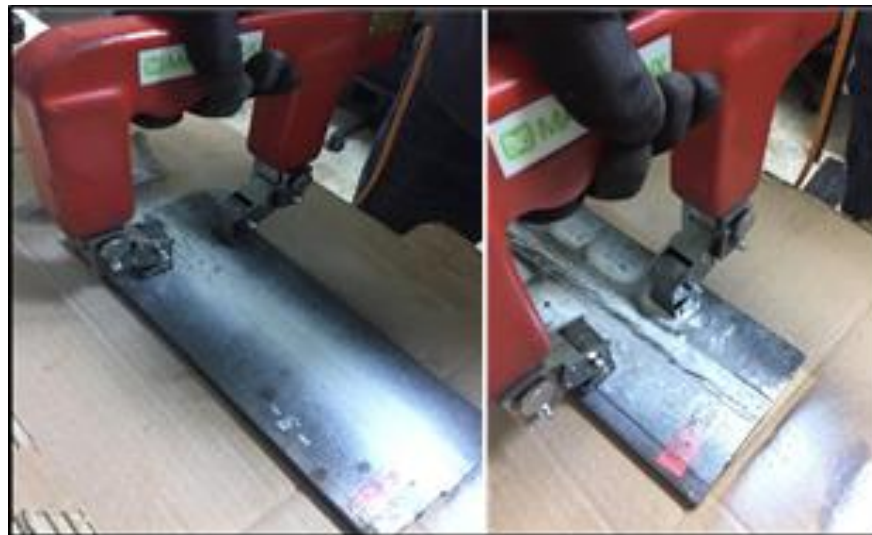
Figure 4. Magnetic particle test application image

It was applied by a magnetic particle inspection test expert in accordance with the TS EN ISO 9934 standard (Figure 4) and reported in accordance with the EN ISO 23277 standard (Figure 5). Upon examination of the magnetic particle test results, no surface defects such as cracks, pores, or combustion grooves were found on the weld surfaces. In the report approved by the expert, it was determined that there were no superficial defects in all welding currents used and that the welds were in compliance with the standards. Özkan [14] reported that no cracks, pores, etc. were detected on the weld surface as a result of magnetic particle tests performed after the welding of structural steels.

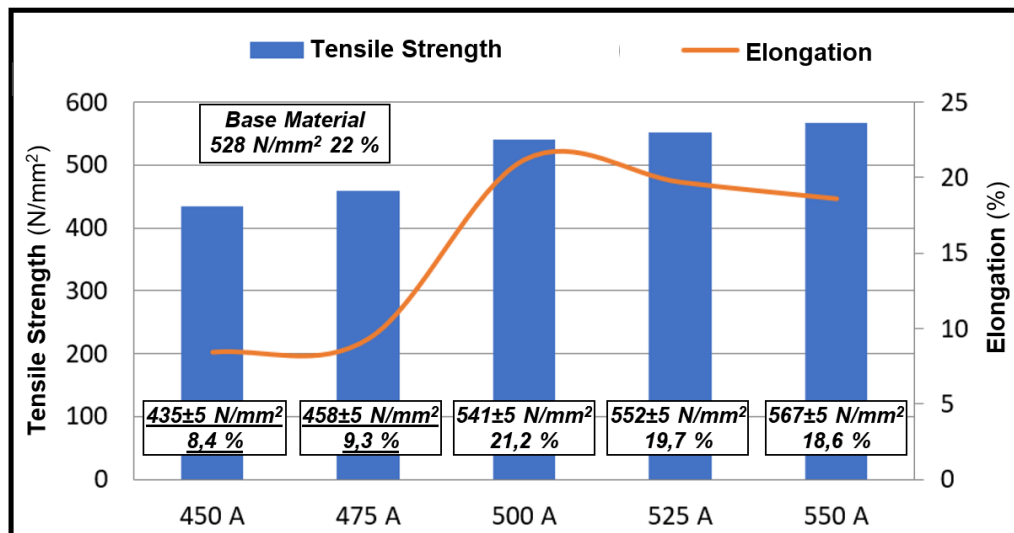
Figure 17. Tensile and elongation graph

The graph of the tensile tests applied to the sheets joined using the submerged arc welding method is given in Figure 17, and the rupture images after the tests are given in Figure 18.

When the tensile test results were examined, the rupture occurred in the welding zone in the plates joined to 450 A and 475 A, while the rupture occurred in the base material in the plates joined to 500 A, 525 A and 550 A. It was determined that the tensile strength of the sheets joined at 450 A ( $435 \pm 5$  N/mm<sup>2</sup>) and 475 A ( $458 \pm 5$  N/mm<sup>2</sup>) welding currents was lower than the tensile strength of the base material (528 N/mm<sup>2</sup>). Ultrasonic (Figure 7), radiographic (Figure 8-9) and macrostructure (Figure 10) results showed that 450 A and 475 A values were not appropriate. In the sample joined at 450 A welding current, it was observed that the welding performed in a single pass did not penetrate the root pass and a lack of melting/penetration occurred with a diameter of approximately 2 mm. It was observed that there was a melting/penetration deficiency of approximately 0.5 mm in the sample joined at 475 A welding current. Tensile test results confirm the results of non-destructive testing and macrostructure studies.

The tensile strengths of the welding areas of the plates joined at 500 A, 525 A and 550 A welding current were determined as ( $541 \pm 5$  N/mm<sup>2</sup>), ( $552 \pm 5$  N/mm<sup>2</sup>) and

In addition, samples welded at 450 A and 475 A showed 8.4 and 9.3% elongation in tensile tests due to the welding errors mentioned above. While the % elongation of the base material was 22%, the samples joined at 500 A, 525 A and 550 A exhibited % elongation of 21.2%, 19.7% and 18.6%, respectively. The reason why these samples exhibit less % elongation than the base material can be explained by the fact that the hardness values of the weld metal and HAZ are higher than the base material due to the increasing heat input in parallel with the increase in welding current (Figure 16). Similar results have been reported after tensile tests applied to steels joined by submerged arc welding method [19,26,27].
