# Application of submerged arc welding at different amperages in the manufacture of storage tanks and examination of the weld zone

*Yazar(lar) (Author(s)):* Yiğitcan ATILGAN<sup>1</sup>, Mehmet Serkan YILDIRIM<sup>2</sup>, Yakup KAYA<sup>3</sup>

In the study, ASTM A36 steel materials were combined with submerged arc welding using different amperages. Non-destructive magnetic particle (MT), liquid penetrant (SP), radiographic (RT), and ultrasonic (UT) examinations were performed on the joints. In addition, optical microscope, microhardness, bending, tensile, and notch impact tests were carried out on the welds. As a result of the RT and UT examinations, a lack of root penetration was found in the welds made at 450 A and 475 A. In the optical microscope examinations, the areas formed by the HAZ-weld metal transition were found to have a similar appearance for each amperage. In the microhardness studies, the hardness values are listed as weld metal, HAZ, and base material from high to low. From the notch impact tests, it was found that increasing the temperature increased the toughness value. From the bending tests performed on the joints where 450A and 475A were used, it was found

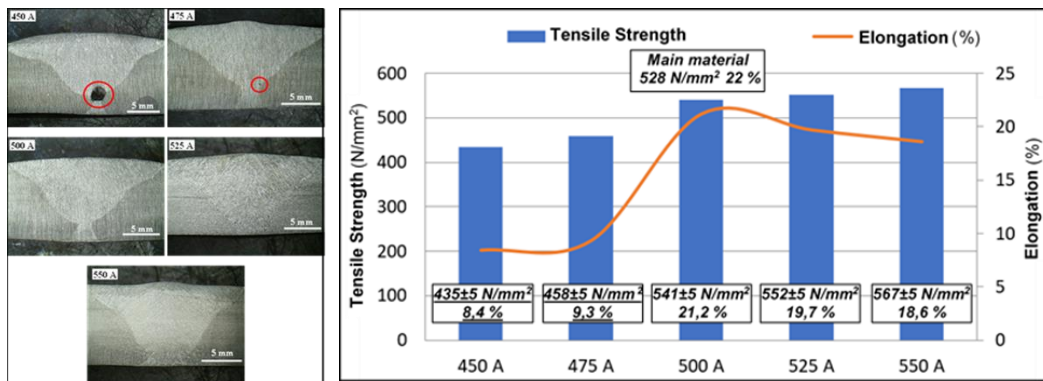
ASTM A36 steel plates are joined by submerged arc welding method using different amperage values.

Figure. Macrostructure images and tensile/elongation graph

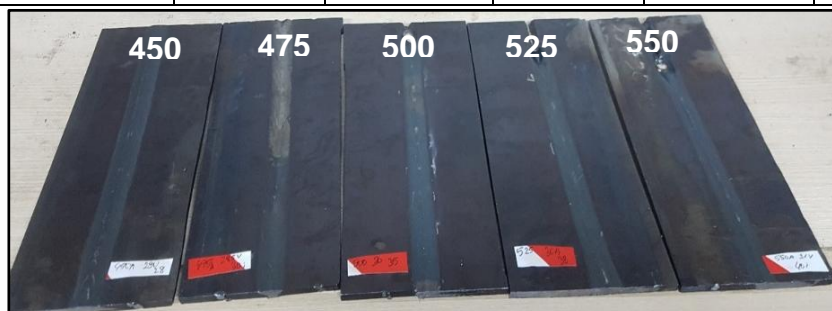
In accordance with EN ISO 15609-1, a 30° V weld groove was opened on ASTM A36 plates and fix from the rear, leaving a 1 mm gap. Prior to welding, the plates were turned upside down and the root pass was made using the electrode arc welding method. The plates, which had been cleaned, were then joined in a single pass using submerged arc welding at different current levels. The parameters used in the welding processes are given in Table 3. The sample image after welding is shown in Figure 1.

**Figure 1.** Sample image after welding

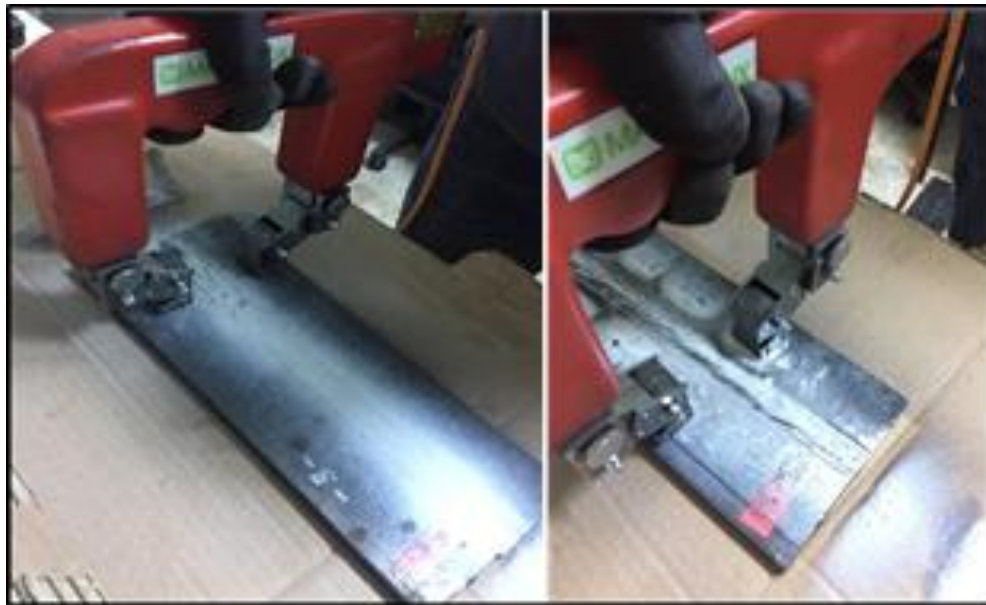
It was applied by a magnetic particle inspection test expert in accordance with the TS EN ISO 9934 standard (Figure 4) and reported in accordance with the EN ISO 23277 standard (Figure 5). Upon examination of the magnetic particle test results, no surface defects such as cracks, pores, or combustion grooves were found on the weld surfaces. In the report approved by the expert, it was determined that there were no superficial defects in all welding currents used and that the welds were in compliance with the standards. Özkan [14] reported that no cracks, pores, etc. were detected on the weld surface as a result of magnetic particle tests performed after the welding of structural steels.

Figure 4. Magnetic particle test application image

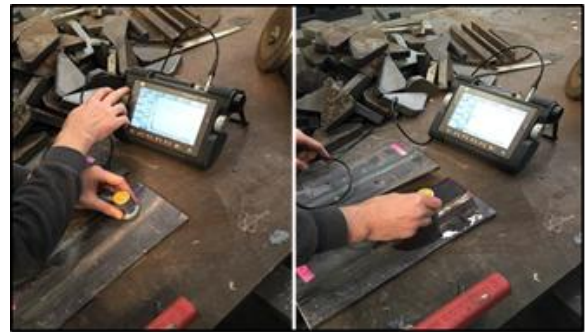
To detect subsurface/section defects, an ultrasonic test was applied by an expert according to TS EN ISO 23279 standard (Figure 6) and reported (Figure 7).

Figure 6. Ultrasonic inspection application image

When the ultrasonic examination results were examined, a lack of penetration at the root (insufficient penetration) was observed in processes using 450 A and 475 A welding currents. As sufficient heat input cannot be achieved at these current values (Table 3), it is thought that full penetration between the root pass and the weld (Figure 10) cannot be achieved. No discontinuities (undercut, residue, pores, cracks, etc.) were observed in the plates joined at 500 A, 525 A and 550 A. In the report approved by the expert, it was determined that the plates combined with 450 A and 475 A welding currents needed to be repaired, while the plates combined with 500 A, 525 A, and 550 A welding currents were suitable.

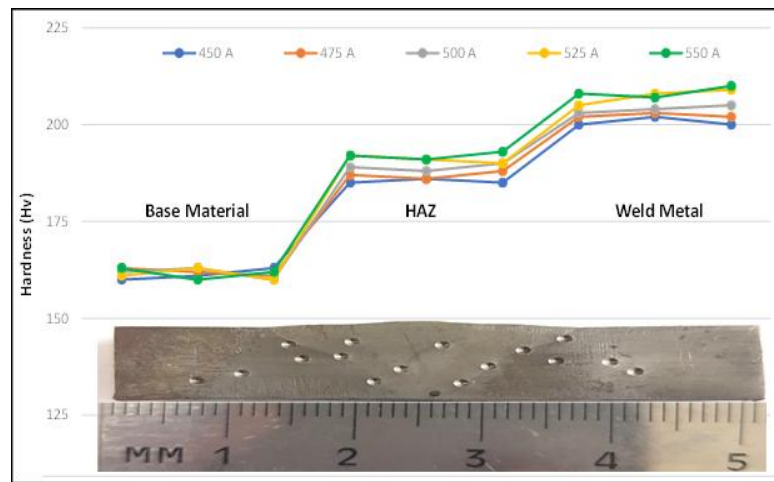
The graph obtained because of the hardness tests applied horizontally to the welding zone of the plates joined by the submerged arc welding method is given in Figure 16.

When the microhardness results of the joints made using different welding currents was explored, it was observed that the measured hardness values were close to each other, but the samples joined using 550 A welding current had higher hardness values. It is thought that the increase in hardness values due to the increase in current values is due to heat input. It was determined that the hardness values of the weld metal in all samples were higher than the HAZ and the base material. The highest hardness value was determined in the weld metal, followed by HAZ and base material. The difference in hardness values of weld metal, HAZ and base material varies depending on the heat and cooling rate they are exposed

Weld metal hardness values were measured as (450 A)  $200 \pm 5$  HV, (475 A)  $202 \pm 5$  HV, (500 A)  $203 \pm 5$  HV, (525 A)  $205 \pm 5$  HV, and (550 A)  $207 \pm 5$  HV. HAZ hardness values were measured as (450 A)  $185 \pm 5$  HV, (475 A)  $186 \pm 5$  HV, (500 A)  $188 \pm 5$  HV, (525 A)  $190 \pm 5$  HV, and

Figure 16. Hardness test results

be explained by the fact that the hardness values of the weld metal and HAZ (Figure 16) are higher than the base material due to the increasing heat input (Table 3) in parallel with the increase in the welding current. Similarly, according to the previous analysis results, the results of the non-destructive and macrostructure studies did not indicate that any welding defects were found in the welding area, and the tensile test results were also supported by these results. The samples that broke in the weld area after the tensile test broke brittle due to the welding defects mentioned above. However, the samples that fractured in the base material experienced ductile failure, and the weld zone did not show any visible damage. In the samples united at 500 A, 525 A or 550 A, the rupture zones were observed in the base material, not in the weld metal or HAZ.

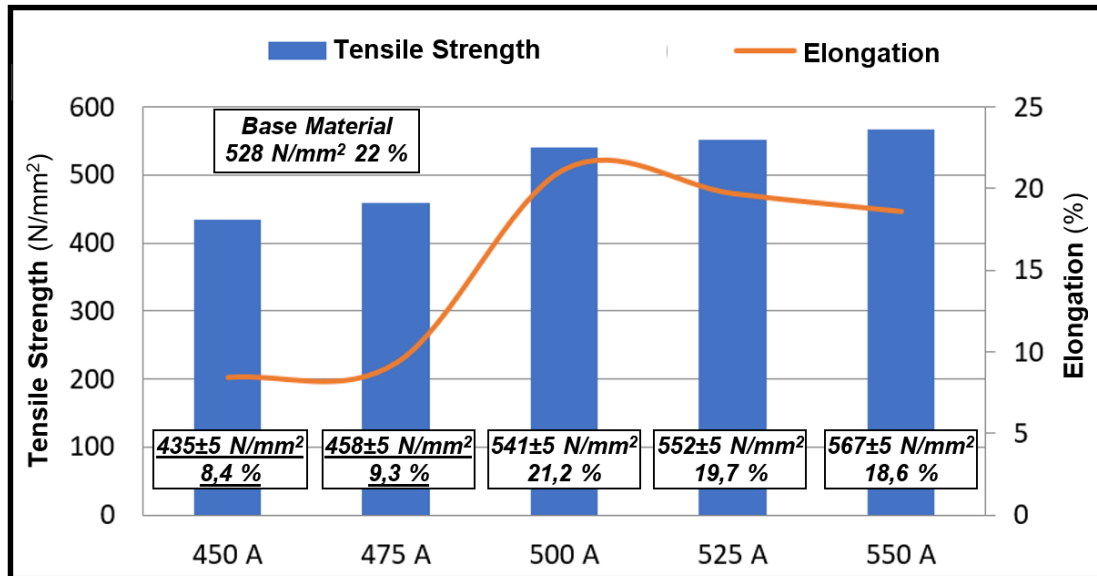
The graph of the tensile tests applied to the sheets joined using the submerged arc welding method is given in Figure 17, and the rupture images after the tests are given in Figure 18.

When the tensile test results were examined, the rupture occurred in the welding zone in the plates joined to 450 A and 475 A, while the rupture occurred in the base material in the plates joined to 500 A, 525 A and 550 A. It was determined that the tensile strength of the sheets joined at 450 A ( $435 \pm 5$  N/mm<sup>2</sup>) and 475 A ( $458 \pm 5$  N/mm<sup>2</sup>) welding currents was lower than the tensile strength of the base material ( $528$  N/mm<sup>2</sup>). Ultrasonic (Figure 7), radiographic (Figure 8-9) and macrostructure (Figure 10) results showed that 450 A and 475 A values were not appropriate. In the sample joined at 450 A welding current, it was observed that the welding performed in a single pass did not penetrate the root pass and a lack of melting/penetration occurred with a diameter of approximately 2 mm. It was observed that there was a melting/penetration deficiency of

Figure 17. Tensile and elongation graph

In addition, samples welded at 450 A and 475 A showed 8.4 and 9.3% elongation in tensile tests due to the welding errors mentioned above. While the % elongation of the base material was 22%, the samples joined at 500 A, 525 A and 550 A exhibited % elongation of 21.2%, 19.7% and 18.6%, respectively. The reason why these samples exhibit less % elongation than the base material can be explained by the fact that the hardness values of the weld metal and HAZ are higher than the base material due to the increasing heat input in parallel with the increase in welding current (Figure 16). Similar results have been reported after tensile tests applied to steels joined by submerged arc welding method [19,26,27].
