Investigation of the earthquake behavior of historical erzincan çadırcı bath and the reasons for its persistence until today

Investigation of the Earthquake Behavior of Historical Erzincan Çadırcı Bath and The Reasons for Its Persistence Until Today

Araştırma Makalesi / Research Article

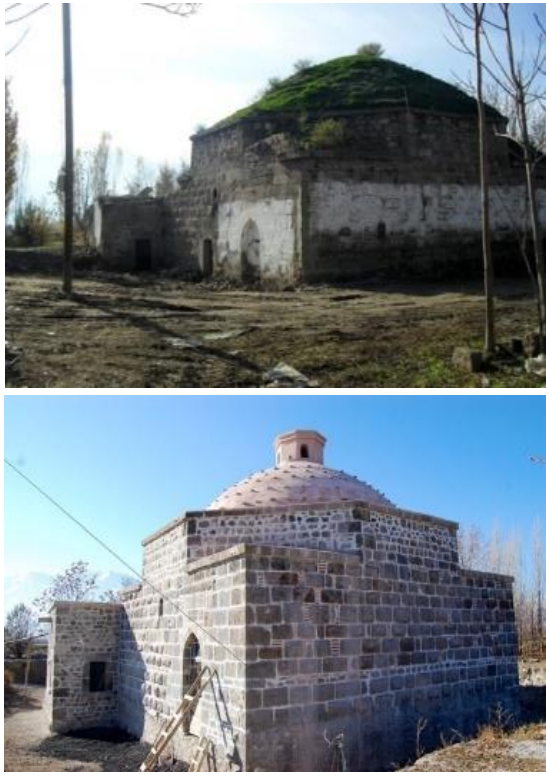
Figure 3. Çadırcı Bath before and after restoration (2016-2020) (from the the Author’s archives)

The Historical Çadırcı bath, the research object, is located in the old city settlement, which was relocated after the 1939 earthquake in the south of the Erzincan modern urban settlement. According to the construction and repair inscriptions on the building, the Çadırcı bath was built in 1548 by the son of Mahmut, Şeyh Ahmet, and it was repaired between 1677-78 [29]. It is one of the three bath structures that have survived the old city, which was destroyed by the 1939 earthquake. There was no structural damage in the Çadırcı bath in the 1992 earthquake either. The building, which continued to function as a bath until the 1950s, remained unused for many years [30]. It was declared a monument by the Turkish Ministry of Culture in 1980 and restored between 2016 and 2020 (Figure 3).

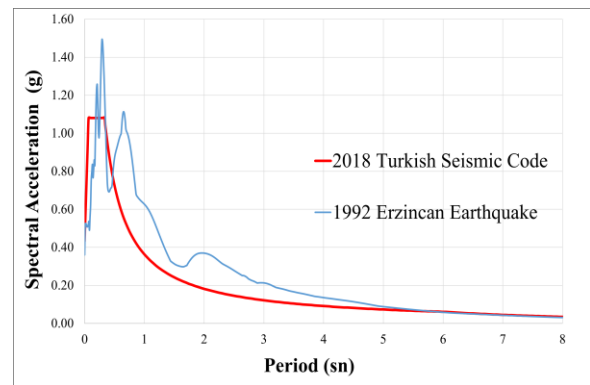
Figure 7. Response spectrum

To assessment the earthquake behavior of the Historical Çadırcı Bath, Response Spectrum analysis was performed according to the Turkish Seismic Code [33]. In the analysis, the earthquake level was determined as a designed earthquake with a probability of exceeding 10% in 50 years (recurrence period of 475 years). As seen in Table 2, local acceleration values of the location of the historical building were taken from AFAD's interactive earthquake risk map [34].

In Table 2, PGA (g): Peak ground acceleration, PGV (cm/s): Peak ground velocity, S_s: Short period map spectral acceleration coefficient, S₁: Map spectral acceleration coefficient for 1.0 second period, S_{DS}: The short period design spectral acceleration coefficient and S_{D1}: the design spectral acceleration coefficient for the 1.0 second period. The earthquake load reduction coefficient (R_a) was taken as 1 since the existing historical structure was evaluated. The response spectrum graph is defined as shown in Fig. 7 by using the values taken from the earthquake risk map according to the location of the historical building.

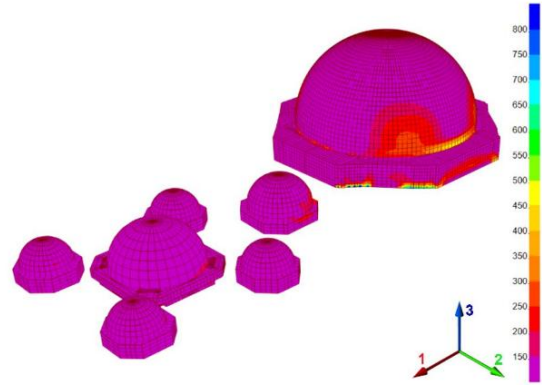
Figure 11. Shear stress distributions

S13 -Domes

S23 -Domes

S13-Vaults

S23-Vaults

S13-Walls

S23-Walls

The results of the analyses were evaluated separately for three different structural elements (dome, vault, and wall). Shear stress distributions due to the earthquake were analysed in two different components, 1-3 and 2-3. For each structural element, the stresses in two different directions were analysed and the maximum values determined on the whole element were noted. The elements where the shear strengths calculated by Equation No. 1 were exceeded were marked in red on Table 5. In the stress distributions given in Figure 11, the 1-3 component represents in-plane stresses for the elements extending in the 1 direction, while it represents out-of-plane behaviour for the elements extending in the 2-direction. The 2-3 component represents out-of-plane stresses for the elements extending in 1-direction and in-plane behaviour for the elements extending in 2-

directions. When Figure 11 and Table 5 are analysed, it is seen that the most damage due to the earthquake occurred in the vaults, then in the internal walls and least in the domes and external walls.

- It has been observed that the building can safely bear the compressive stresses under its weight.
- When the shear stresses under the effect of the earthquake were examined, it was observed that the masonry walls under the D-7 dome were severely damaged under the effect of the earthquake. It was observed that the walls under the D-3 dome were partially damaged and the other outer walls were not damaged. When the vaults were examined, it was observed that the slip safety of the V-1 vault, which is known to be used as a water tank, was exceeded and partial damages were observed in the other vaults. No damage was observed under the earthquake load in any of the domes in the building.
