Reliability Assessment of Cracked Reinforced Concrete Slab and Verification using a Full-Scale in-Situ Load Test

This paper presents a case study focused on the deterministic and probabilistic structural assessments of a cracked reinforced concrete (RC) slab and evaluation using in-situ load testing. The case study explores the practical application of in-situ load testing as a diagnostic tool for evaluating the condition of the slab and determining its ultimate load-carrying capacity in the presence of cracks, and service loads are used to verify its serviceability. Through comprehensive analysis and interpretation of test results, this study aims to provide valuable insights into the structural performance of cracked reinforced concrete slabs and inform effective repair and rehabilitation strategies. The building under examination is a G+4 reinforced concrete structure constructed using ready mix concrete transported to the construction site. Upon inspecting the slab, which had a total thickness of 170 mm, numerous deeply mapped cracks were evident, visible from the slab's surface and extending through its entire depth. Structural analysis indicated that the design included suff

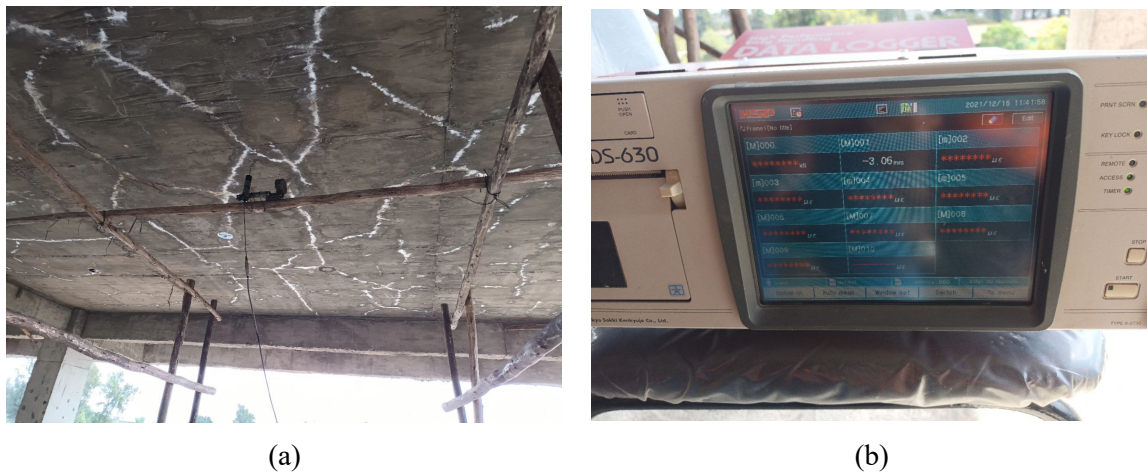
Fig. 3. Set-up for loading test (a) slab deflection measurement and (b) data logger

For the test setup, the slab to be investigated was first selected, with existing cracks, damages, or deformations documented. Instrumentation such as displacement transducers (LVDTs) was installed to measure deflections at the mid point and crack width scale was used to measure cracks. Before loading began, initial measurements of deflections, crack widths, and the slab's condition were taken for comparison throughout the testing process. The loading test was conducted using the setup presented in Fig. 3.

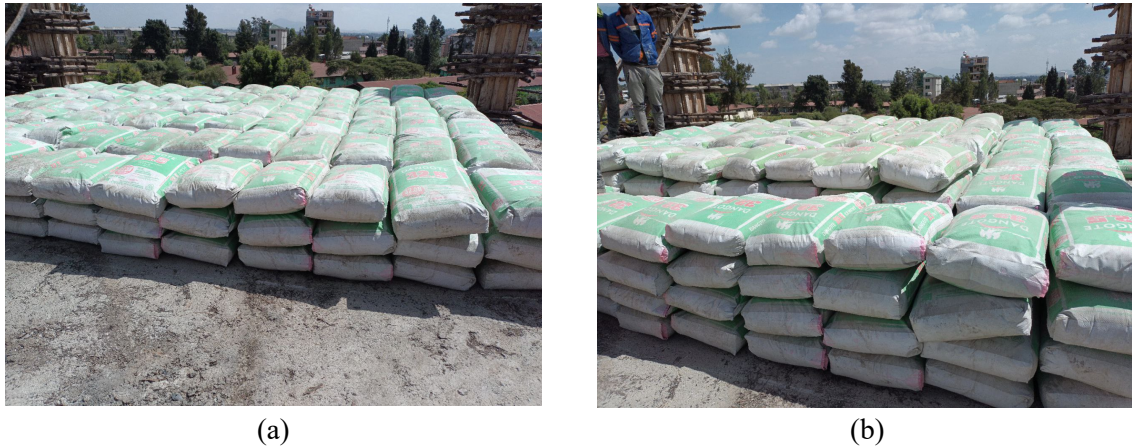
Fig. 4. Surface loads used for loading test a) three layers b) five layers

During the test, the behavior of load-deflection response of the slab was checked at each loading step. The test load was applied incrementally in five layers as recommended by ACI 318 [15] up to the maximum load intensity of 8.0kN/m^2 and deflection is measured using LVDT [16]. In addition to the deflection measurements, any possible cracks formation, opening/closure of flexural cracks were tested and taken after each load increment to monitor the slab's response. The test continued until the slab showed signs of failure, which could include excessive deflection, significant crack widening, material distress (such as spalling or crushing), or instability in the form of a rapid increase in deflection without a corresponding increase in load. Fig. 4 shows a loaded RC slab with cement bags. Finally, the loads are removed immediately after all response measurements (deflection and crack widths) are made. In each loading and testing steps, safety provisions are properly followed.

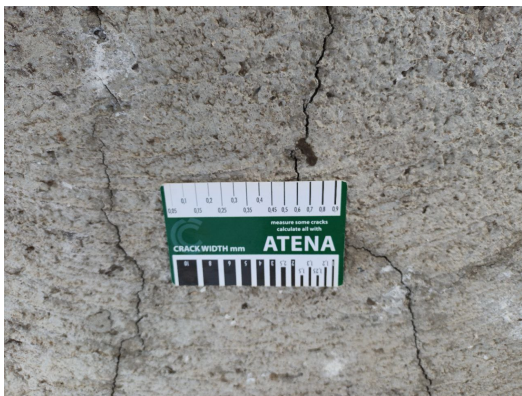
Fig. 5 presents the cracks seen on top surface of the deck; they are found to be of random pattern and distributed in the panel fully indicating a non-structural cause i.e., contraction of the paste. The site observations showed that the concrete has been leaking water through the cracks indicating crack opening running deep to the depth of the slab. To confirm this, two core samples were taken at locations where cracks were visible on the surface. The core samples verified that the cracks observed on the top surface extended to the depth of the slab, as illustrated in Fig. 6. For the cracked slab under investigation, a maximum crack width of 0.6mm has been measured.

Fig. 5. Cracks observed at deck top surface

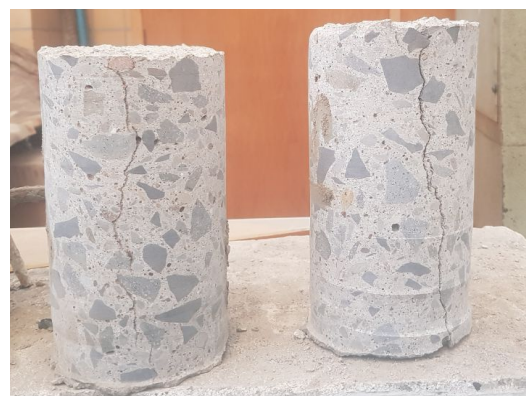
Fig. 6. Core samples reaching the full depth of the slab

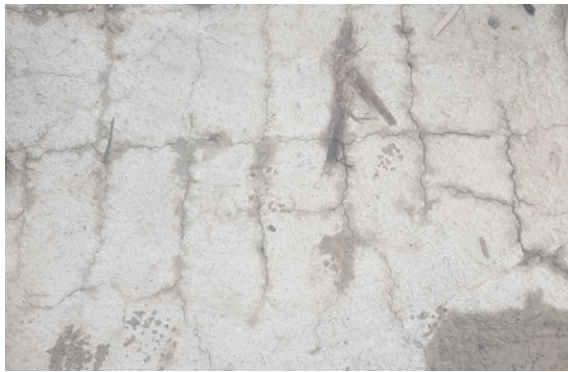
Fig. 7 below shows plastic settlement cracks which run along the directions of top restraints. By their nature settlement cracks are known to occur primarily while the concrete is plastic and bleed water is still rising and covering the surface. They tend to roughly follow restraining elements such as reinforcement bars (see Fig. 8) or change in depth of members. To avoid formation of such cracks it is recommended to use mixes with lower bleeding characteristics and increase the ratio of cover depth. Bleed of concrete may result from excessive water to cement ratio (greater than 0.50) or excessive water reducer dosage that causes free water to rise to the top surface. It is also suggested that the finishers wait to proceed until the water evaporates or re-trowel the surface to close the settlement crack openings while the concrete is still plastic.

Fig. 7. Plastic settlement cracks

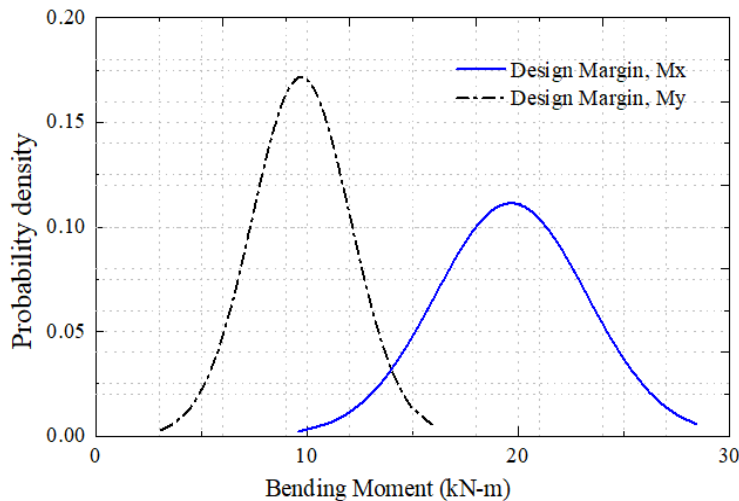
The probabilistic assessment results in terms of design margin for bending moment in x- and y-directions are computed and the corresponding probabilistic distribution graphs are presented in Fig. 12. The reliability indexes of the slab under investigation for bending moments in x- and y- directions are computed using Eqn. (5) and they are found to be 5.52 (β_{Mx}) and 4.17 (β_{My}), respectively. Thus, the safety index of the slab structure becomes 4.17 with a probability of failure of 10^{-6} [21]. The slab is found to fulfill the minimum requirements for ultimate limit states with medium consequence of failure (office and public buildings), with a reliability index limit of 3.8 (for a 50-year return period) [21,40]. Furthermore, it satisfies the minimum target reliability index requirement of 2.5 for a slab element subjected to bending [41].

Fig. 12. Probabilistic distribution of design margin for moment

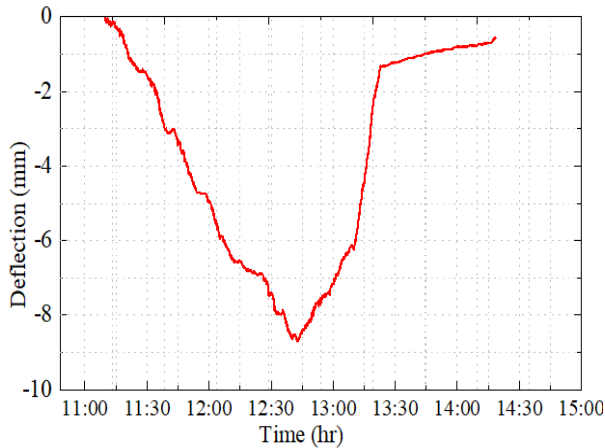
Time-history and record of mid-span deflection of RC slab due to external surface loads are shown in Figs. 13 and 14, respectively. From Fig. 14, under the action of various loading steps, it is observed that the load-displacement relationship is linear and no opening or closure of cracks have been noticed. As there was no nonlinear load-deflection was observed at each loading step, the slab was loaded up to the maximum load (8kN/m^2). As can be observed from the deflection curve of the RC slab, the structure’s deflection due to additional dead and live loads (6.06kN/m^2) was found to be 6.81mm. The deflection of the slab for 5 layers of surface load was measured as 8.68 mm.

Fig. 13. Time-history of deflection
