# Comparison of Microleakage of Monolithic Zirconia after Surface Treatment and Thermal Cycles Using Data Analysis Software

Article Info	ABSTRACT
<b>Article History</b> <b>Received:</b> 16.06.2024 <b>Accepted:</b> 14.10.2024 <b>Published:</b> 15.10.2024	<b>Objective:</b> The aim of this study was to investigate the microleakage of monolithic zirconia after different surface treatments using computer software. <b>Materials and Methods:</b> Three different monolithic zirconia ML (Multilayered), STML (Super Translucent Multilayered), UTML (Ultra Translucent Multilayered) were prepared as discs with a diameter of 15 mm and a thickness of 1.2 mm. Four different surface treatments (Hydrofluoric acid, Tribochemical silica coating, Hydrofluoric acid application + Tribochemical silica coating, Milling + Tribochemical silica coating + Hydrofluoric acid application) were applied to the prepared samples according to their groups (n=8). Samples, Group C: Control group, Group HF: Hydrofluoric acid application, Group T: Tribochemical silica coating, Group HF+T: Hydrofluoric acid application + Tribochemical silica coating, Group F+HF+T: Milling + Tribochemical silica coating + Hydrofluoric acid a

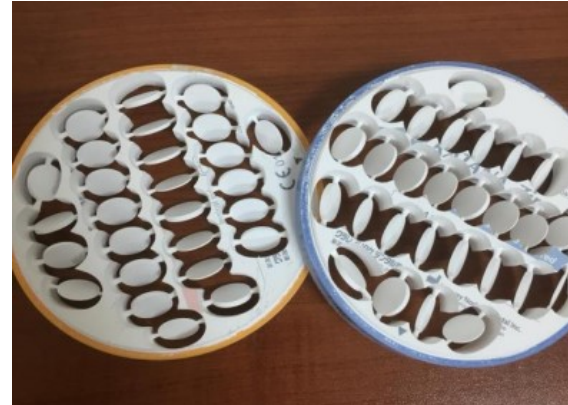
**Figure 1.** Preparation of Specimens

test.<sup>14</sup> A total of 120 samples were included in the study. All were of the same brand (Katana; Kuraray, Noritake Dental Inc, Tokyo, Japan) and were manufactured using a CAM (Yenadent D43, Yenadent Ltd, İstanbul, Türkiye) system. The sample was designed using computer software (Meshmixer, California, USA) and pre-sintered in a laboratory with a sintering furnace (Everest Therm; KaVo Dental GmbH, Biberach, Germany) following the manufacturer's instructions. According to the international standard ISO 6872, the final dimensions were in the form of a disk 15 mm in diameter and 1.2 mm in thickness, consistent with the methodology used in scientific studies on the durability of all-ceramic materials (Figure 1).<sup>15</sup>

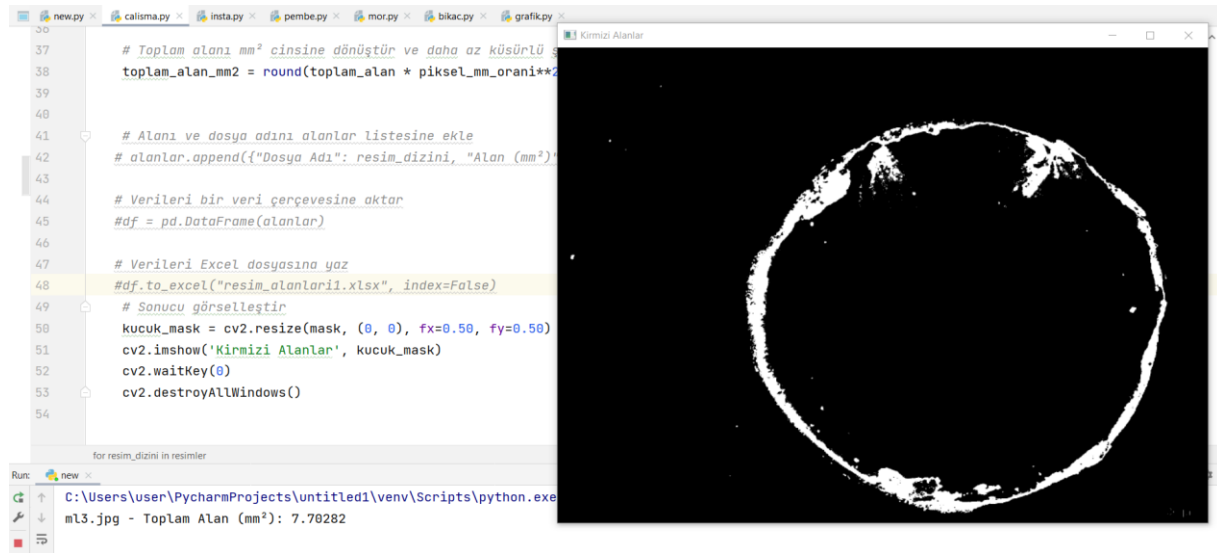
Figure 3. Measurement of microleakage areas in the Pycharm program

were soaked in 0.5% basic fuchsin at 37°C for 24 hours. After staining, the prepared samples were cut in half to evaluate the microleakage. Using a linear precision saw (Isomet 1000 Linear Precision Saw; Beuhler, Illinois, USA), the specimens were cut in half at a speed of 600 rpm. The cutting process took into account the thickness of the water-cooled cutting blade, which is 0.3 mm. The prepared samples were kept in basic fuchsin solution for one day to evaluate the coloration of the microleakage areas. Then, images of the samples were taken under a stereomicroscope (SZx10 Olympus, Tokyo, Japan) at 25x magnification) (Figure 2). Calibration was performed by placing a ruler within the field of view of the microscope and utilizing the microscope's measurement capabilities. Surface images were captured once the ruler's measurements were aligned with the measurements provided by the microscope's software. The images were transferred to a computer program (Pycharm 3.12.3, Prague, Czech Republic), and the dimensional sizes of the images were obtained in square millimeters (mm<sup>2</sup>) through the program (Figure 3).
