FIELD APPLICATIONS FOR RISK ASSESSMENT METHODS OF URBAN TRANSFORMATION LAW NO. 6306: A CASE STUDY OF BEYOĞLU

Özgür ANIL^{1*}, Mustafa K. KOÇKAR¹, Mustafa ŞAHMARAN²

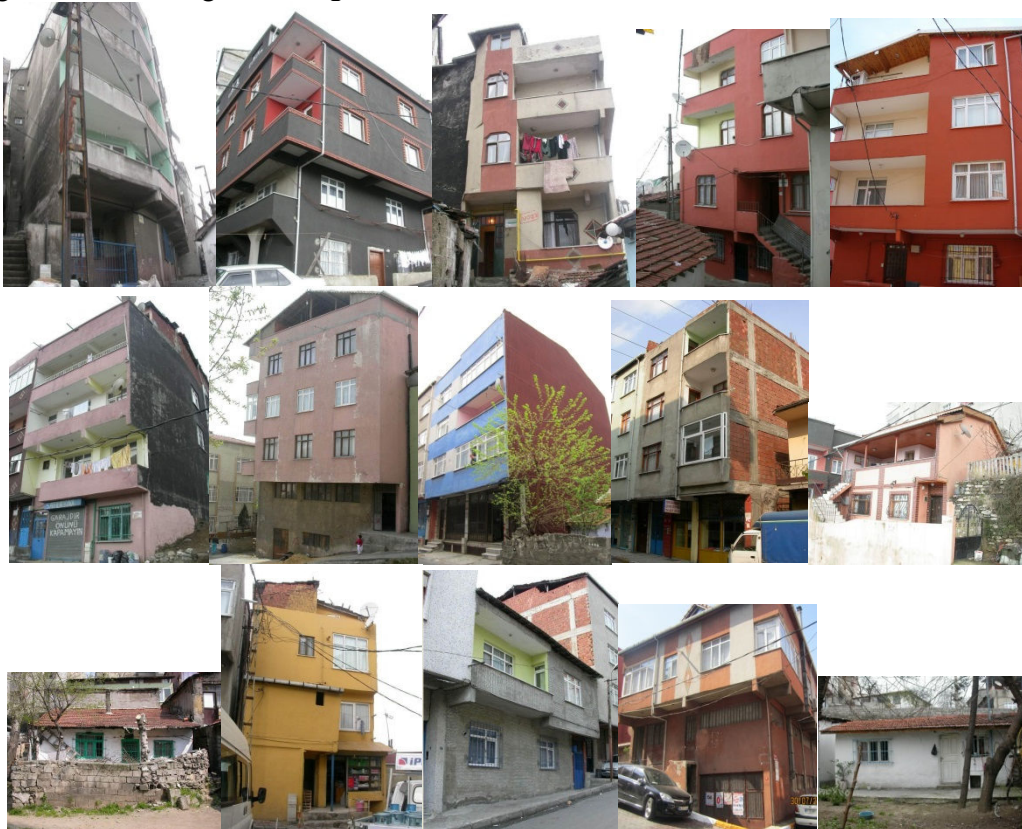
Figure 3. Example Photographs from Masonry and Reinforced Concrete Buildings in the Area

Building performance points (PPs) of each of 5561 structure identified to be suitable for this study within the study area were calculated according to methodology specified in Annex A and filling the forms for masonry and concrete buildings presented also in Annex-A of the Regulation on the Implementation of Law No. 6306 of Transformation of Areas under the Disaster Risks. Method given in Annex A is a rapid assessment technique and is based on an information sheet to be filled in the field to identify earthquake risk level of reinforced concrete and masonry buildings. In order to apply this method, primarily information sheet given in Annex-A is filled for each building in the area which allows acquiring important information on these structures. The project teams performing the field work have taken minimum 2 photographs of each building. Performance points of each building is calculated as outlined in Annex-A. Special software was developed in Excel to expedite these calculations. This software allows automatic calculation of performance points for each building after all data in the data (information) sheets are presented as input to the system, and this software also allows transferring the data to suitable Geographical Information Systems (GIS) software as well. Transfer of data and performance points to GIS environment allows acquisition of various statistical interpretations and preparation of thematic maps. Example photographs from typical masonry and reinforced concrete buildings in the area are given in Figure 3.

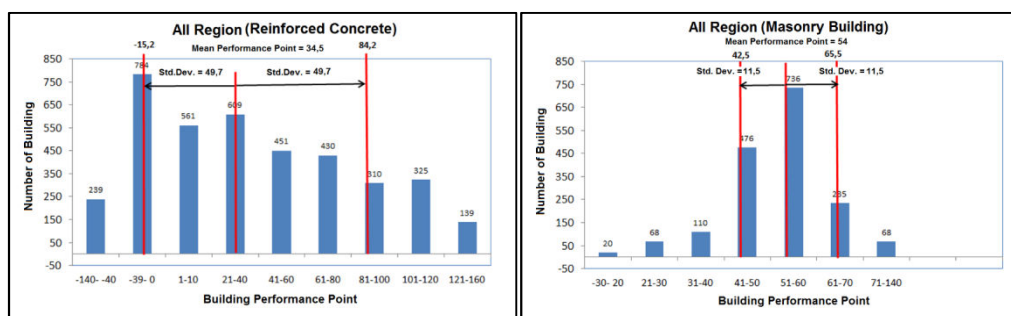
Figure 4. Performance Point Distribution of Reinforced Concrete and Masonry Buildings in the Study Area

According to investigations performed within the risk assessment area have shown that there are total of 5561 buildings within 6 neighbourhoods in the area and 3848 of these are reinforced concrete and 1713 are masonry. According to assessment of storey number of these buildings, it was observed that the reinforced concrete buildings are generally 4 storey and masonry buildings are generally single storey structures. Charts showing PPs of reinforced concrete and masonry buildings in the study area are given in Figure 4. High standard deviation value for reinforced concrete buildings shows that PPs of reinforced concrete buildings have wide distribution range and high difference. The PPs of reinforced concrete buildings have significant difference. According to mean and standard deviation of performance points of reinforced concrete buildings, it was observed that significant number of reinforced concrete buildings falls within -15 and 84 PP range. On the other hand, average PP value of total of 1713 masonry buildings was calculated as 54. This value can be considered to be low for masonry buildings composed mostly of single storey. It is known that number of storey is an important parameter in calculation of performance points of buildings. As the 50-60 range is considered as average and lower than average PP, total of 1410 masonry structures was observed to have lower than average performance points. The percent of masonry structures within average range or lower than average was found as 81%. Standard deviation calculated for PPs of masonry buildings is 11.5. This value is considerably lower than standard deviation calculated for reinforced concrete buildings. The lower standard deviation value of masonry buildings shows that PPs of masonry buildings have narrower range and have smaller difference. According to mean plus one standard deviation of the PPs of masonry structures, it was observed that most of the masonry buildings fall within 42-66 range. Thematic GIS map showing distribution of building PPs within the study area is given in Figure 5.

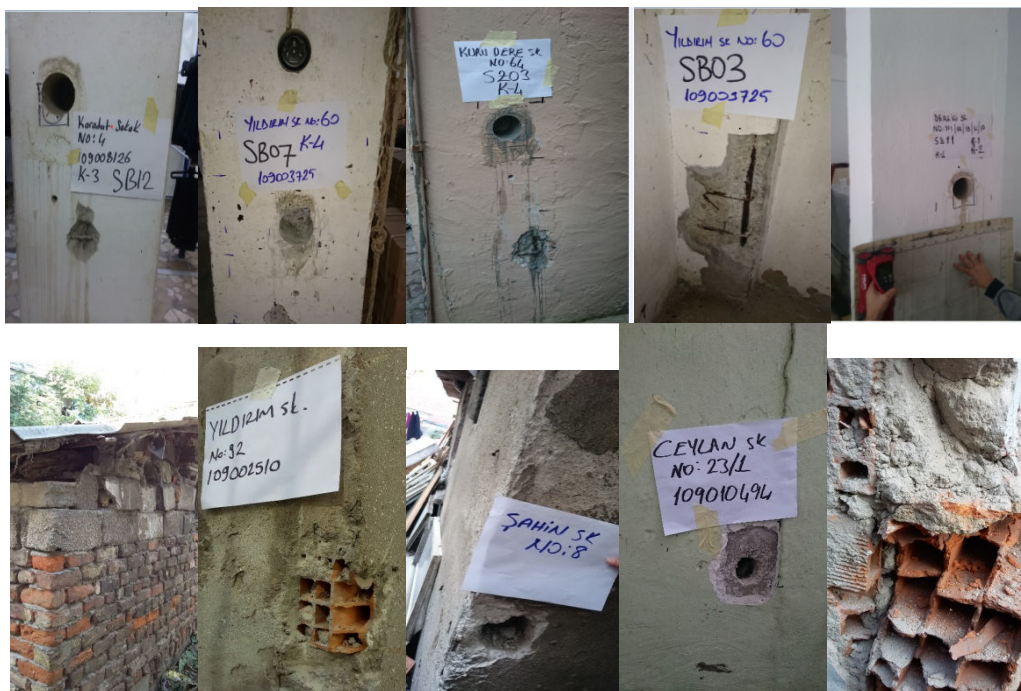
Figure 6. Data Collection from reinforced concrete and Masonry Buildings

and sampling methods to identify the number of buildings to be subset are presented. A cooperative study was performed with cooperation of Beyoğlu Municipality according to number of sample strata and buildings to be selected, and detailed second stage assessment and analyses were performed on the buildings satisfying the criteria and with the permission of the building owners according to the Circular on Detection of Risky Buildings given in Annex-2 of the Regulation on the Implementation of Law no. 6306. During identification of buildings for the second stage assessment number and quality of buildings presented in both statistical sampling methods summarized above were considered. The sampling through destructive test methods can be made only after permission of the building owners. Thus total of 150 buildings, reinforced concrete of 113 and masonry of 37, were selected and second stage risk assessment was performed. Example photographs taken during material strength and building surveys performed on reinforced concrete and masonry buildings during the second stage risk assessment are given in Figure 6. In assessment of reinforced concrete structures, concrete material strength, reinforcement quality, amount of longitudinal reinforcement, tie (stirrup) interval, length of structural elements and structural geometry defects are factors effecting earthquake performance of buildings. Considering these, it was observed that concrete material strength and reinforcement quality was observed to be considerably low in general. Average concrete compressive strength of 113 buildings is 9.4 MPa. Unchecked preparation of reinforced concrete elements of buildings, which are constructed between 1960 to 1970, with unwashed aggregate, inhomogeneous manual mixing, low binder dosage, high water/binder ratio and insufficient maintenance are the main reasons of low average concrete compressive strength. It was observed from core samples that concrete includes rock particles larger than 3 cm. The highest and lowest concrete compressive strength values of 113 inspected buildings were 21.7 and 3.5 MPa, respectively.

Reinforcement class of 108 building is S220 unribbed reinforcement. Furthermore, in-situ investigations have shown that stirrup densification is not present in any of the inspected buildings. Stirrup hook detail of 135° was not present in the entire study area. These deficiencies in stirrups causes shear capacity of elements to be insufficient. Average reinforcement percentage is 0.92%. Shear wall elements are not present in the buildings except basements. As rigidity of earthquake shear walls is higher when compared with columns, they can bear earthquake loads more. Bending moments in columns is higher due to structural rigidity insufficiency. Low Concrete strength and insufficient longitudinal reinforcement causes bending capacity (strength) to be insufficient. 111 buildings out of 113 were

identified as risky. The above summarized reasons were the main causes of these results. Low material strength and structural systems indicates structure risk status. Reinforced concrete buildings to be in high damage or collapse region in design spectrum indicates the risk status of building stock of the area.

Total of 37 masonry building was investigated according to RYTE, 2013 [7]. The investigation has shown that load bearing wall materials of the buildings are briquette, hollow briquette and horizontal coring brick. Only one building has vertically perforated brick as load-bearing wall material. Class of load bearing wall material is the main factor impacting strength of structure under stresses. Although it is mentioned in article 1.5 of RYTE 2013 [7] that "is risky report is given for buildings constructed with adobe and materials with no load bearing character, by indicating technical reasons, via institutions licensed by the ministry, then these structures are assumed to be risky under Law no. 6306.", structural analyses were performed for buildings with load bearing wall materials as briquette, hollow briquette and horizontal cored brick which have no load bearing character according to DBYBHY, 2007 [8] section 5. It was observed in some of the buildings that shear safety stress is not exceeded. It was identified that total length limit, load bearing wall longest unsupported length condition; load bearing wall hollowness rule stated in regulations is not satisfied in the buildings. Horizontal and vertical lintels to increase horizontal rigidity of walls and hinder out-of-plane movement are not present in any of the inspected buildings. It is obvious that no engineering service was procured and no planning was made for the buildings. Only 1 out of 37 masonry buildings were classified as unrisky in accordance with the detailed risk analyses.

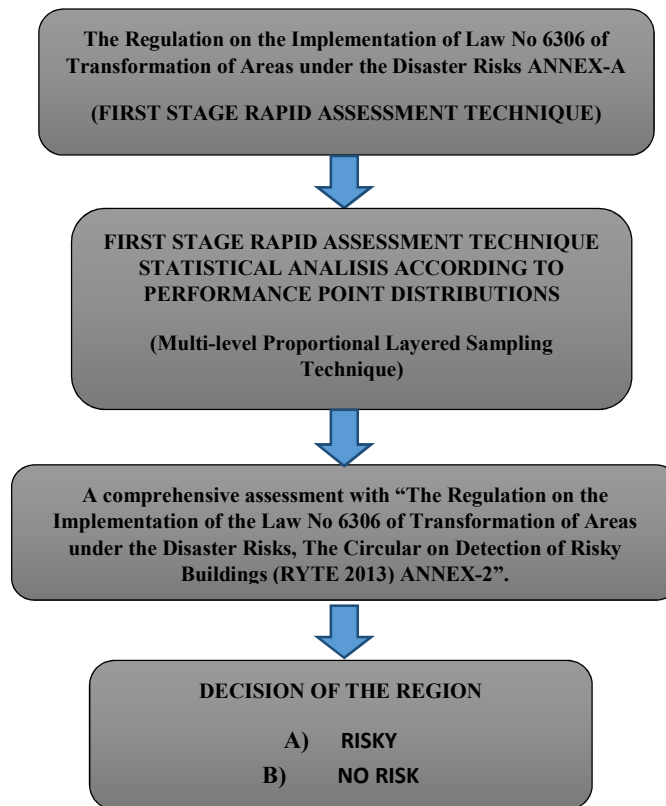
Figure 7. Flow Chart of Proposed Risk Area Assessment Method

Summary diagram of the above summarized methodology is given in Figure 7. The method is developed as a general methodology that can be applied to identify risk status of any region based on superstructure distribution. The methodology supports the rapid assessment and detailed assessment methodologies given respectively in Annex-A and Annex-2 of the Regulation on the Implementation of the applicable Law, and set forth based on scientific literature. There are studies which is necessary to increase the correlation between the above summarized three stage risky area assessment methods. The studies and detailed application performed by the authors have shown that research is required to increase correlation of results acquired by rapid assessment technique shown in Annex-A and RYTE, 2013 [7] methodology in Annex-2. It is considered that revision of certain aspects of scoring system of rapid assessment technique and addition of certain new scoring categories may increase correlation between two assessment techniques. It is considered that comparison of construction year of the building with earthquake regulations in place in Turkey is an important parameter to be included as additional criteria. Another important parameter is concrete compressive strength for reinforced concrete buildings. In order to avoid over-extending the application time of rapid assessment technique, a solution other than core sampling should be considered. It is considered that the risk area assessment approach with the
