An Overview of the Factors Affecting the Migration of Sturgeons in Yeşilirmak

Cite this article as: Ustaoglu Tiril, S., Memiş, D. (2018). An Overview of the Factors Affecting the Migration of Sturgeons in Yeşilirmak. *Aquatic Sciences and Engineering*, 33(4): 138-144.

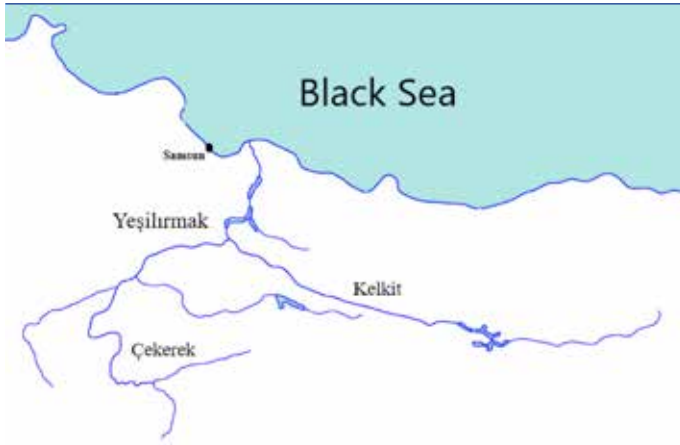
Figure 1. Yeşilirmak

Yeşilirmak is 519 km long and is derived from Köseadağ located within the boundaries of Sivas Province and flow into the Black Sea in Samsun-Çarşamba (Figure 1). While passing through Tokat, Amasya and Samsun, it connects with Çekerek, Tersakan and Kelkit Streams.

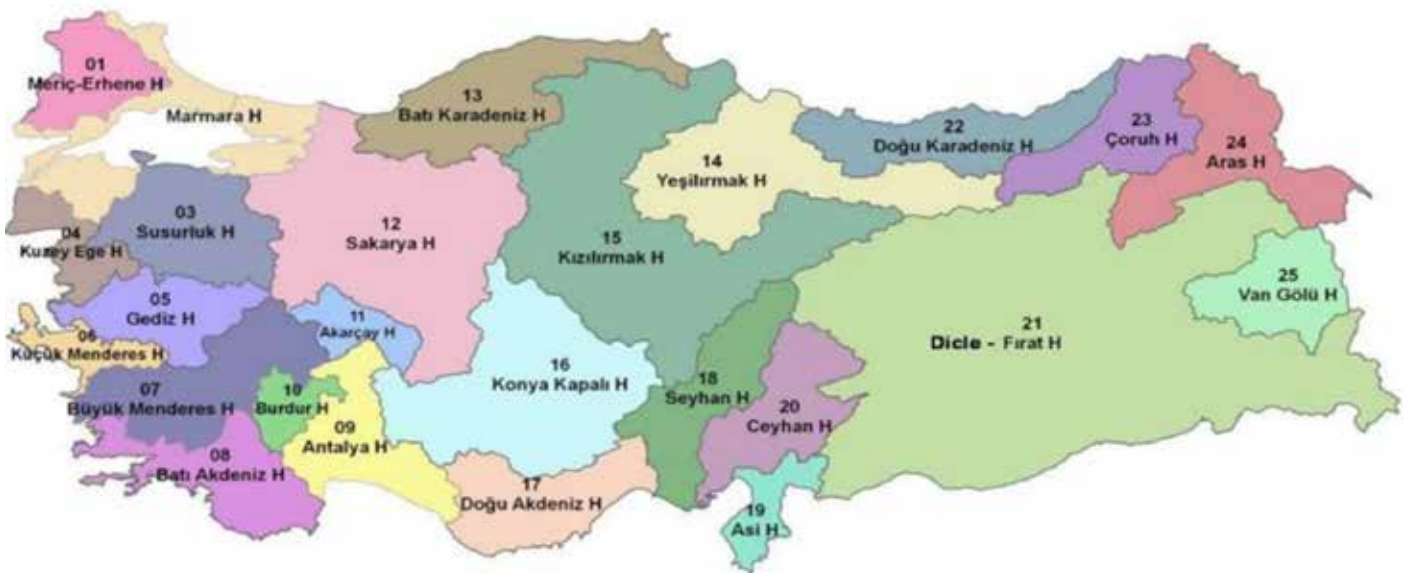
Figure 2. River Basin Map of Turkey (National Watershed Management Strategy (2014-2023) - (07/04/2014 date and 29050 numbered Official Newspaper)

Yeşilirmak, streams and brooks located in the west and east of the Yeşilirmak spilled into the sea individually, formed Yeşilirmak river basin which is one of the 25 river basins of Turkey (Figure 2). The Yeşilirmak Basin (Number 14) contains all and/or parts of Tokat, Samsun, Amasya, Çorum, Sivas, Yozgat, Gümüşhane, Giresun, Erzincan, Ordu and Bayburt. Yeşilirmak River Basin, covering approximately 5% of the surface area of Turkey, which is the third largest precipitation area covers an area of 39628 km² of the country. Silts carried by Yeşilirmak and its branches forms the Çarşamba Plain (Anonymous, 2015a).

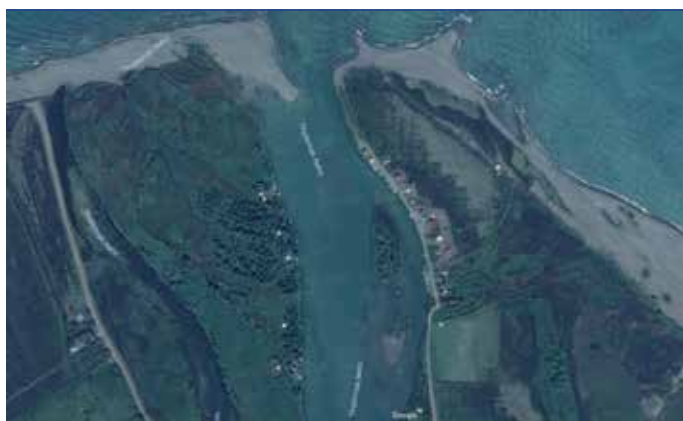
Figure 4. A view from the Yeşilırmak river mouth (Photo: Google Earth, 2018)

Yeşilirmak estuary is used as relatively low density area for human settlement compared to many other estuaries in Turkey. However, since there is no fishing port around the river mouth, the inner part of the river mouth is used as a fishing port. The increasing use of river mouth as fishing ports and illegal settlement problems are serious threat to Yeşilirmak (Figure 4). Monitoring and control of this situation by authorized institutions and taking necessary precautions are important both in terms of the protection of environment and the future of sturgeons in Yeşilirmak.

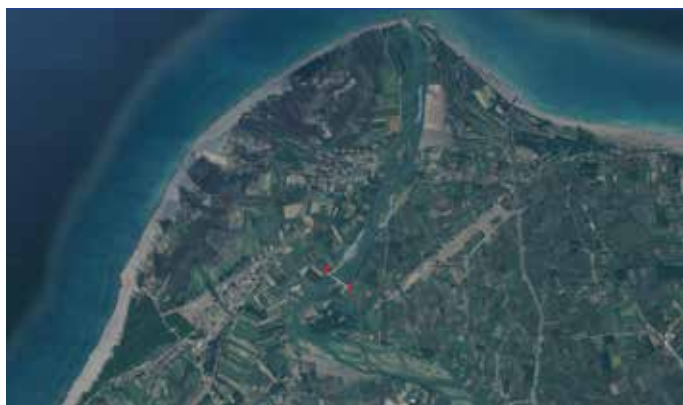
Figure 5. The location of Hürriyet-Kumtepe Bridge on Yeşilırmak (Photo: Google Earth)

There are still 7 reinforced concrete bridges on the section from the river mouth to the first HPP on Yeşilırmak and one bridge is under construction. The bridge, which is the closest to the river mouth (about 4 km) was completed in December 2017 and this bridge is 310 meters long (Figure 5, 6).

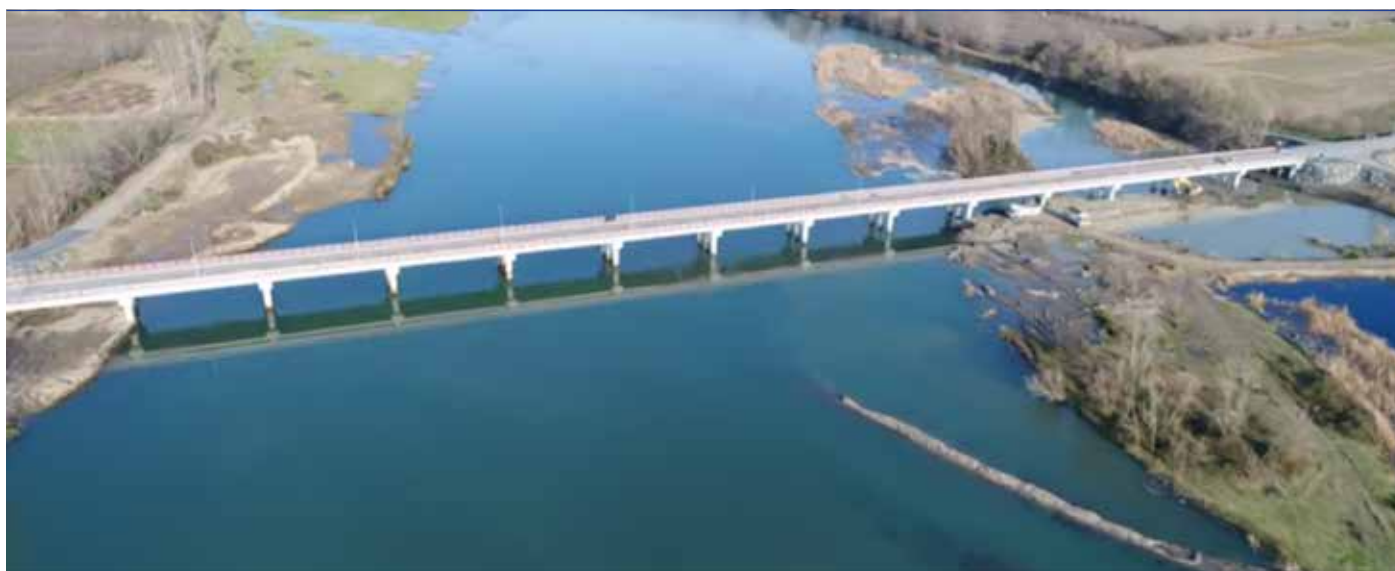
Figure 6. A view of Hürriyet-Kumtepe Bridge on Yeşilırmak (Photo: <https://www.youtube.com/watch?v=LB2XsnuGjZU>)

Bridge abutments and embankments between them like a dike may affect the movement and passage of sturgeons negatively when water is stored behind the dam or HPP. Therefore, during the design and construction of the bridge the natural life in the river should be considered. The bridges which fully span the watercourse channel provide the best opportunities for maintaining river habitats (Anonymous, 2012). Nevertheless, in the bridges on Yeşilırmak, the natural life in the river has not been considered and critical habitat loss has occurred.

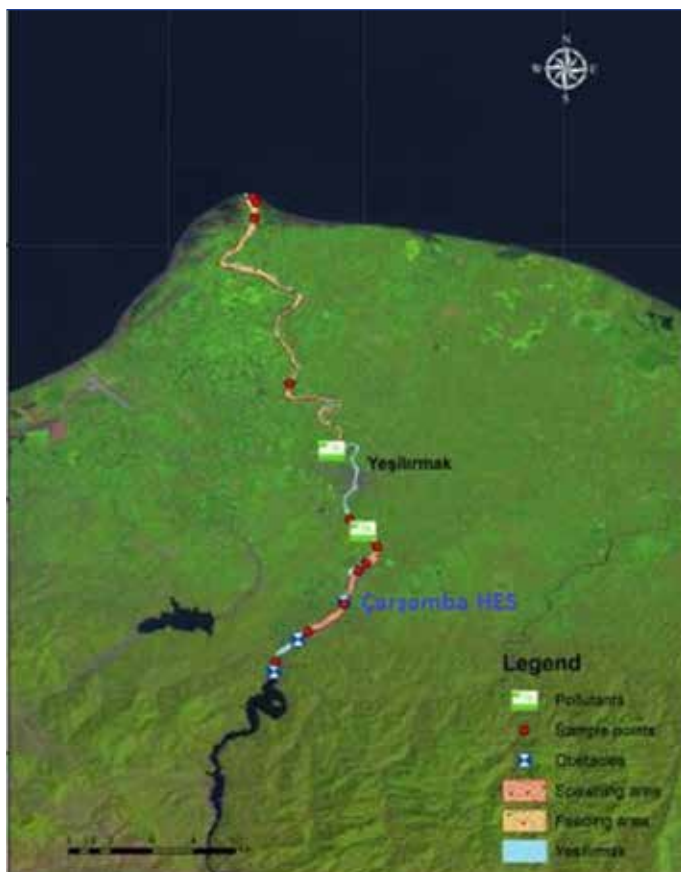
Figure 7. Spawning and feeding areas of sturgeons in Yeşilirmak (Anonymous, 2015b)

Considerable habitat degradation and loss have occurred through dams, HPPs, bridges and river bed modifications in Yeşilirmak. However, it is known, that sturgeons can still migrate upstream into Yeşilirmak and are accidentally caught sometimes in the river mouth or in the river. The information in this regard was reported in the National Action Plan for the Conservation and Restoration of the Sturgeons of Turkey, which prepared within the scope of the project entitled "Recovery of Sturgeon Population in Turkey: Habitat Assessment and Restocking" supported between 2008-2011 by the Food and Agriculture Organization of the United Nations (FAO) and coordinated by the Ministry of Agriculture and Rural Affairs of Turkey (MARA). Moreover, the spawning and feeding areas are identified in the habitat evaluation studies during this project which was given in this National Action Plan (Figure 7).

According to the Action Plan, very limited spawning and feeding areas for sturgeons have remained in Yeşilirmak between the last HPP (Çarşamba HPP) and the river mouth (Figure 7). It is of utmost importance to protect these last remaining areas and to avoid practices that would destroy their habitat. In other words; "last minute" measures are needed urgently. Also it is vital to develop communication tools to increase the awareness of local communities about the conservation value and its role for future rehabilitation measures. It would also be very useful to develop a guarding system in cases where potential poaching might affect the population during migration or reproduction (Anonymous, 2015b).
