## COLONNATED STREET AT SALAMIS

S. Hakan ÖZTANER

### Abstract:

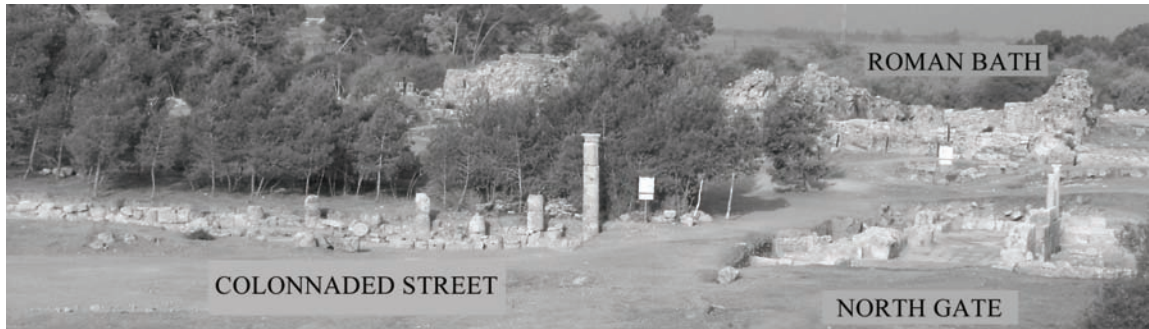
Figure 1

**Figure 1.** The colonnaded street, the north gate and the Roman Bath, view of the area from the east.

Soon after carrying out the researches in the area to figure out the original structure to which these columns belonged, we found the existence of a colonnaded street extending at the north-south direction (Fig. 1). During the excavations between 2002-2004, the trenches were dug in the direction of the street and when the spaces between the trenches were completely dug and joined, the majority of the well-preserved ruins of the street were unearthed (Fig. 2).

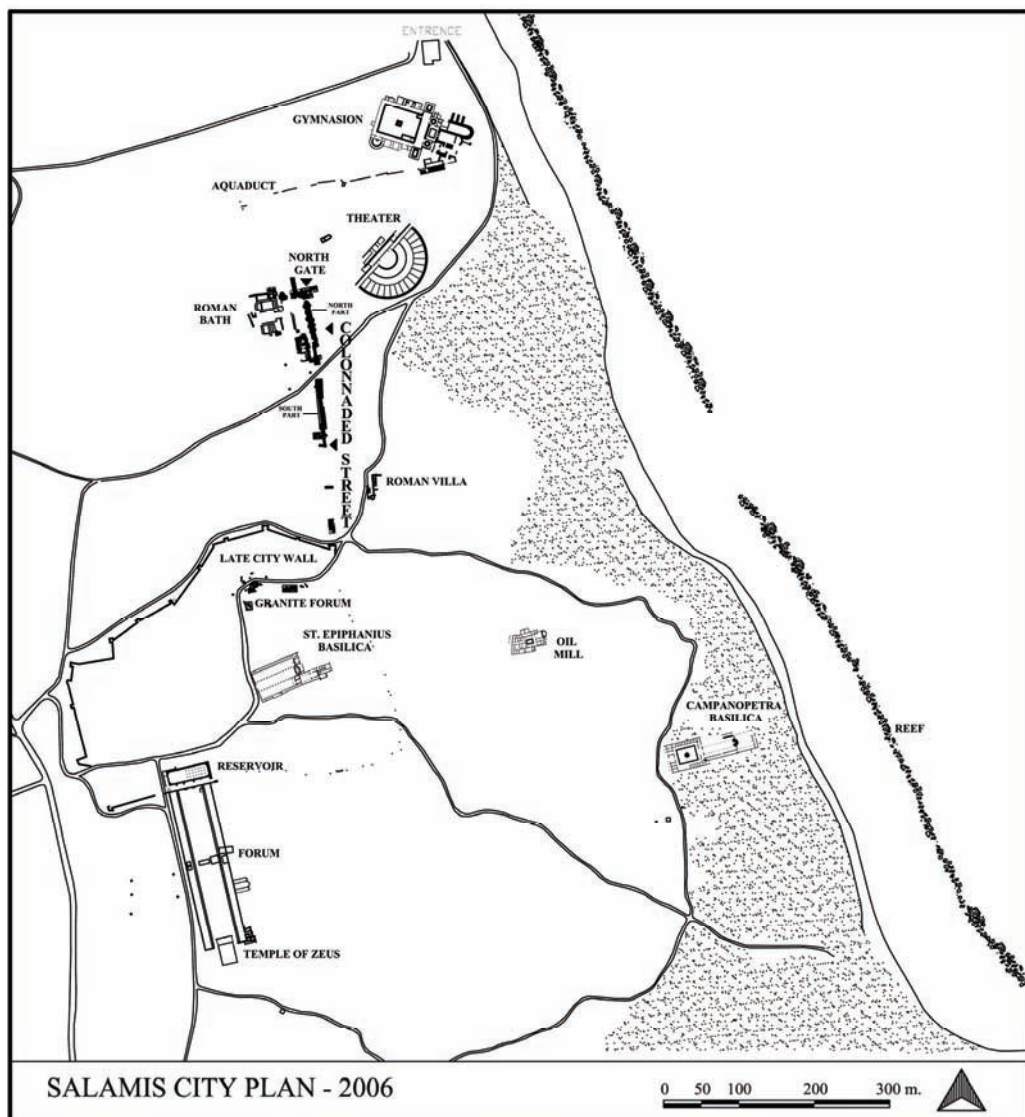
Figure 2

**Figure 2.** The Salamis Ancient City Plan.

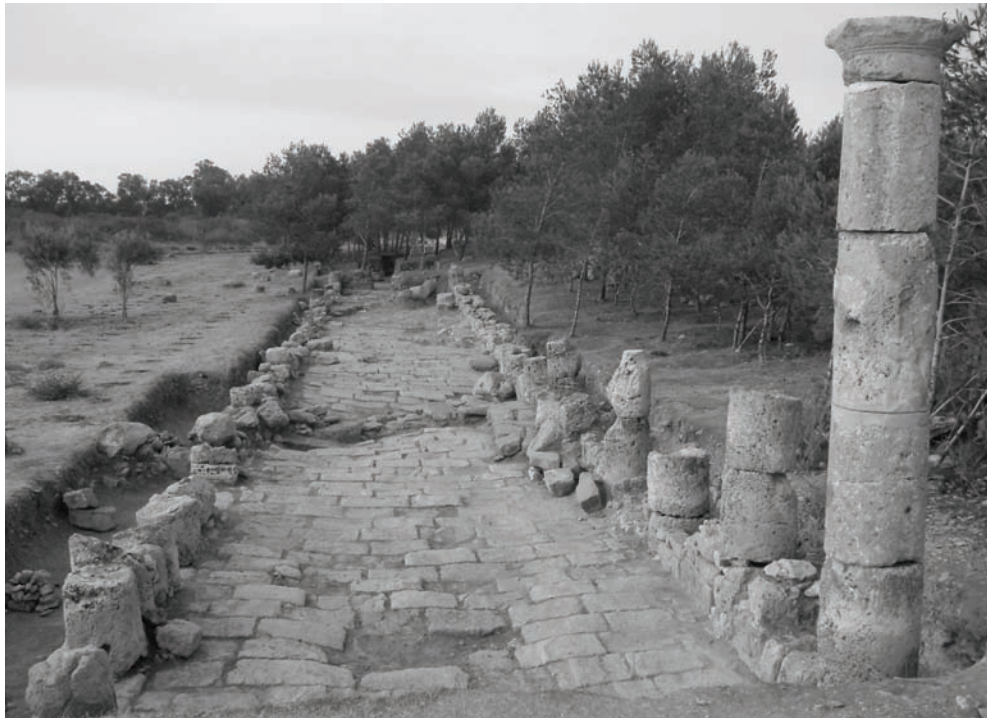
Figure 3

**Figure 3.** The north part of the Colonnaded Street (A), view from the north.

The first phase paving stones placed horizontally to the course of the street in regular rows at the east-west direction with the widths varied between 0.40 and 0.50 m. They were cut of yellowish, *calc-arenitic*, gritty limestone in narrow and long rectangular form with the lengths varied between 0.55 and 1.10 m and the thickness of about 0.15 m. No mortar was used between them for binding (Fig. 3).

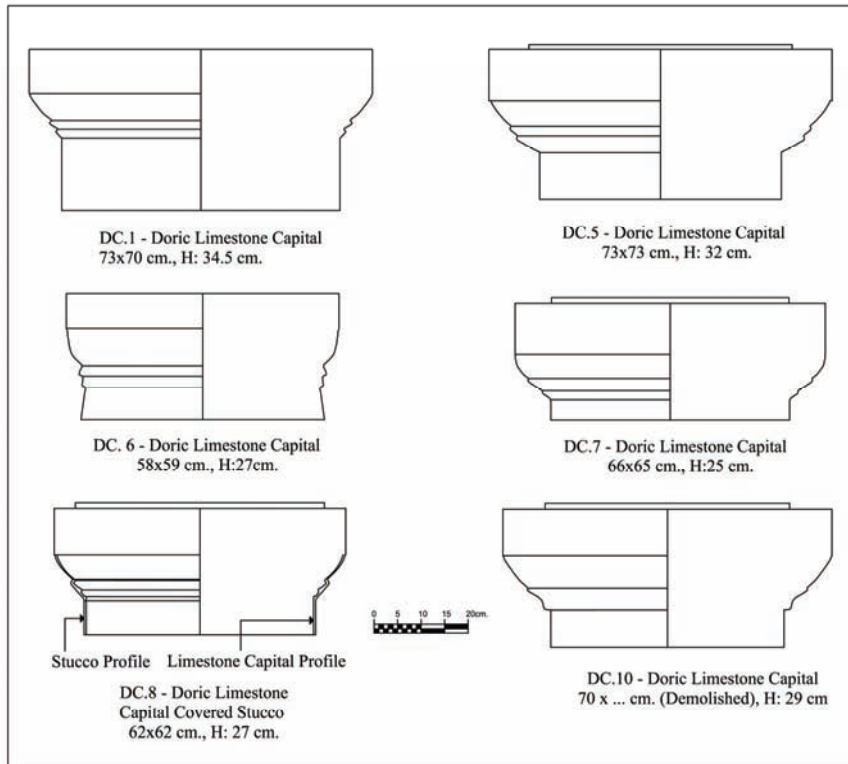
Figure 4

**Figure 4.** The profile drawings of the Doric capitals belonged to the colonnaded street.

During the excavations at the north part of the street, ten Doric limestone column capitals were found, of which two were utilized as reused materials in the wall construction and the others were embedded in the filled soil (Fig. 4). The column capitals with 0.27 – 0.345 m heights had generally a square abacus with dimensions of 0.58 x 0.59 m, 0.62 x 0.62 m, 0.65 x 0.66 m, 0.73 x 0.73 m, with a bottom diameter ranging between 0.49 - 0.56 m. They had a double annulet on their echinus with varying gradients of 20 to 32 degrees. On some of the capitals, we could see stucco-covering traces. We observed that the stucco covering on the capital numbered DC-8 was preserved in good condition comparing to the others. Its ech-

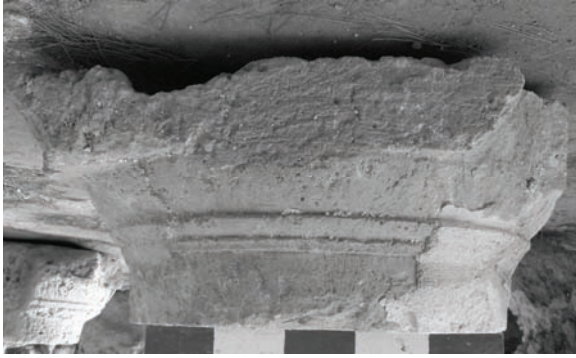
Figure 5

**Figure 5.** DC.8 numbered Doric capital with stucco repair and covering traces on it.

inus profile with double annulet on the limestone was covered with stucco later and turned into a single large moulding. It was observed that the broken part on the bottom surface of this capital was repaired by filling with stucco (Fig. 5).

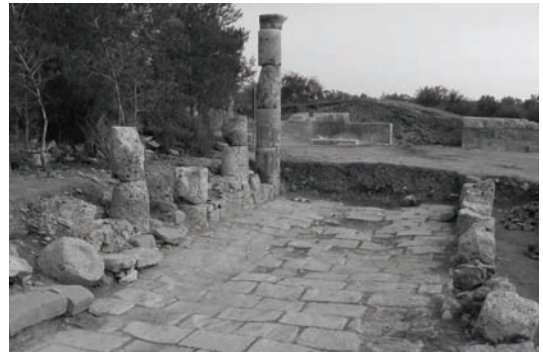
Figure 6

**Figure 6.** The north part of the colonnaded street (A) and the north gate, view from the south.

Placement of the columns directly on the first phase pavement borders of the street without bases, and the Doric column capitals most probably belonged to those columns indicated that there were porticos in Doric order at each side of the street (Fig. 6).

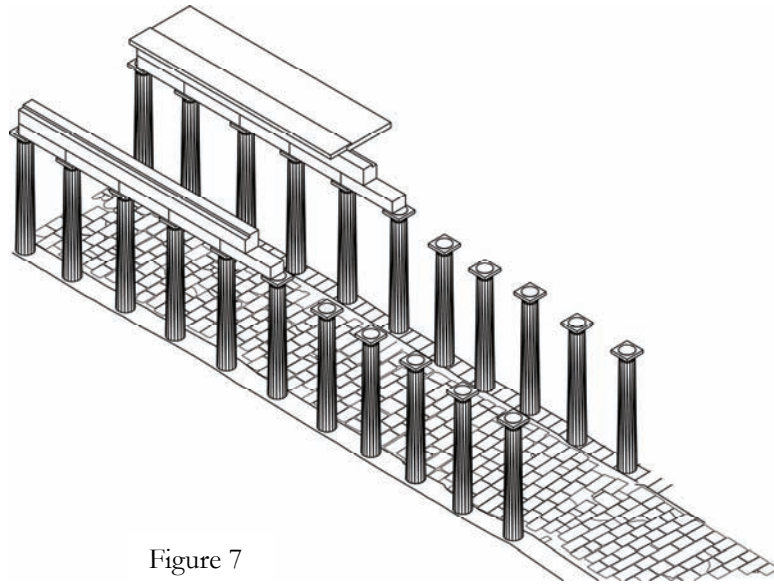
Figure 7

**Figure 7.** The restitution model of The Colonnaded Street.

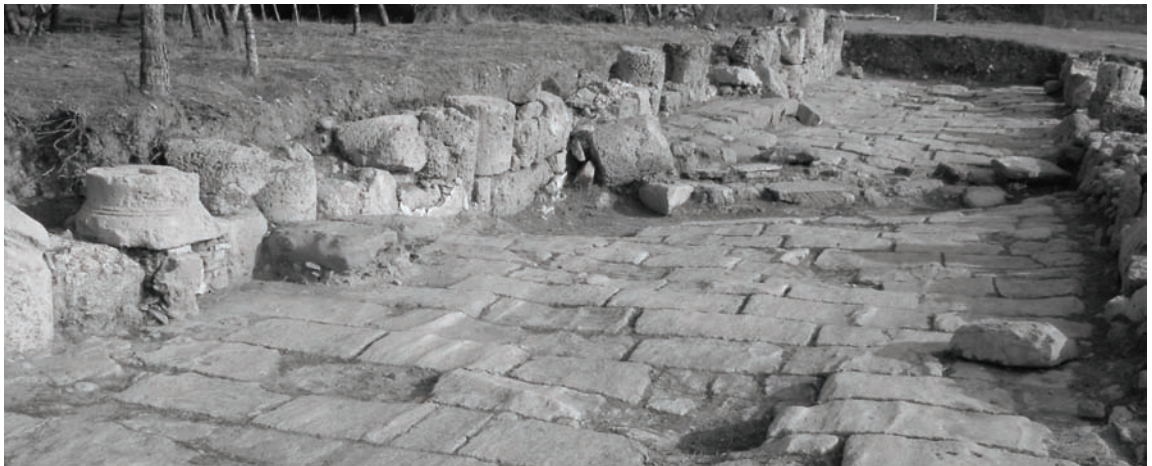
Figure 8

**Figure 8.** The North part of the colonnaded street (A), the wall of reused materials and rubble stones built between the columns, view from the south.

At a later date, probably during the paving of the second phase pavements, the rubble stone walls with soil or lime mortar were constructed between the columns to serve as a border. These walls with 0.40 – 0.65 m thickness that covered the spaces between the columns on both sides of the street were preserved at the heights of approximately varied between 0.30 and 0.70 m at the west side and 0 - 0.50 m at the east side. Two Doric capitals and twelve column drums belonging to the first phase of the street were employed in the construction of these walls as reused materials. Two of these columns were used on the west side and ten of them (two of them in hexagonal forms) on the east side of the street (Fig. 8).

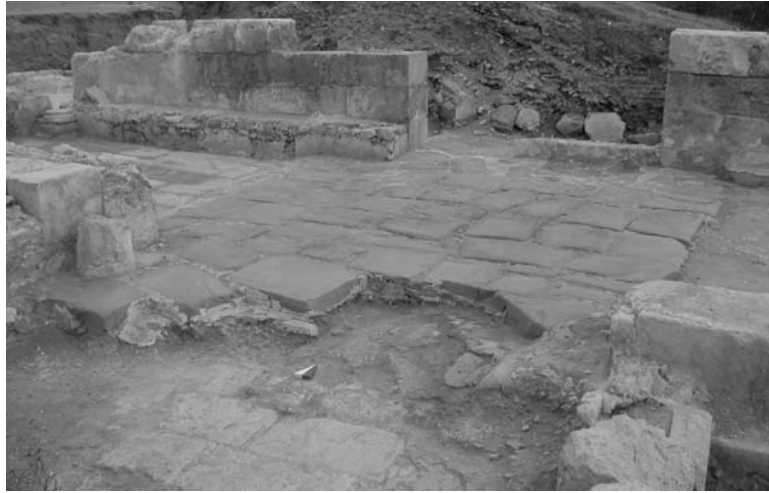
Figure 9

**Figure 9.** The street-second phase pavements and the north gate, view from the north.

It was found out that there was a gate<sup>3</sup> at the north end of the street (Fig. 9), and at its south, there was a Late City Wall<sup>4</sup> intersecting the street (Fig. 18). From that point, it has not yet been ascertained up to which point the street extended and terminated in the south. The total length of the street was measured as 341 m from the North Gate to the Late City Wall and approximately 204 m length of it was unearthed in the excavations. The width of the unearthed parts of the street varied between 4.64 - 4.73 m at the north, 4.56 - 4.62 m towards the south, and 4.80 - 4.85 m near the Late City Wall.

In the north part of the street, inside the North Gate and at the part 6.65 m south of it, there was a second phase pavement (Fig. 9), and at its continuation to the south, there was a first phase pavement of about 40 m. In this part, some of the second phase paving stones preserved through the west border of the street in a single line of 5 m, 1 m and 7m long. In this section, there was a late period canal, which cut the street at the southwest - northeast direction, and narrowed in this direction from a width of 0.50 m to 0.13 m, with a depth of 1.45 m and a length of 4.40 m. The canal passed across the street, cutting the first phase pavement at a level under the second phase pavement (Fig. 14-A).

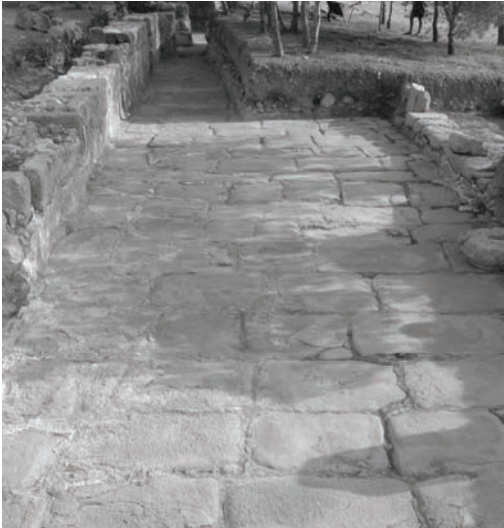
Figure 10

**Figure 10.** The north part (B) and the south end of the street, the second phase pavement, the western border wall, and view from the south.

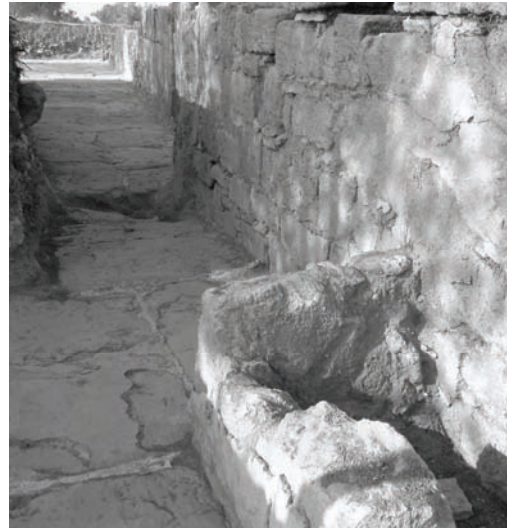
Figure 11

**Figure 11.** The north part of the street (B) the second phase pavement, the west border wall and the trough, view from the north.

At 3.35 m north of this corner, there was a trough placed on the second phase pavement of the street that was preserved up to a 0.57 m height with the dimensions of 5.63 x 0.63 m (Fig. 11). The inner faces of the trough were plastered with a hydraulic mortar. However, there was no archeological evidence to indicate that this trough was a part of a fountain. The second phase pavement of the street was used as the floor of the trough, and therefore it was thought that the trough was used in the later phase of the street, and was probably constructed to meet the water needs of the animals passing through the street.

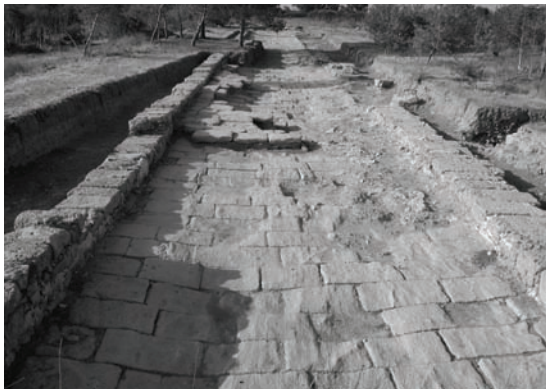
Figure 12

**Figure 12.** The south part of the street (A) the first and the second phase pavements, view from the north.

In the south part of the street, the cut stone blocks (at 0.40 x 0.60-0.80 m dimensions in general) of the walls bordering the second phase pavement on both sides of the street, were preserved at the foundation level or in a level of two rows (Fig. 12).

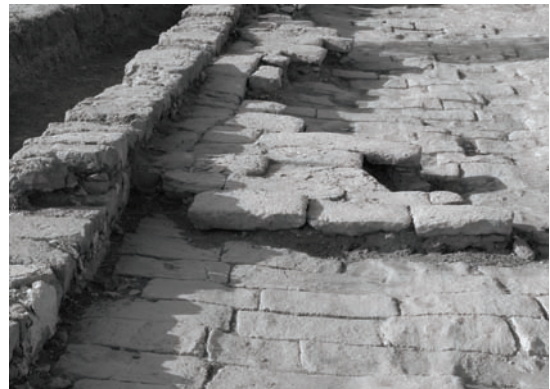
Figure 13

**Figure 13.** The south part of the street (A), the first and the second phase pavements, view from the north.

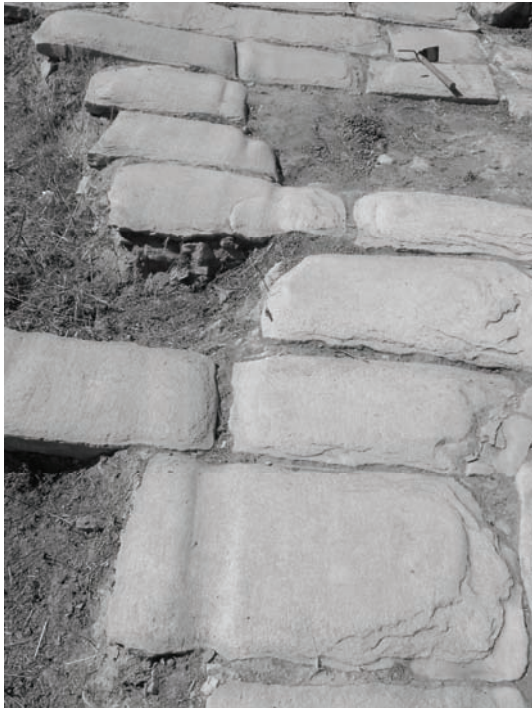
Figure 17

**Figure 17.** The south part of the street (C), the wheel ruts on the second phase pavement, and view from the north.

When we look at the thickness of the pavement (0.15 – 0.20 m), the prepared base for the pavement and the wheel ruts observed on some of the first and second phase paving stones, (Figs. 16, 17), we could conclude that the street was open to the vehicle traffic<sup>10</sup>. The wheel-ruts of the carts on the paving stones showed that the two phases of the street were used for long periods. When we examined the wheel ruts that could be observed clearly at the south of the street near the late city walls, we determined that these ruts were caused by carts with 1.3 - 1.35 m wheel dimensions from

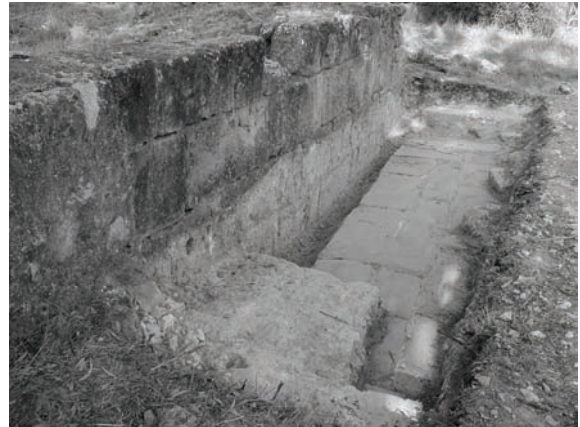
Figure 18

**Figure 18.** The second phase of the street, which the late city walls cut it at its south, a view from the east.

On the other hand, following this destroyed part, at the trenches dug 57 m towards the Late City Wall, we could observe the second phase pavement which was preserved here for a length of 19 m and almost covered the whole width of the street. The first phase paving stones could also be seen under the dismantled parts of the second phase pavement (Fig. 16). We observed that at the trench dug near the Late City Wall, which intersected the street, the second phase pavement was completely preserved. This part was the last point of the street, which we could follow to the south (Fig. 18).
