The Old Mosque (Eski Camii) At Nimetli Village, Seben District Of Bolu And Its Conservation Problems

ABSTRACT

This article is on the Old Mosque (Eski Camii) located in Bolu province, Seben district, Nimetli village which is compiled from the ongoing M. S. thesis, based on "Restoration Proposal Of Nimetli Village Old Mosque In Bolu Province, Seben District". The main objective of the study is to create a basis for the work to be done to transfer the structure to next generations by analyzing and documenting the current situation of the mosque and evaluating the information obtained. For this purpose, the problems and the potential of the structure is evaluated by examining the historical and architectural characteristics of the Old Mosque (Eski Camii) of Nimetli village.

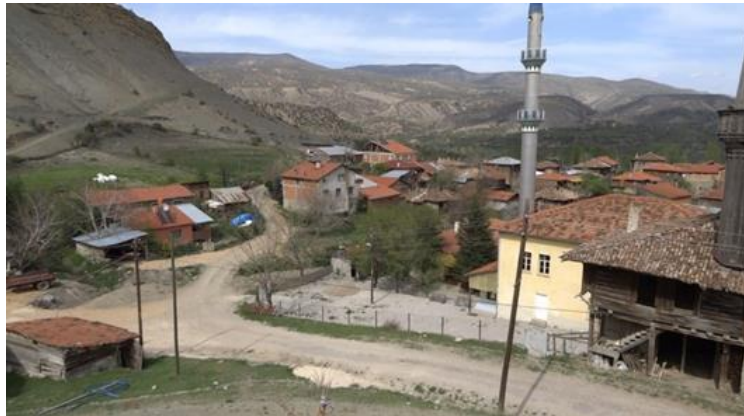
Figure 2: General view from the village

The traditional houses of the village are one or two story high simple buildings which are built by rubble masonry with wooden beams, plastered and whitewashed at the interior. The roofs are coated by traditional tiles. The first floor of the house is used for living, where the ground floor used as barn (Figure 2) [7].

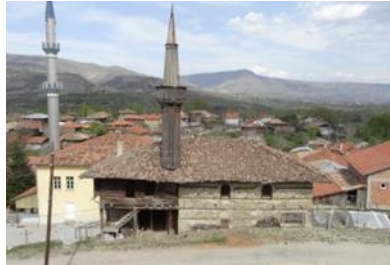
Figure 4: Old and new mosques

- After the construction of new concrete mosque in the same court which is located at the east of the Old Mosque, unused Old Mosque is abandoned and used as storehouse. Deterioration process of the Old Mosque has accelerated due to neglecting and indifference.
- The lower windows of the mosque have been partially buried in the ground and window barriers disappeared because of the rise in the west side road.
- The roof of the mosque had taken water because of broken, slid and lost roof tiles. Cracks, rotting and deflection occurred in the wooden load-bearing structures of the roof.
- Expansion of the “mahfil” and plaster renovation in the “harim” of the mosque resulted in loss of authentic material and architectural elements.

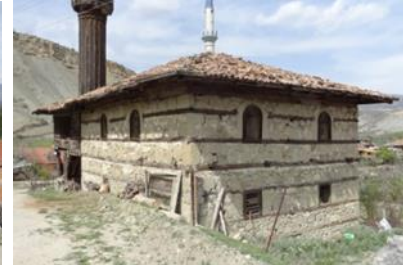
Figure 5: South-west façades

The building is located in the province of Bolu, Seben district, Nimetli village. Mosque is located in the west of the residential area of the village, on a hillside overlooking the settlement on a sloping land. There are

height differences at the east-west facades as well as north-south facades. There is a dirt road along side of the west front where entrance door is located (Figure 3-8) [7].

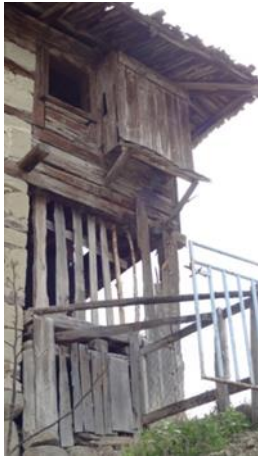
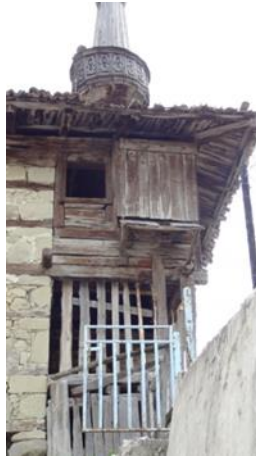
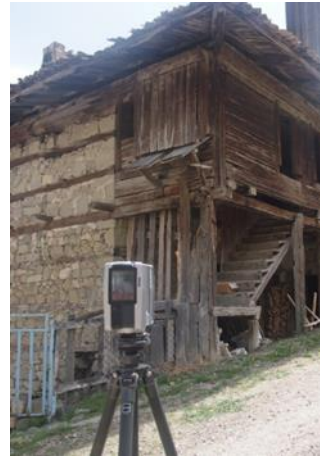
Figure 18: Wooden projection Figure 19: Wooden projection Figure 20: Wooden projection

visible. Wooden projection on the north facade resembles bathing cubicles of the traditional houses [9]. This projection is considered as providing evacuation of the water used for ablution to the garden (Figure 18-20) [7].

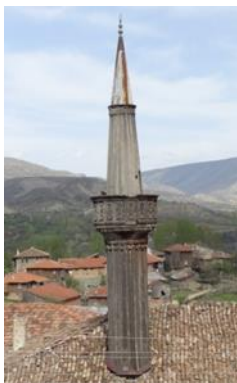
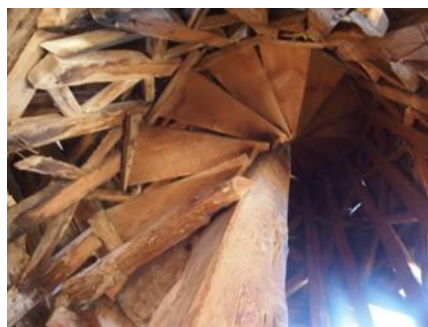
Main outer walls of the Old Mosque of the Nimetli Village are built with rubble masonry with wooden beams, interior walls are plastered and whitewashed, exterior walls are not plastered. Distances between the beams are different from each other. Wooden beams are connected with lap joints in the corners. Wooden posts and wooden joists in the northwest corner of the mosque construct a shelf formed by wooden bearing structure. Wooden boom of the minaret is located over

the 50cm northwest of the main entrance door of the Mosque. Wooden posts forming the body of the minaret starts around the boom after the shelf. Steps between boom and outer posts provide horizontal connection. Minaret construction is installed between posts by cross-links and minaret body is formed by timber cover from outside (Figure 21-23) [7].

Figure 21: Minaret

Figure 22: Minaret

Minaret: Minaret rising from the northwest of the roof has cylindrical body. There are partition joints on the wooden body. Upper side of the balcony of the minaret is also wood sided; cylindrical minaret is tightened to the up side and ends with cone plate.

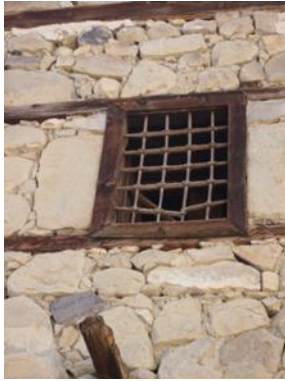
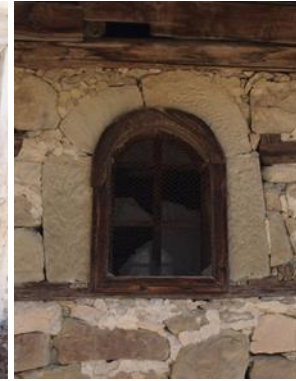
Windows: The lower windows of the “harim” have double-leaf shutters on the interior side of the wall. The lower windows have wooden barriers on the outer face

of the wall. Upper windows of the “harim” are arched and glazed on inner face of the wall. Gaps in the outer surface of the window are covered with wire. There are no frames in the windows of the downstairs village chamber. There are three sliding sash windows of the upstairs village chamber. Two of the sliding sash windows are rectangular shape, one is arched. There are also window gaps without woodwork on the landing (Figure 24-27) [7].

Fig. 24: "Harim" window

Fig. 27: "Harim" window

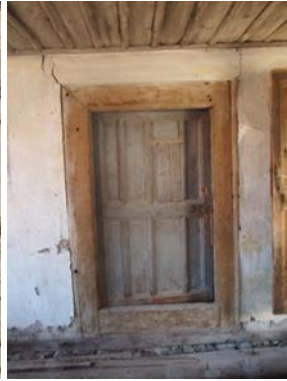
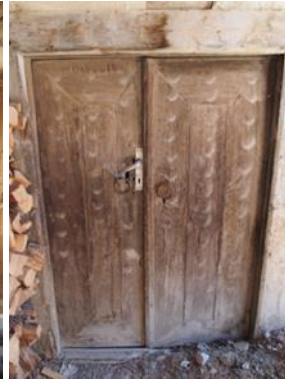
Doors: Entrance gate of the “harim” is double-wing and wings are wood frame construction. Chamber doors of the structure are wooden frame construction with one wing and opens to the inside of the chamber. Back side of the doors was secured with horizontal battens and braces.

Fig. 25: Door

Fig. 26: "Harim" door

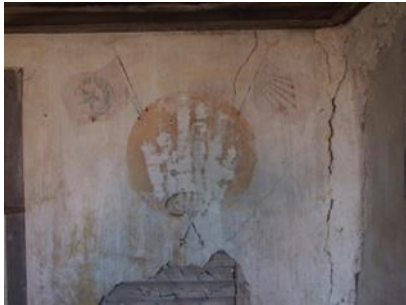
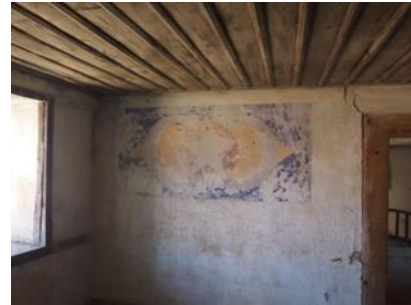
Ornaments: Walls of the upper floor village chamber have hand carved figures (Figure 28-30) [7].

Figure 28: Ornaments

Figure 30: Ornaments

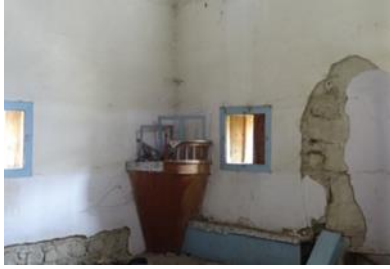
Beside deterioration in materials under the influence of climatic conditions, deteriorations caused by locals influence are also observed in the Old Mosque of the Nimetli Village. Major change made by locals is expanding the original "mahfil" section through "harim". Other human interventions are cement based plasters instead of original plasters, oil paint on dais and wooden window frames (Figure 31) [7]. In addition, deteriorations on architectural elements and construction materials are as follows: loss of stone wall pointing, swelling and cracks on original plaster, color and texture deteriorations on wooden structures, degradability and slipping on tiles.

Figure 31: Deteriorations

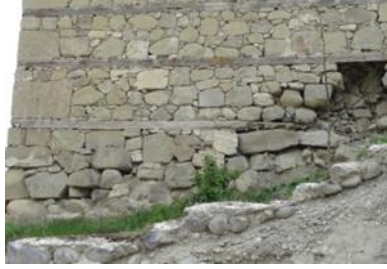
Main outer wall is made by rubble stones, however, a big portion of loss of the soil mixtures is observed on the sides open to external effects. In some places wall pointing covers the stone surface visibly (Figure 32) [7]. There are losses of rubble stone on the main northern

Figure 32: Deteriorations

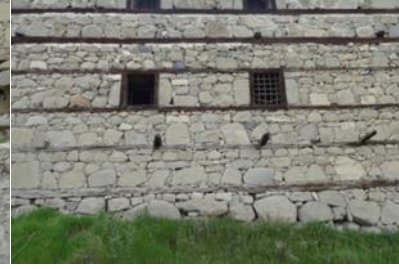
wall close to ground level. There are color and texture deteriorations, cracks and corrosion on the wooden beams in the walls as a result of external weather conditions (Figure 33) [7]. Interior sides of the walls are plastered; however, original plasters of the village chambers are swelled and cracked arising from moisture and pollution (Figure 34) [7]. Wooden construction at the entrance of the structure exposed to color and texture deteriorations under the influence of rain, snow, sun and wind. Color deteriorations are defined as change, losing and darkening in color, texture deteriorations are defined as roughening, leakage and swelling on surface. Beside color and texture deteriorations on all external sides of the minaret, there is loss of decoration elements and fragments on upper side of the minaret "şerefe"/ balcony (Figure 35) [7]. Fragments on pantiles, changing places and deformations are seen on the roof. Quality loss on tiles as a result of being exposed to water resulted in leakage. Because of the leakage of the tiles, there are problems

Figure 33: Deteriorations

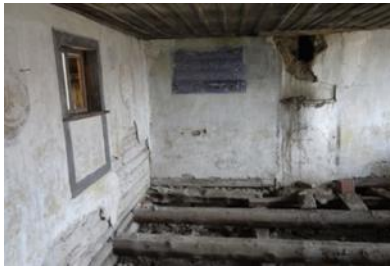
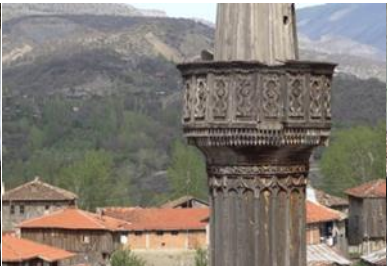
Figure 34: Deteriorations

Figure 35: Deteriorations

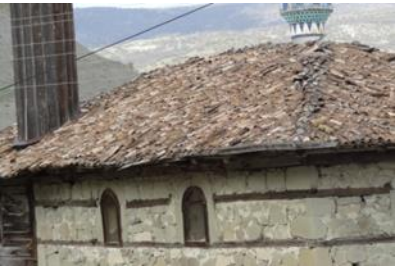
occurred with wooden roof board and roof bearer construction. Some deflections of the roof are

symptoms of the not functioning of bearer construction (Figure 36) [7].

Figure 36: Deteriorations
