Historical Stone Arch Bridges' Damage Causes and Repair Techniques

Abstract: Many historical stone arch bridges have been exposed to the different environmental effects, which could cause structural damage, at different times. Under these natural or human-induced effects such as floods, earthquakes, the bridges were partially or completely damaged. The repair of the historical arch bridges has been repaired against to these damages. The success of the repair work depends on both a detailed archaeological-historical survey and a detailed structural evaluation process carried out together. It is very important to determine the answers to questions such as date and time of construction of the structure, whether there was any interruption in the construction process, the scheme and the order of the damages of the structure, what were the repairs and strengthening done in the structure and whether there was any change in the use of the environment. After these process, the repair method is determined considering many alternatives such as partial or complete disassembly for remodeling of the bridge, regional repair or regional strengthening, full strengthening of the upper structure, re

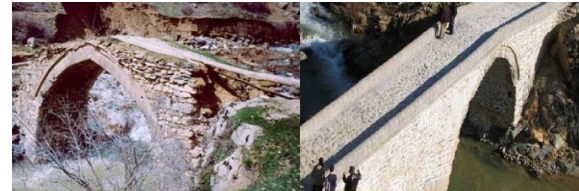
Figure 1. Examples of bridges damaged and destroyed by floods

had flood cutters, many arch bridges were damaged due to floods. As a result of the flood of the İlicak Bridge in Bitlis, the tempın wall and deck were largely destroyed. The bridge, which was restored in 2005, was completed by KGM in 2006 (Figure 1). The Akcaabat Osmanbaba Bridge was completely destroyed as a result of excessive rain water carving the bridge's feet [12].

Historical İlicak Bridge

Osmanbaba Bridge

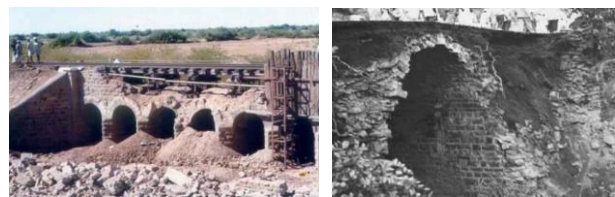
Figure 2. Bridges damaged by the 2001 Bhurj earthquake and the Koyna earthquake in India

Due to the presence of many active faults in our country, it could be affected by destructive earthquakes. The bridges were constructed of stone material with high resistance to pressure stresses. Therefore, it could withstand high stresses under vertical loads. However, they were vulnerable to damage under horizontal forces caused by earthquakes (Figure 2). In order to compensate for these horizontal forces, metal elements could be used which could meet the tensile forces such as tension, clamp and tenon.

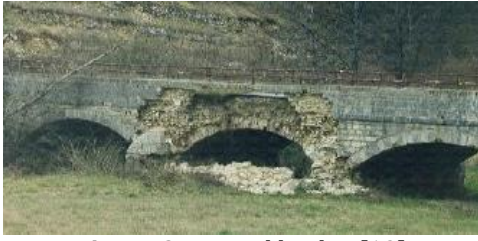
Figure 3. Injured bridge [13]

After the Umbria Marche earthquake in 1997, a major collapse occurred in the central opening was shown in Figure 3.

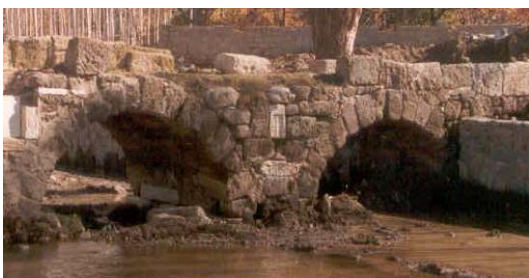
Figure 4. Damage to the historical Dortgoz Bridge on the road route

The stone material and the arch form were very important considering that the compressive force carrying capacity of the bridge arches continued to function smoothly. However, the increase in loads on the fill could cause swelling and collapse of the façade walls, and as a result of overloading, the horizontal forces created by the belt stones could not be compensated and separations could occur in the arch vaults and disintegration of the keystones (Figure 4) [5].

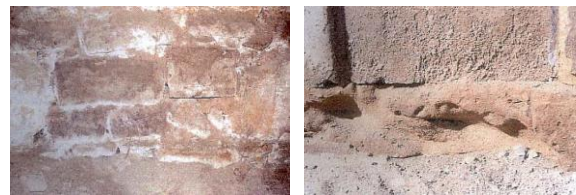
Figure 5. Damage caused by salting and freezing-thawing of stones

The chemical composition of the building material must have been such that it does not interact with the binder and air it was in contact with. For example, as a result of the use of cement with lime-based stones, moisture in the air could cause new salt compounds in the stone material. The salt compounds formed in the stone cavities could disintegrate the stones due to the increased in volume (Figure 5).

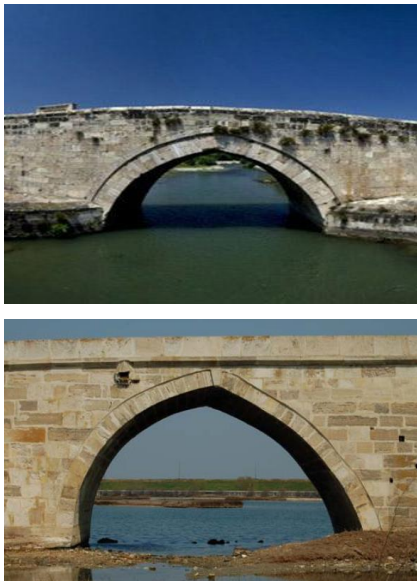
Figure 7. Deformed arch after repair, Buyukcekmece Bridge

During some repairs, the arch form were changed consciously or unconsciously. Some faulty repaired not only disrupt the architectural authenticity of the structure, but also changed the static balance of the bridge. Changing the belt shape made the push line more unfavorable than the ideal belt curve (Figure 7).

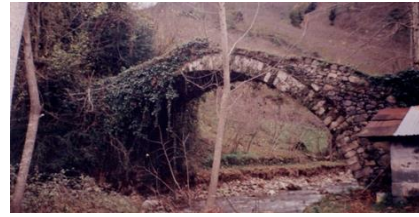
Figure 8. Giresun, Dereli road Yavsan Bridge and Savsat Bridge in district of Artvin

Our country was rich in vegetation because of its abundant rainy. Under the effect of elongation of the roots, plants caused cracking and disintegration of large rock fragments [4]. Weaknesses in the bridge pavement and drainage system also formed the basis for the formation of vegetation (Figure 8). Apart from the plants that damage the structure with their roots, various types of fungi were also fed with minerals such as calcium, aluminum, iron and potassium within the building blocks of the bridge. As a result, acids released the binders on the structure.

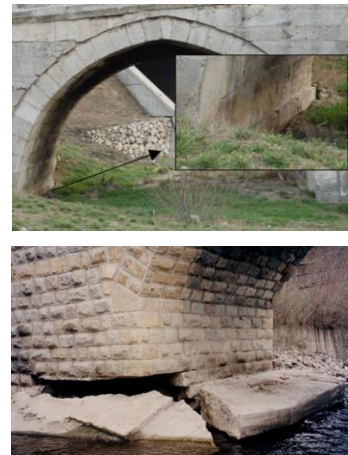
Figure 9. Trabzon, Macka road Mataraci Bridge

As a result of the change of direction of the river bed, the carving of the foundations of the bridges occurred. As a result of these engravings, some settlements occurred on the bridges. These settlements could cause cracks and fractures (Figure 9) [4].

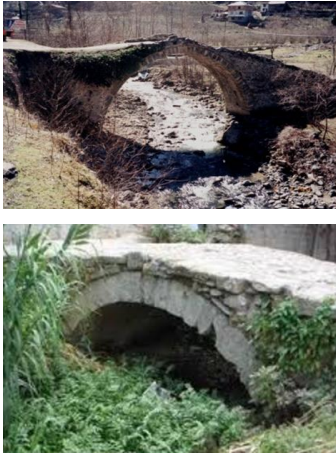
Figure 10. Kinali bridge and Ozbek bridge

Among the most important reasons for the damage of arch bridges was temperature differences between day and night and the recurrence of natural phenomena such as wind and rain over time (Figure 10) [4].

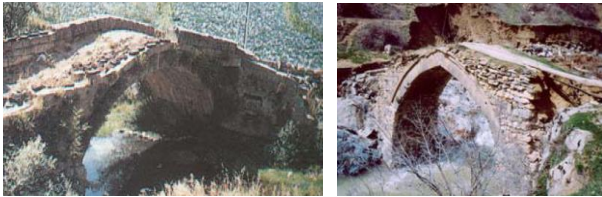
Figure 11. Historical Hersan and Ilicak bridges in Bitlis

Poor coating and drainage system caused surface water to leak into the filling area of the bridge. As a result of this, the filling material was crushed and thrown away from the structure and gaps occurred in the filling (Figure 11). In addition, water leaking into the filler could cause expansion in temperature changes.

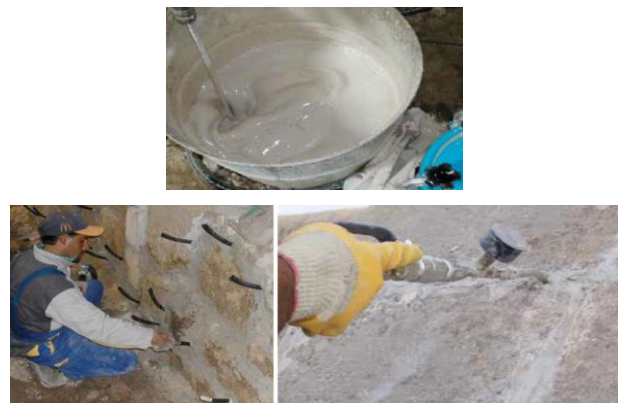
Figure 12. Injection application

Cracks in stone arch bridges should be filled by injection. Before the injection, the crack must be revealed by removing the previously made plaster. Afterwards, hoses should be placed at certain intervals (approximately 50-100cm) on the cracks based on the crack width and covered with hydraulic lime material that would not leak over the crack. After a minimum of 24 hours, the appropriate material must be injected into the crack using the injection pump to remove the damage. Injection material should be applied at the lowest point and should not be stopped until it reaches the upper point (Figure 12).

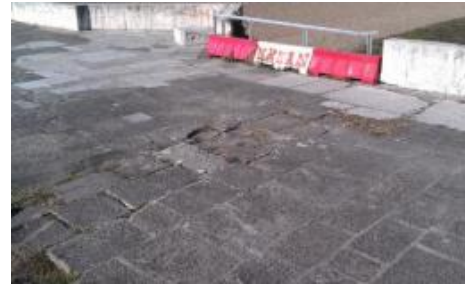
Figure 16. Superstructure repair

One of the types of damage often seen in historical arch bridges was the large destruction of side railings. One of the weakest parts of the bridges was the railing stones, which were built in one row. In addition, due to pedestrian and vehicle traffic, some cracks, abrasions and abrasions occurred in the superstructure of the bridge. Guardrails generally formed parts of all bridges that need to be repaired

due to vehicle crashes as well as deterioration over time (Figure 16).
