# Effect of Humidity and Temperature on Composite Plates With Different Fiber Orientations

In this study, the effect of humidity and temperature on glass fiber reinforced epoxy composite plates with different fiber reinforcement angles and different widths were experimentally investigated. For this purpose, composite plates with fiber reinforcement angles of  $[0^\circ]_8$  and  $[45^\circ/-45^\circ/0^\circ/90^\circ]_8$  were prepared in 25 mm and 30 mm dimensions and kept in hot water at 40 °C, 60 °C and 80 °C for 15, 30 and 45 days. At the end of the duration, the moisture absorption rates and strengths of the specimens were obtained. The obtained data were compared among themselves and with that of dry specimens. In addition, the morphologies of the specimens were visualized with the help of Scanning Electron Microscope (SEM) and the effects of humidity and temperature on failure behavior were examined. It was determined that the strength of the  $[45^\circ/-45^\circ/0^\circ/90^\circ]_8$  fiber orientations specimens was lower than the strength values obtained from the  $[0^\circ]_8$  fiber orientations specimens. It has been determined that when the waiting time and temperatur

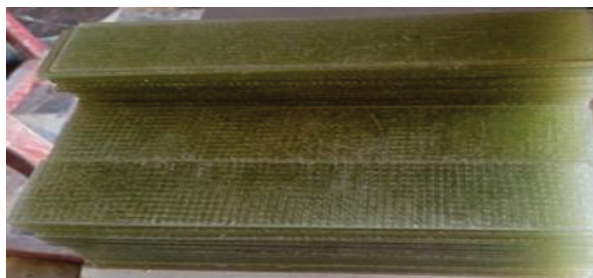
Figure 1. Specimen Preparation

and Trade Ltd. Co. Composite plates are produced with a thickness of 2 mm ( $t$ ). The length ( $L$ ) of the composite plates with both fiber orientations was taken as 175 mm and their widths were prepared as ( $w$ ) 30 mm and ( $w$ ) 25 mm (Figure 1). Three specimens were prepared from each geometry.

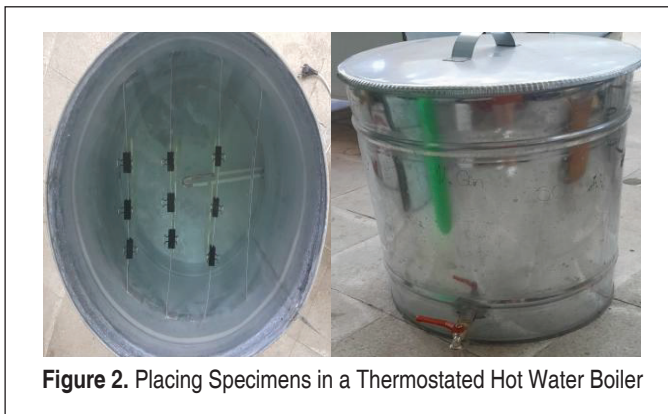
In addition, specimens were formed by gluing additional pieces of the same material using adhesive to prevent the formation of stress concentrations in the compression regions during in the tensile test. Composite specimens with both geometric dimensions and fiber orientations were placed in closed boilers filled with hot water in which thermostats adjusted to 40 °C, 60 °C, and 80 °C. Additional hangers were made for the placement of the specimens in the boilers (Figure 2). They were kept at each temperature for 15, 30, and 45 days.

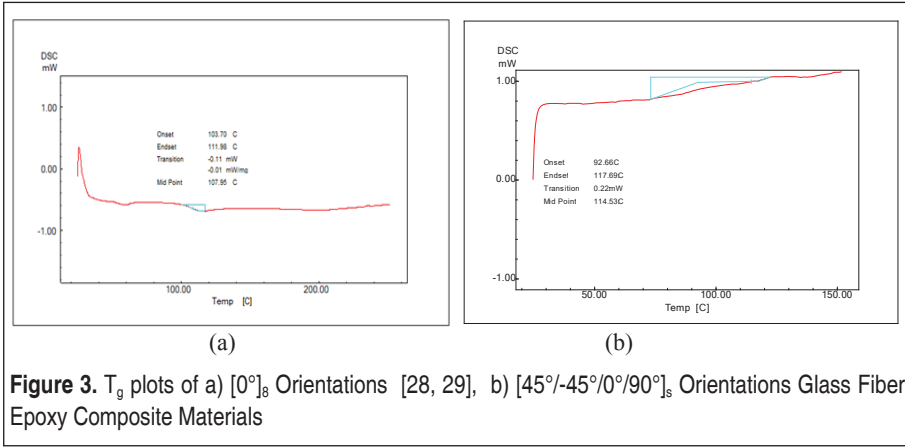
properties of these materials may vary at different temperatures, -especially below or above the glass transition temperature. Therefore, the glass transition temperatures ( $T_g$ ) of the plates in both fiber orientations were determined by Differential Scanning Calorimetry (DSC) analysis in order to better understand the effects of humidity and temperature. This analysis was carried out with Shimadzu DSC-60 type device by increasing the temperature by 10 °C per minute. As a result of DSC analysis,  $T_g$  of glass fiber reinforced epoxy composite materials with  $[0^\circ]_s$  and  $[45^\circ/-45^\circ/0^\circ/90^\circ]_s$  fiber reinforcements were 107.95 °C, 114.53 °C respectively (Figure 3).

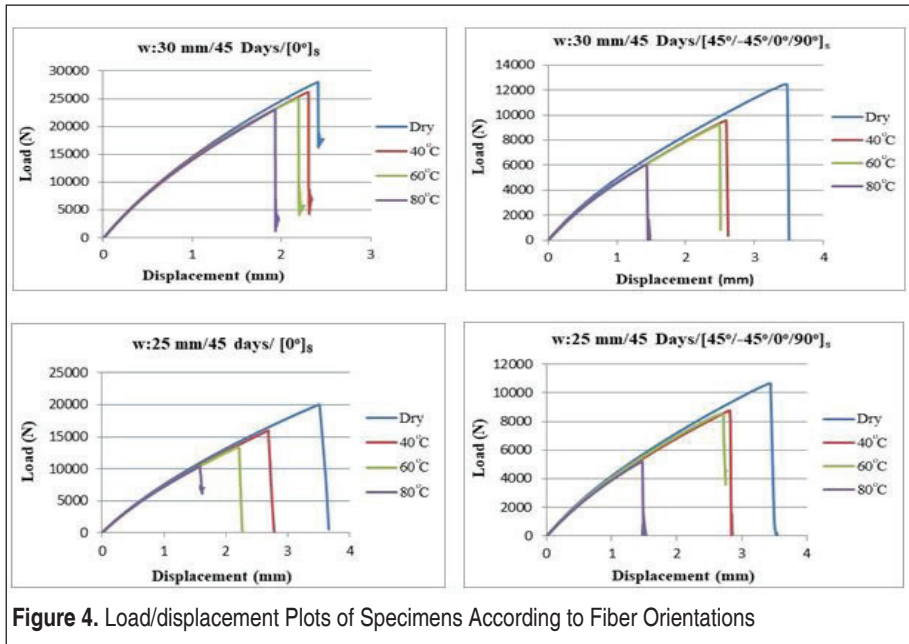
**Figure 4.** Load/displacement Plots of Specimens According to Fiber Orientations

The values obtained as a result of the tensile test of glass fiber reinforced composite specimens and the standard deviation rates of these values are given in Table 2. Load-displacement plots obtained according to fiber orientations and specimen width are given in Figure 4 over the maximum waiting time (45 days). At the same time, the waiting times of composite specimens in hot water - with regard to their fiber orientations - and the load values obtained at the end of these periods are given in Figure 5 and Figure 6 comparatively.

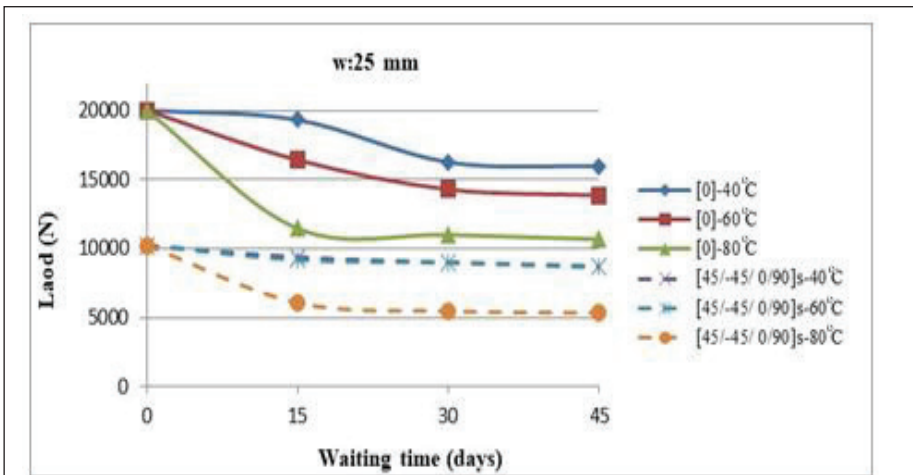
Figure 6. Waiting Time and Load Relationship Graph

The failure load values obtained when the 25 mm wide specimens with the [0°]<sub>s</sub> and [45°/-45°/0°/90°]<sub>s</sub> fiber orientations are kept at 80 °C for 45 days is found to be decreased respectively by 33.06% and 38.72% compared to that of specimens that were kept at 40 °C for 45 days. (Table 2, Figure 6). For the specimens with [0°]<sub>s</sub> and [45°/-45°/0°/90°]<sub>s</sub> orientations and 25 mm width; It was determined that the failure load values obtained when kept at 60 °C for 45 days decreased by 30.73% and 15.59%, respectively, compared to the failure load values obtained from the dry specimens. (Table 2, Figure 6).

the material strength tends to decrease significantly due to the plasticization of the epoxy [18]. In our study, the strength values of the composites with  $[0]_8$  and  $[45^\circ/-45^\circ/0^\circ/90^\circ]_s$  orientations decreased depending on the waiting time in hot water and the amount of moisture absorbed during these periods. Specimens with both orientations and widths presented a significant decrease at 80 °C (Table 2, Figure 5 and Figure 6).

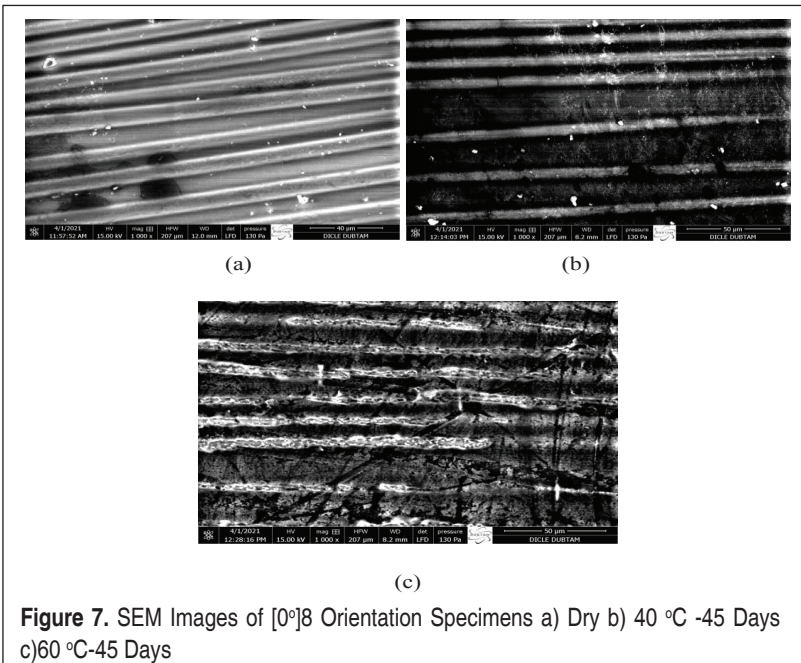
Figure 7 (b) shows SEM images of  $[0^\circ]_8$  orientation specimens with 0.91% moisture absorption and 26214.5 N failure load when kept at 40 °C for 45 days. In Figure 7 (c), SEM images of  $[0^\circ]_8$  orientation specimens with 0.79% moisture absorption and 25120.5 N failure load when kept at 60 °C are shown. In Figure 8 (b), SEM images of specimens with 9891.45 N failure load and  $[45^\circ/-45^\circ/0^\circ/90^\circ]_8$  orientation that presents 2.08% moisture absorption when kept at 40 °C for 45 days are presented. In Figure 8 (c), SEM images of specimen - with the same orientation - that displayed 9366.08 N failure load due to the 1.41% moisture absorption rate when kept at 60 °C are presented.

In Figure 7 (b, c) and Figure 8 (b, c), deterioration stages that occur in the matrix or at the interface, depending on the temperature and humidity changes, are presented. This deterioration is more evident, especially for specimens with higher moisture ab-
