Investigation of The Traditional Seljuks and Principalities Period Baths Within The Conservation and Restoration: The Example of Isparta Baths

Ayşe Betül GÖKARSLAN*, Meryem Elif ÇELEBİ

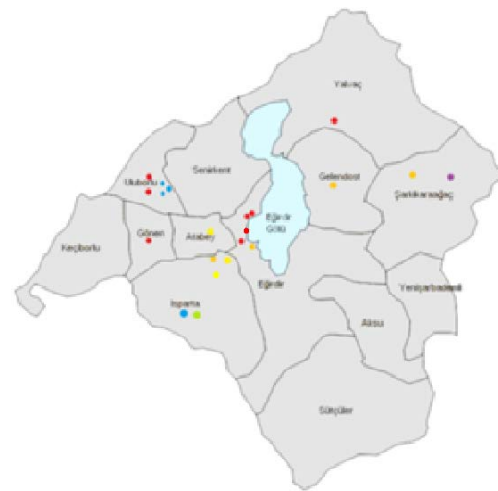
Figure 2. Isparta Baths Location in Seljuk and Principalities Period [13]

Public baths were perceived as significant structures earning income for foundations such as mosques, madrasahs, public houses and fountains. Such profit-making baths became a part of social complexes or a construction element of other foundation structures. Baths of Uluborlu Baltabay, Uluborlu Karabey, Yalvaç Eski, Barla Çaşnıgir Paşa, Eğirdir Esmâ Sultan, Gelendost Avşar Village, Büyükgökçeli Village and Atabey Municipality were established close to the mosques or madrasahs in the city center and earned profits for the foundation structures. Isparta Keçeci Bath which did not survive was built close to Hızırbey Mosque and its madrasa (Figure 2).
