## Feshane-i Amire Evaluation of Structural System for Adaptive Reuse

*Feshane-i Amire,  
industrial heritage,  
adaptive reuse,  
structural system  
intervention,  
sustainability*

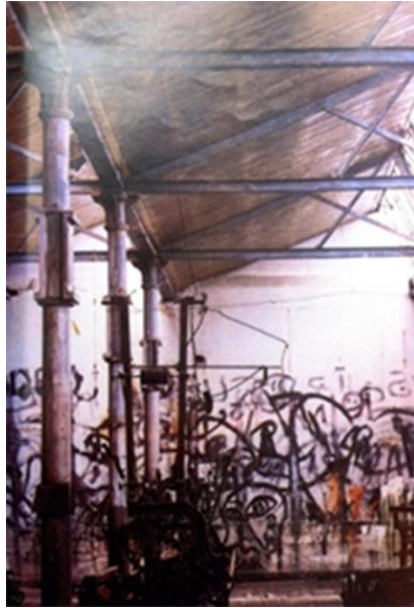
**Figure 3.** Feshane-i Amire before the first restoration [27]

Circular cast-iron columns and roof trusses are the most significant structural members of the building and were brought from Belgium (Figure 3) [26].

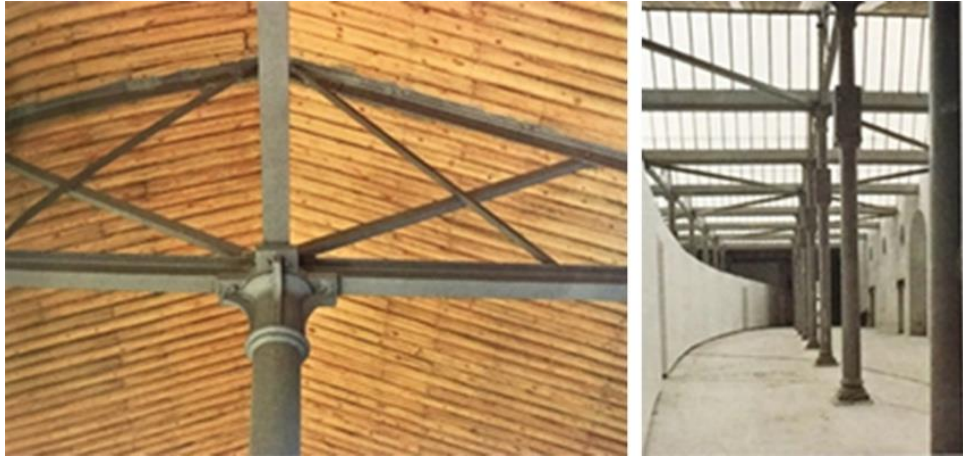
*Figure 4. Photos from Feshane-i Amire after the first restoration [28]*

The dimensions of the masonry structural system are sufficient in terms of thickness, but out of limits in terms of height. During the first restoration, the increase in plan symmetry, retrofit, and repair against settlement cracks in the masonry walls, strengthening of the steel structural system members, and ground improvement works positively affected the behavior of the structural system (Figure 4).

In the initial restoration, the columns were considered sufficient in terms of structural capacity. Therefore, the columns were preserved and protected without any interventions. Only the columns with corrosion damage were repaired. The roof structure was authentically preserved and retrofitted, and the roof finishing was completely reconstructed [29].

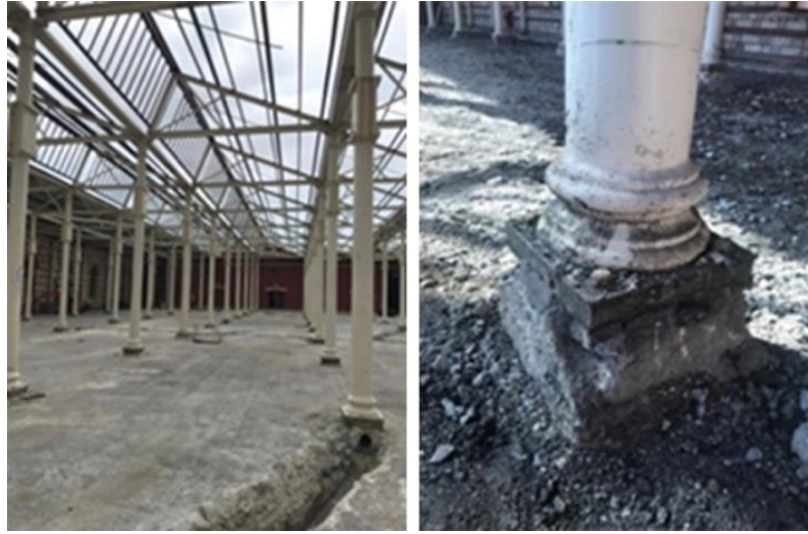
**Figure 6.** Status before the current (second) architectural restoration [30]

In the steel frame structural system, there are no braces or masonry walls to meet the horizontal loads. However, in the original steel roof construction, the trusses were connected to steel diagonal bracing members for the horizontal loads. Steel structural system member sections are at a sufficient level if there are no problems with the material. Because it was detected the beginning of corrosion in some steel components. There is no protection against fire in steel members. On the other hand, although the building remained empty for a long time, no big problems such as loss or damage were detected in the steel structural system. In addition, it was determined that welding and bolt joints, which may show negative behavior, were not used together in steel members.

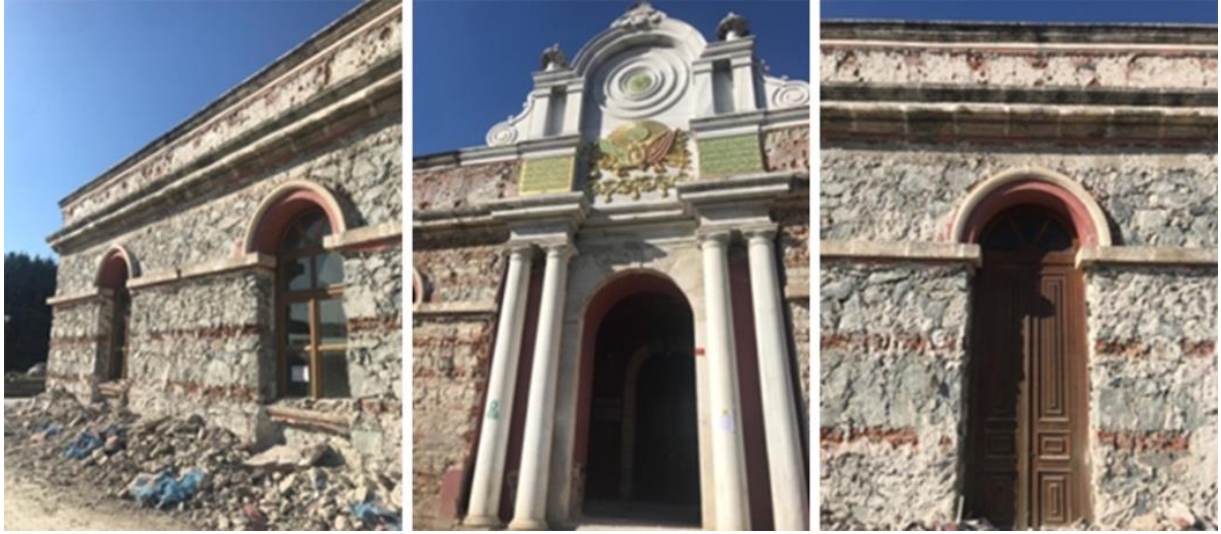
*Figure 7. Currently exterior masonry wall*

The original masonry and steel components of the structural system have been protected. In this context, the materials and sections of the facade walls have been preserved following their original form, and the parts that were damaged in the masonry wall and the joint material that has been emptied were repaired with the original material (Figure 7). The cast-iron columns, I-beams, and trusses have been maintained and preserved in their original form. It was determined that a diaphragm wall was added to retrofit the ground and prevent water from coming from the sea / Golden Horn side. While the number of floors has not been changed, only a mezzanine floor with an independent structural system will be added to the office unit.

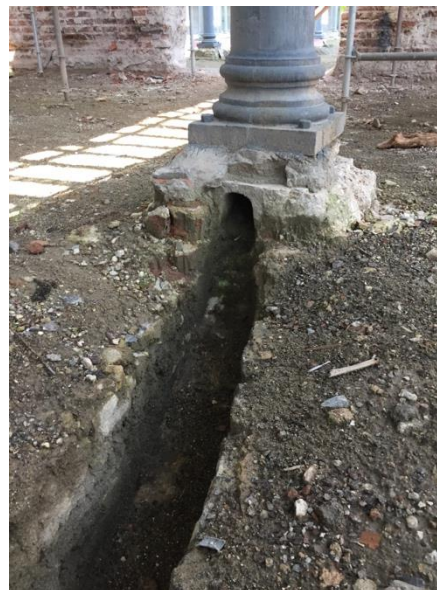
**Figure 12.** Detail of the column drainage system before it was covered

The Belgian precast steel columns have been used as the most suitable solution for the drainage of water to be collected on the sawtooth roof since its construction (Figure 12). The water taken from the columns with circular pipe cross-sections was conveyed to the Golden Horn through channels at the foundation level. During the current restoration, this channel system will be preserved and covered with a proper cover system.
