The reuse and conservation of Ottoman commercial inns on the Historic Peninsula in Istanbul

Keywords: Ottoman inns, reuse, conservation, historical peninsula

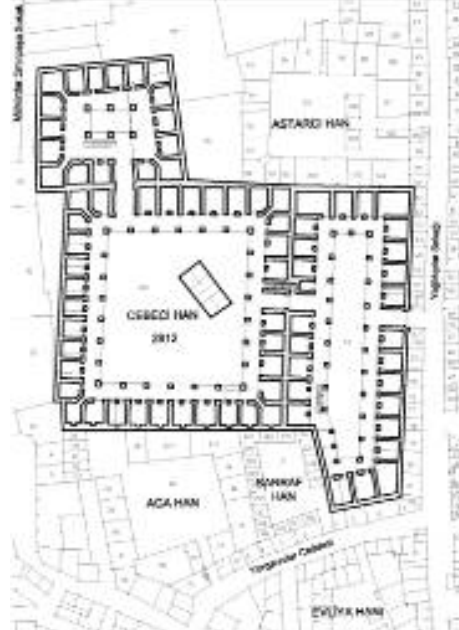
Figure 2. Cebeci Inn (17th yy), ground floor plan [2]

Ottoman inns were accessed from the street through a passage that led into the courtyard and from there the colonnades and individual rooms were accessible. In other words, the rooms themselves did not have street access (Figure 2). Likewise, shops located on the street were not accessible through the central courtyard. In this way, the courtyards of inns constituted an inner world that was separated from life on the streets outside [2-3].

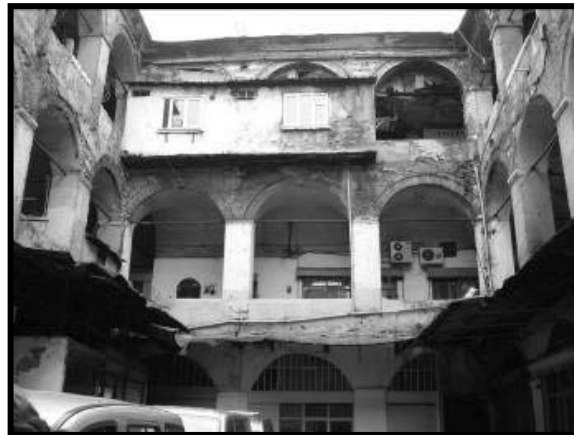
Figure 4. Additional rooms in Buyuk Yeni Inn (17th yy) [2]

Such additions were initially made with materials that could easily be removed, but those were later reinforced with more permanent materials such as fired bricks and brick blocks. Over time, new additions have been made on top of those as well. Such additions occupy the central courtyard area, blocking off the structure of the building. It has been found that the owners of the properties, seeking to enlarge their space, have detracted from the architecture of the inns by adding mezzanines on the upper floors of inns, as well as building mezzanine floors in colonnades, knocking down walls to join rooms, blocking off colonnades and building additional rooms in corridors, and building rooms against the facades of the courtyard walls which have in some cases been plastered over and painted (figure 4). The creation of additional rooms by blocking off colonnades and the creation of corridors between them makes it difficult to recognize the colonnades for what they are.

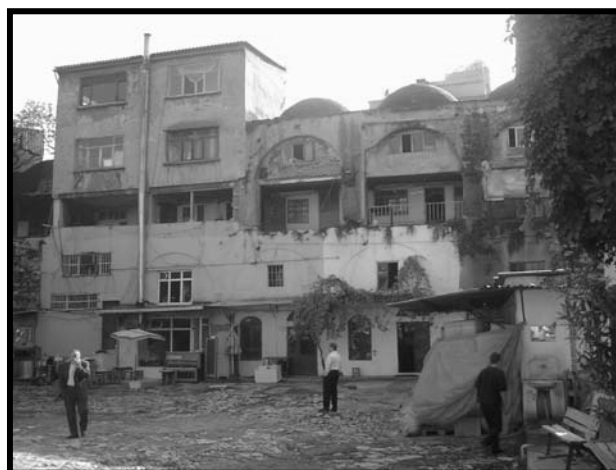
Figure 5. Mezzanine floors in Balkapanı Inn (17th yy) [3]

The random construction of mezzanine floors, the building of dividing walls, the opening of display spaces in facades facing the street and the construction of new entrances have resulted in rapid changes in the inns. A mezzanine floor, added to the second-story colonnade at an inn to increase the space, was built all the way up to the steel tie rod which was then used to support its weight. It has been noted that entire walls have been removed so that large machines could be brought into inns that are used as workshops and it is thought that the vibrations created by those machines have further strained the structure of the buildings themselves. Such uses of inns have been detrimental to their original structure and led to structural damage such as cracks, separation, collapses and crumbling.

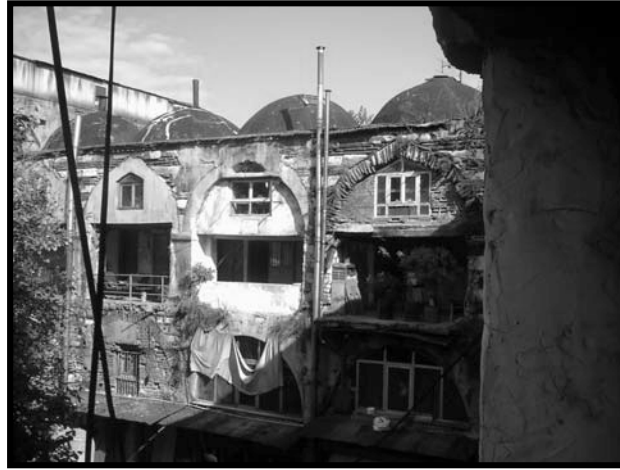
Figure 6. Additional rooms in the porticos of Balkapanı Inn (17th yy) [3]

Much damage has been inflicted on the historical Inn District as individuals move to the city with the aim of doing business but are unaware of the historical value of the places where they conduct their trade. The socio-cultural values of the property owners lead to inappropriate approaches to the treatment of the buildings which brings about destruction of the historical ambiance of the area as well as physical damage to the inns. Even if the original facades of some inns have been preserved, it has been noted that the courtyards are undergoing a negative transformation. While the contours of the courtyards may still be visible, additions made to rooms and colonnades using modern construction materials have resulted in a state of affairs in which the original architecture is disappearing (Figure 6). It has also been noted that concrete multistory buildings have been built on the premises of inns, leading to a situation in which the original design has been altered and is no longer discernable.

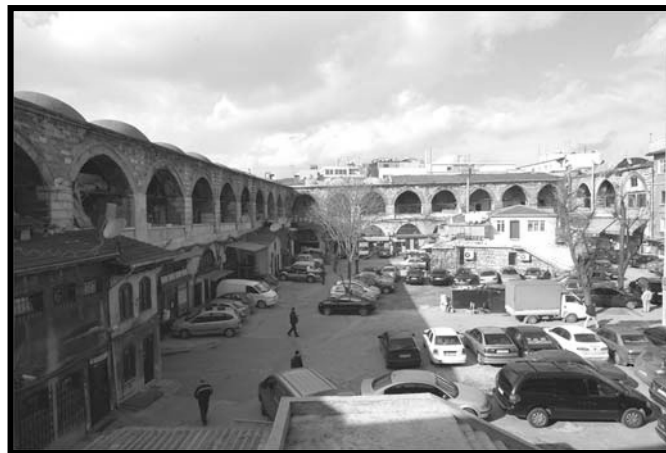
Figure 7. Cars in the courtyard of Vezir Inn (17th yy) [3]

Due to the fact that there aren't any parking lots in the district, the courtyards of the majority of inns are used as parking areas and delivery trucks bringing and picking up goods enter the courtyards as well. The tremors created by such vehicles as they come and go has a negative impact on the buildings of the inns. In addition, the streets in the district aren't broad enough for the large amount of vehicular and foot traffic, leading to yet another negative situation, along with the problems created by the loading, unloading and storage of goods. Because the district is not residential, at night it is rather empty, thus leading to problems of security; additionally, the grounds in the area aren't looked after and are unkempt (Figure 7).
